MARCH 2000

DOCKING & LANDON STATE OFFICE BUILDINGS CODE REVIEW

FireDynamics

Docking and Landon State Office Buildings

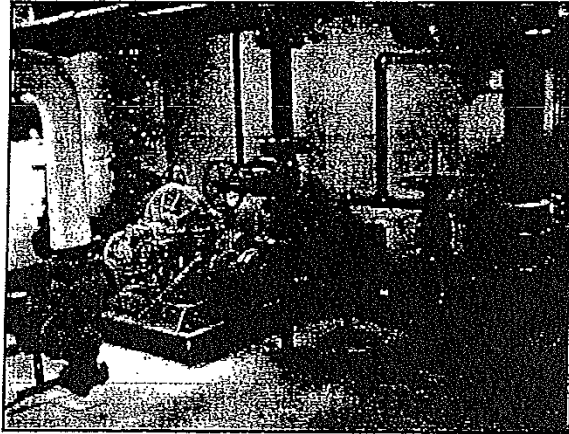
The building is equipped with a Class II standpipe system with 2-1/2-inch hose valves with 1-1/2-inch threaded hose connections in cabinets located outside of each stairway on all floors. The

system is fed by a 500 gpm at 125 psi horizontal split-case fire booster pump located in the subbasement. The pump is arranged to start automatically. The fire pump had not been tested in many years. Refer to the attached fire pump test report at the end of this document. The fire pump takes suction from a six-inch connection to the public water supply. Static pressure and a limited water supply are maintained in the standpipe system by an approximately 3,000 gallon water storage tank located in the Mechanical Penthouse. The tank is maintained approximately 2/3 full and

It is recommended that minor maintenance is performed on the fire pump and the pump is kept in service. The pump performed satisfactorily during the flow test on March 15, 2000. The new sprinkler system will be designed with the option of adding a new fire pump, jockey pump and controller at some time in the future when it is determined that this expense is justified.

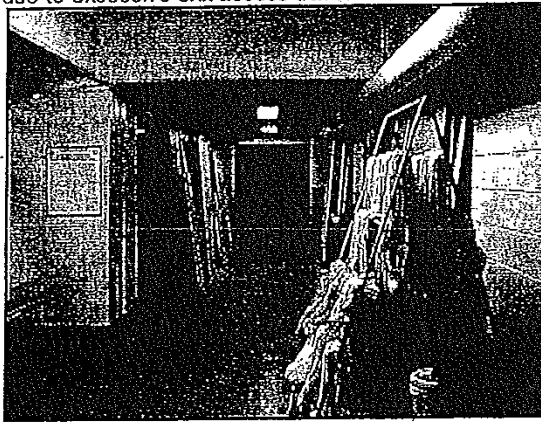
The corridors are required to be separated from adjacent spaces with fire resistive construction due to excessive exit access travel distance. There are many significant penetrations in the walls

which need to be sealed or firestopped. Although the physical separation is almost complete for the corridors, the exit access separation needs to be extended near the service elevator. This can be accomplished by constructing a one-hour rated separation with a minimum one-hour rated self- or automatic-closing fire doors west of the south bank of elevators. The double doors at the south end of the hallway should be provided with self- or automatic-closing hardware.

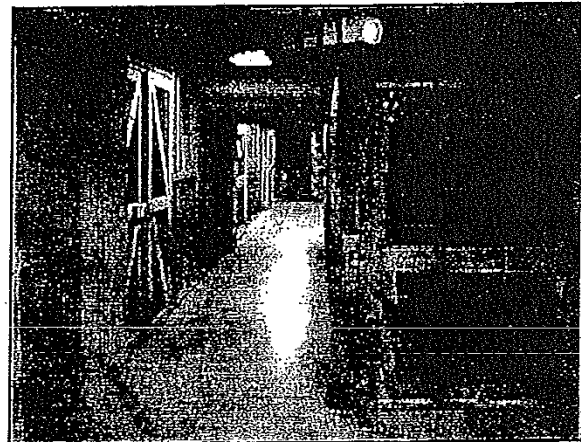
The General Storage Area is divided into spaces with wood-frame and wire mesh partitions. The wall separating the General Storage Area from the adjacent hallway is 4-inch concrete block. The two sets of double doors connecting this area to the adjacent hallway do not appear to be fire rated but are of solid-core metal-clad construction with steel frames without closers.

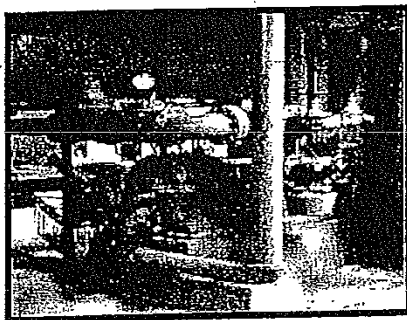
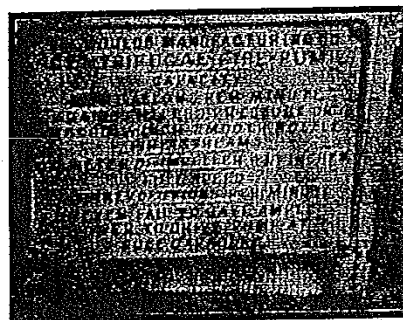
An existing 80 year old electric split-case, multi-stage, end suction fire pump with an accumulator

tank serves the standpipe system. The controller is an across the line start type with a manual start switch. Corrosion was noticed on the pump shaft where at least 10 percent of the diameter has corroded away near the bearings. The electric motor is an open frame type, non-drip proof design. It is recommended later in this report that the fire pump, tank and controller are replaced with newer and more efficient models.

The existing fire pump will be removed and replaced with a new fire pump, jockey pump and controller which meet current code. This design will be included in the next phase of the project. The new pump will be located in the same room, however it will be separated from the corridor with a one-hour fire resistive rated wall and 60 minute rated door.

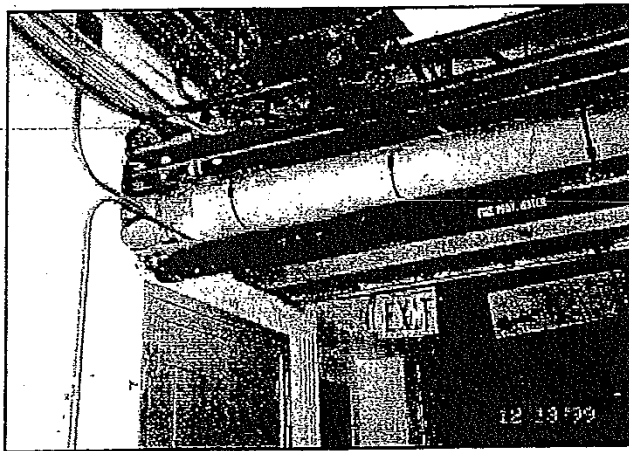
The west corridor wall appears to have been a rated wall at some time. This wall is built of masonry block and brick of varying sizes. Many louvers and grilles now penetrate the wall to ventilate the battery and electrical switch gear rooms. Numerous unprotected pipe and conduit penetrations are located along the corridor and through out the basement. There are also many old holes in the ceilings where pipe or conduit has been removed.

The rating of the existing corridor should be completed and reinstated to its original construction for several reasons:

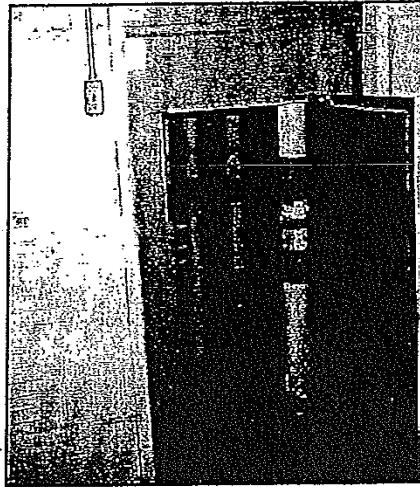
Old ventilation shafts are being used as pipe and conduit chases. A steam condensate pump with motor starters is located in the ventilation shaft near column 53. The shaft extends up through the building and communicates with every floor. There are doors into the shaft on every other floor level. The shafts are not rated and have many penetrations in them that would allow smoke from the basement to spread through out the building. Combination fire/smoke dampers and firestopping should be installed at every intersection of every horizontal to vertical communication. Rated fire doors should be installed at every opening. Sealing of this shaft will be nearly impossible, as has been demonstrated already in an attempt to perform the halon test. It is advisable to provide a sprinkler within the shaft at every level, due to the quantity of combustible cable and insulation visible in the shaft.

There are several other locations where pipe, conduit or ductwork extends through the ceiling of the basement into and beyond the first floor. Again, these penetrations should be filled with similar material and firestopped.

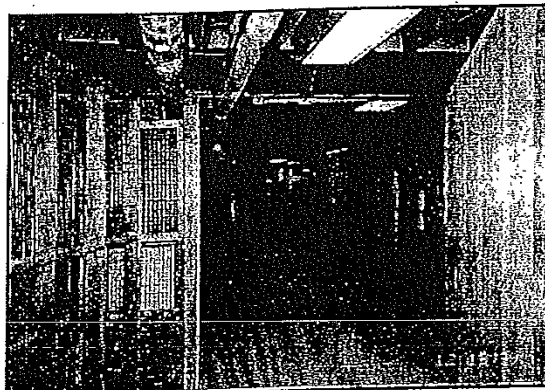
The exhaust duct along columns 29 and 30 is being used for storage.

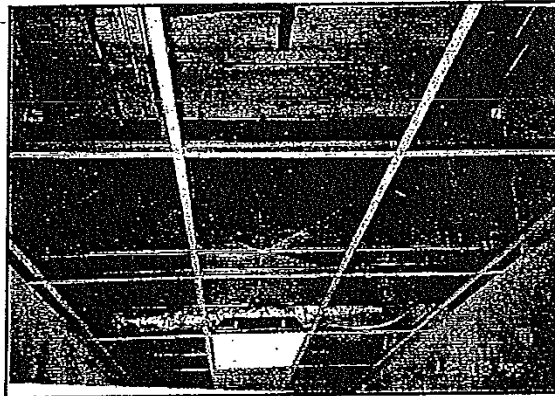
The original corridor doors on the tenant floors had operable transoms installed above each door for ventilation. These have been sealed with plywood panels. It appears that the sashes of the transoms are wood construction. Most of the doors are original and are non-rated solid-core wood construction. The doors to the newer emergency fire exit stairwells are rated labeled fire doors.

The corridors were not originally designed as fire-resistance rated egress elements. The 1997 Uniform Building Code allows non-rated "hallways" in office buildings if the exit access travel distance is less than 250 feet when provided with a full sprinkler and smoke detection system. Therefore, upgrading of the existing corridors on each floor, with the exception of the Basement, is not required. Interior hallways within tenant spaces are not required to be fire-resistance rated either.

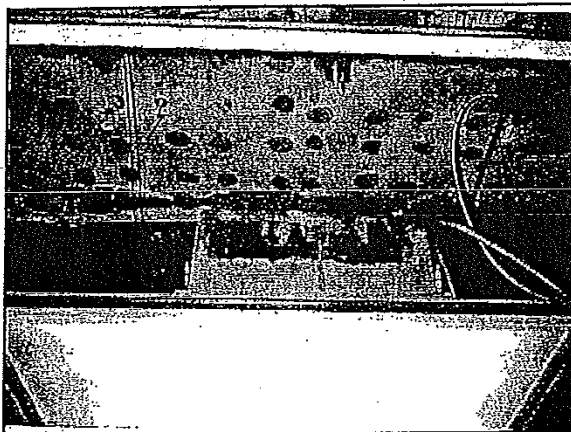
It is a code violation to use the corridors for air exchange. Without a requirement for rated corridors, it is still required that the return air plenums above office spaces are separated from the corridor environment. Corridor wall, therefore, are required to extend to structure and be smoke-tight. Rated doors are not required in the corridor walls. The plenum is required to extend across the corridor in duct-work to the mechanical room on the other side. This is similar to the remodel recently completed on the 6th floor.
