**Subject:** Summary of work performed on electrical distribution system in the Docking Building.

Capital Electric Construction was contracted to perform maintenance and cleaning of the 13.2kV electrical distribution system in the Docking Building. The work was started on Wednesday, November 24 and completed on Saturday, November 27. This report summarizes our findings.

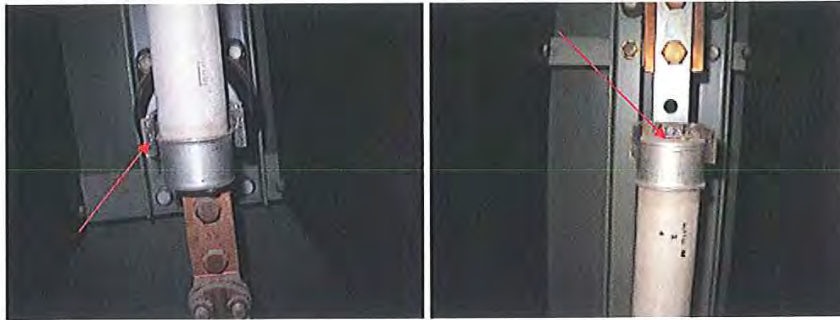
- 5.8 LUCS 5, on the (3rd) floor was found with the C phase fuse improperly inserted into the fuse clip. This could cause overheating, premature aging of the fuse and unscheduled outages. Capital Electric Personnel were to correct this problem before restoring service. The left picture is the load side of the fuse and the right picture is line side of the fuse.

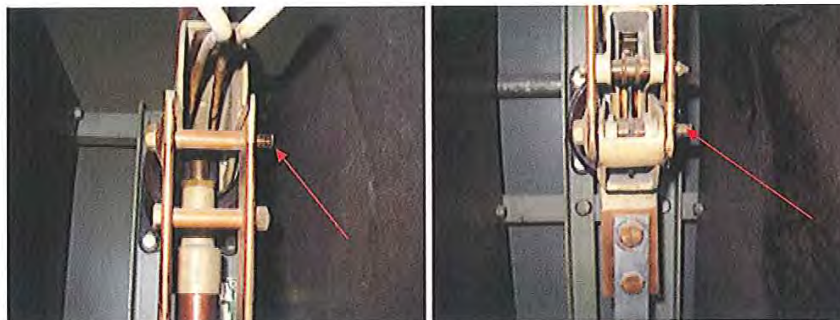
- 5.9 LUCS 3, on the (1st) floor was found with the knife blades fully penetrating the stationary contacts. However the C phase knife switch was found to be missing a nut and cup washer on the line and load side of the switch. This could cause contact heating, deterioration, and eventual failure of the switch. This problem was corrected before restoring utility power by Capital Electric personnel. The left picture is the moving portion of the switch, and the right picture is the elbow or pivot part of the switch. No further mechanical action required at this time.

- It is suggested that a complete cleaning and maintenance test be performed at the next scheduled outage. Electrical Reliability Services would be pleased offer this service.

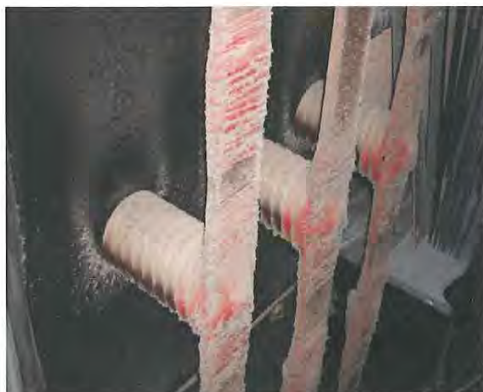
The dangers presented with the existing equipment include the possibility for an arc to be started with the displacement of the existing dust. Refer to Photographs 1 and 2 for pictorial representation of the extent of dirt/dust accumulation. The dust itself is explosive. If an electrical arc is started due to the conductivity of the dust particles, the addition of the fault electrical current could lead to an explosion in the electrical bus duct causing sever damage to the electrical equipment and harm to any personnel in the area.

Photograph 1: 15 kV Vertical Copper Bus (Side view)

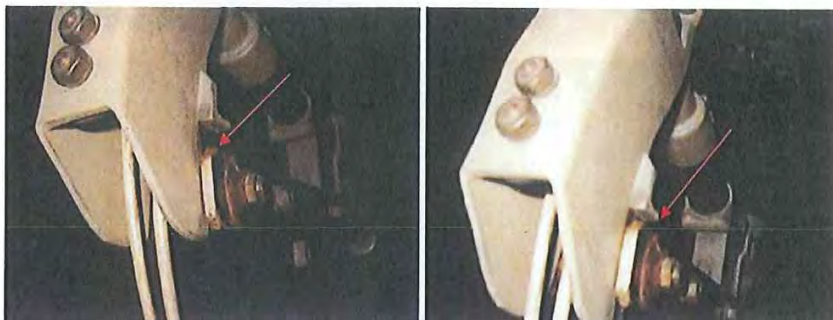
The pictures below are examples of this condition. The left picture is the before adjustment picture and the right picture is after corrections were made.

- It is recommended that all the switches be cleaned and tested. Electrical Reliability Services would be please to provide this service.
- 5.7 LUCS 5, on the (3rd) floor was found with the B phase fuse improperly inserted into the fuse clip. This could cause overheating, premature aging of the fuse and unscheduled outages. Capital Electric Personnel were to correct this problem before restoring service. The left picture is the line side of the fuse and the right picture is load side of the fuse.

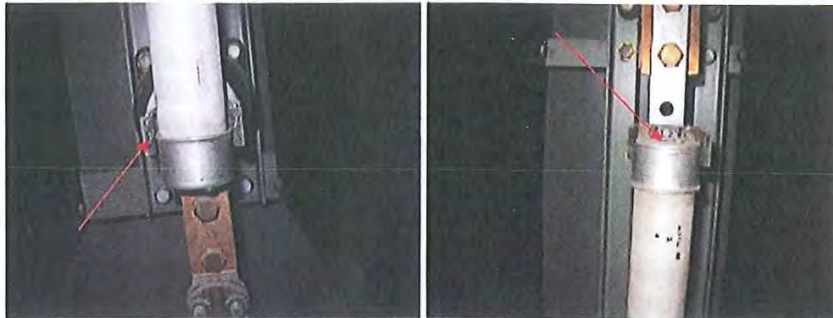
- 5.8 LUCS 5, on the (3rd) floor was found with the C phase fuse improperly inserted into the fuse clip. This could cause overheating, premature aging of the fuse and unscheduled outages. Capital Electric Personnel were to correct this problem before restoring service. The left picture is the load side of the fuse and the right picture is line side of the fuse.

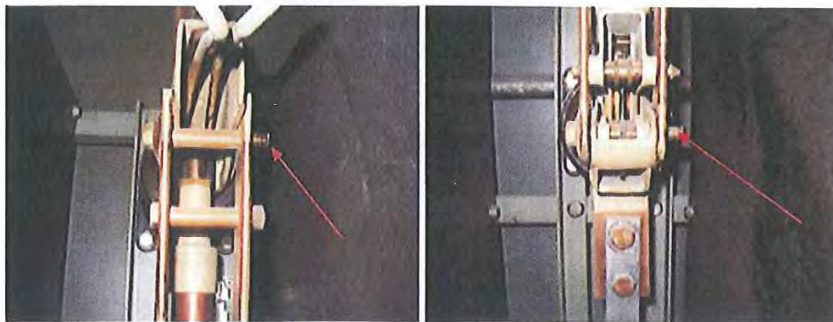
- 5.9 LUCS 3, on the (1st) floor was found with the knife blades fully penetrating the stationary contacts. However the C phase knife switch was found to be missing a nut and cup washer on the line and load side of the switch. This could cause contact heating, deterioration, and eventual failure of the switch. This problem was corrected before restoring utility power by Capital Electric personnel. The left picture is the moving portion of the switch, and the right picture is the elbow or pivot part of the switch. No further mechanical action required at this time.

- It is suggested that a complete cleaning and maintenance test be performed at the next scheduled outage. Electrical Reliability Services would be pleased offer this service.

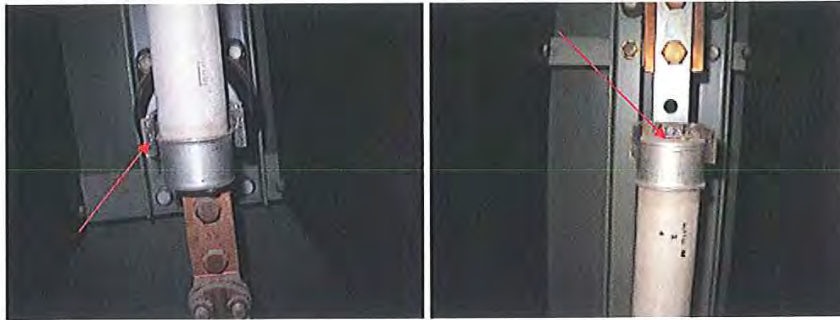
- 5.8 LUCS 5, on the (3rd) floor was found with the C phase fuse improperly inserted into the fuse clip. This could cause overheating, premature aging of the fuse and unscheduled outages. Capital Electric Personnel were to correct this problem before restoring service. The left picture is the load side of the fuse and the right picture is line side of the fuse.

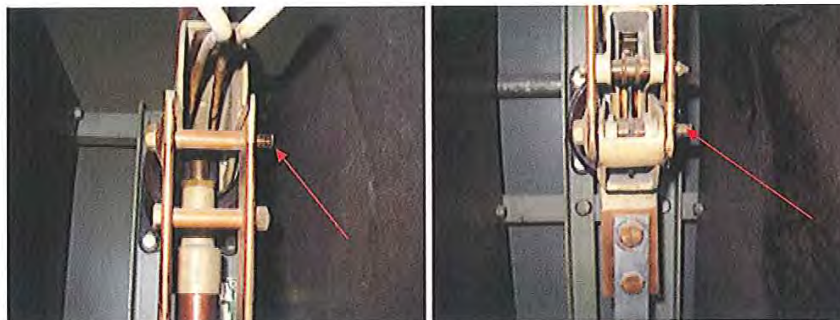
- 5.9 LUCS 3, on the (1st) floor was found with the knife blades fully penetrating the stationary contacts. However the C phase knife switch was found to be missing a nut and cup washer on the line and load side of the switch. This could cause contact heating, deterioration, and eventual failure of the switch. This problem was corrected before restoring utility power by Capital Electric personnel. The left picture is the moving portion of the switch, and the right picture is the elbow or pivot part of the switch. No further mechanical action required at this time.

- It is suggested that a complete cleaning and maintenance test be performed at the next scheduled outage. Electrical Reliability Services would be pleased offer this service.

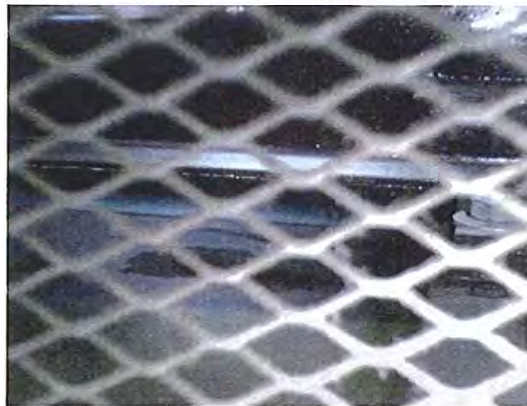
62IDC\_2984.jpg

| There is possible resin residue from the phase coils indicating possible failure. | | | |

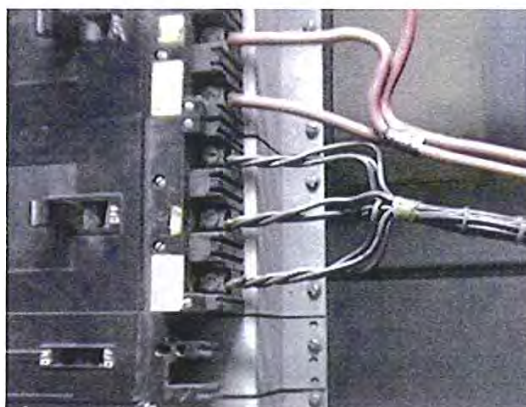
62ldc\_2995.jpg

Parallel conductors smaller than 1/0 are installed improperly. 2002 NEC 310.4

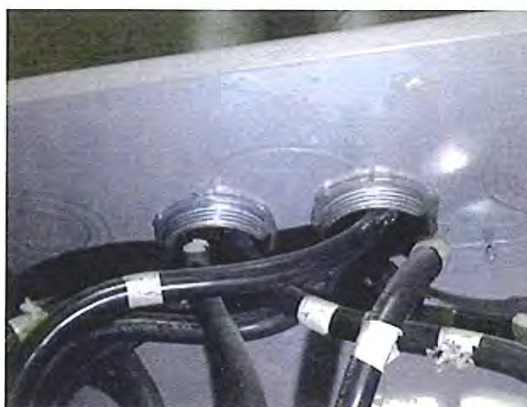
62IDC\_2928.jpg

Missing insulated fittings/bushings (2002 NEC 300.4 (F)), raceways containing ungrounded conductors 4 AWG or larger entering a cabinet or box enclosure must have bushings installed.

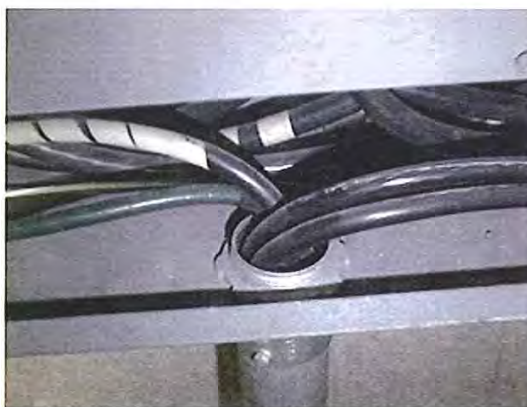
62IDC\_2870.jpg

Missing insulated fittings/bushings (2002 NEC 300.4 (F)), raceways containing ungrounded conductors 4 AWG or larger entering a cabinet or box enclosure must have bushings installed.
