Inspection Number: 865708002

INDOOR AIR QUALITY ASSESSMENT REPORT

This report provides the results of an Indoor Air Quality Health Inspection of the Docking State Office Building located 915 Harrison St. in Topeka, KS. On July 24, 2007 Helen Cook, Certified Industrial Hygienist, and Betsy Gaydness, Industrial Hygiene Consultant Trainee, conducted an indoor air quality inspection, in response to employee concerns relative to indoor air quality to determine if any unhealthy conditions were present relative to indoor air quality. The inspection consisted of a visual inspection and a review of material safety data sheets (MSDSs). At the time of the inspection the Kansas Department of Labor found no problem regarding indoor air quality at Docking State Office Building facility.

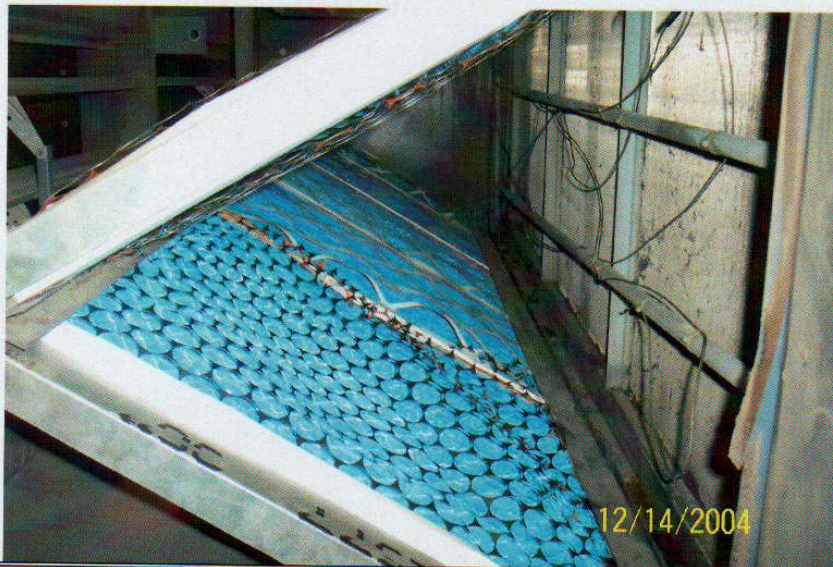
View of filters in 10th floor air handling unit. Filters appear to be well maintained with no build-up of excessive dust or debris.

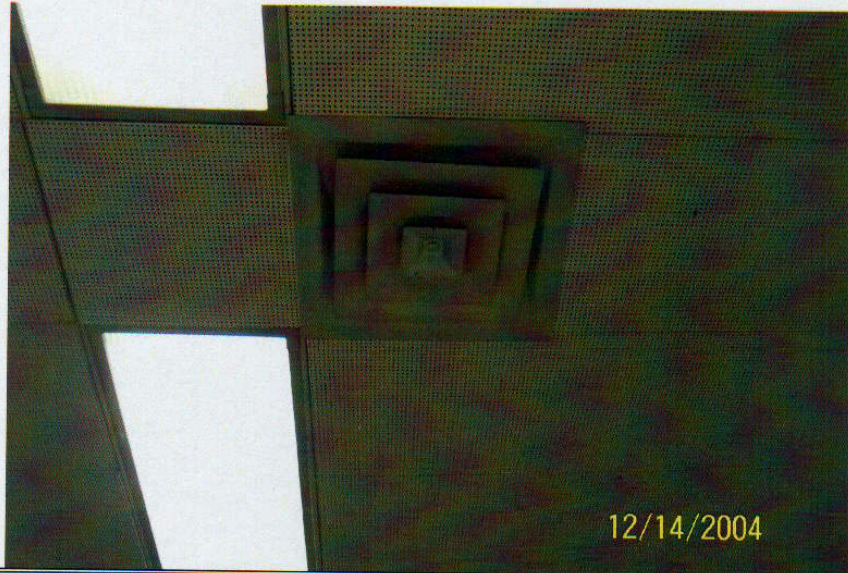
Photo No. 3 View of ceiling air diffuser located on 10th floor. Diffuser appears to be relatively clean with no evidence of fungal growth. Typical of all diffusers on 10th floor.

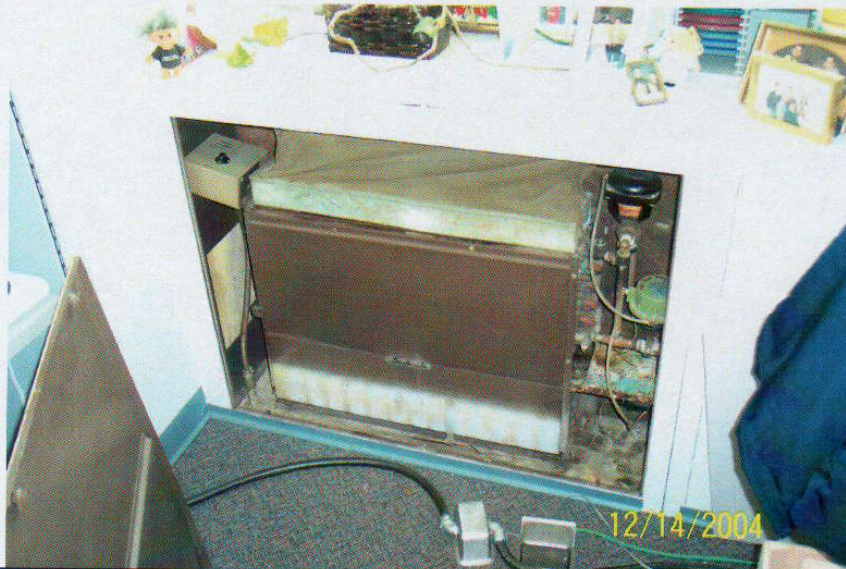
Photo No. 5 View inside 10th floor ventilator unit.

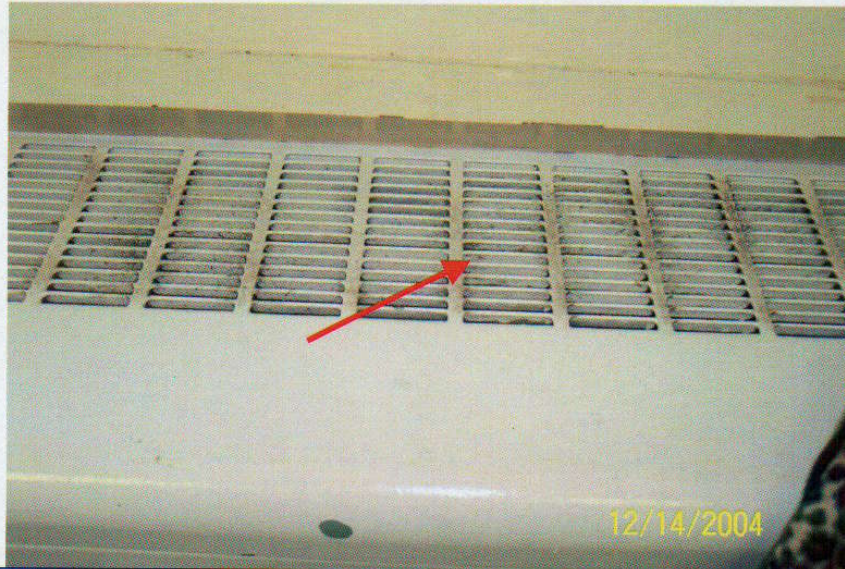
Photo No. 7	View of diffuser on 10 th floor ventilator. Note discoloration on diffuser. Arrow denotes location of sample T-13.
--------------------	---

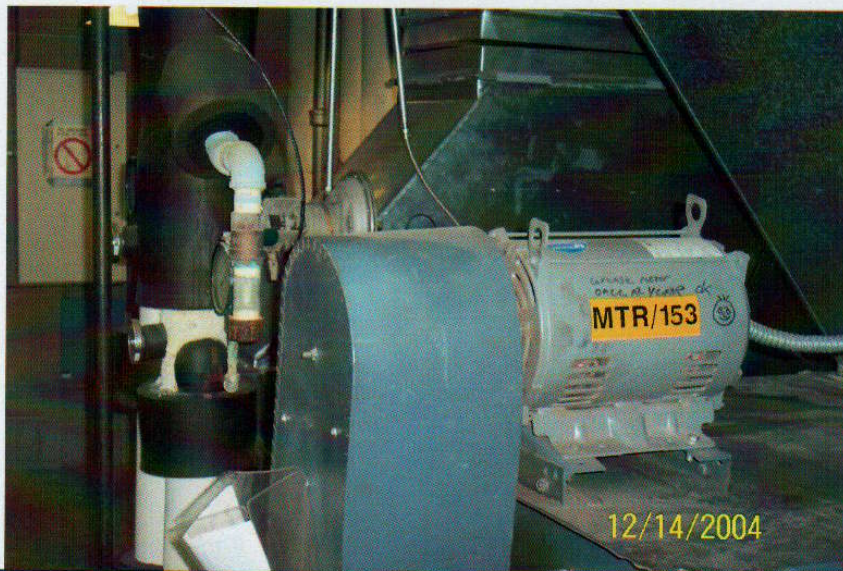
Photo No. 8	View of air handling unit in 4 th floor mechanical room.
--------------------	---

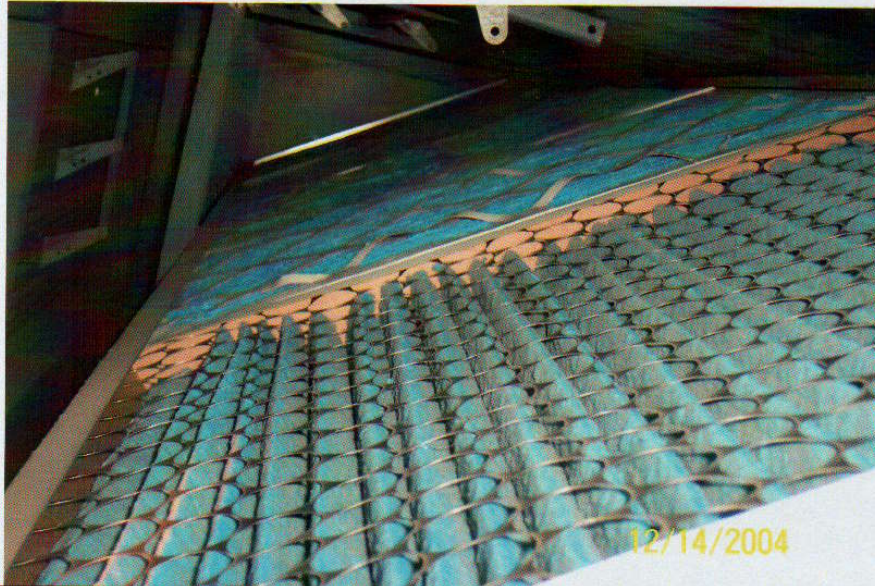
Photo No. 9 View of filters in 4th floor air handling unit. Filters appear to be well maintained with no build-up of excessive dust or debris.

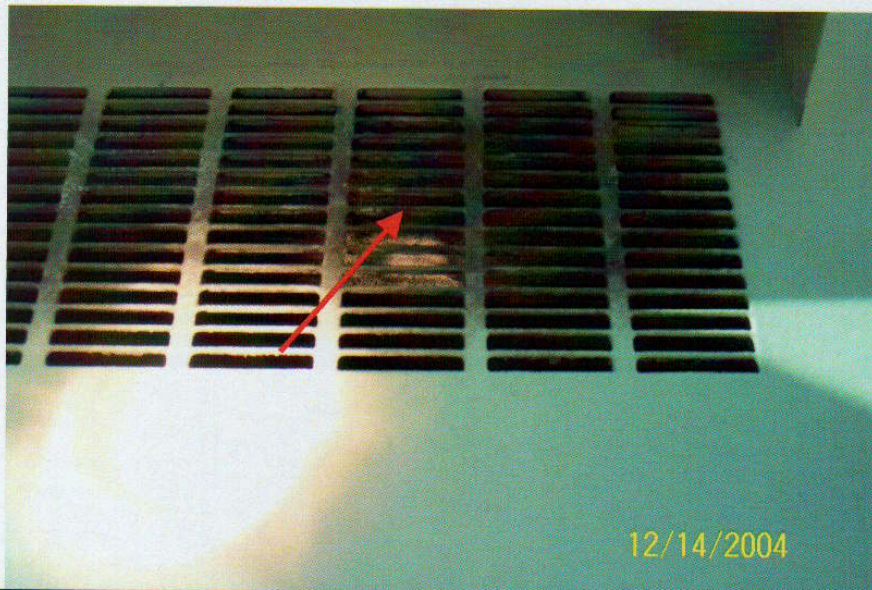
Light fungal growth was identified on top of some of the convector units that run along the perimeter walls on both the fourth and tenth floors (see Appendix B, Photo Log). Surface sampling indicates this fungal growth consists of species of Cladosporium. Cladosporium is a ubiquitous type of fungi commonly observed in the outdoor environment and is not considered to be a "toxic mold". Furthermore, based on the

Photo No. 10 View of diffuser on 4th floor ventilator. Note discoloration on diffuser. Arrow denotes location of sample T-08.

Due to the light fungal growth on the top of the convector units, APEX recommends that the units be cleaned in accordance with NADCA standards. Future cleaning of these units should be performed on the current quarterly maintenance schedule.

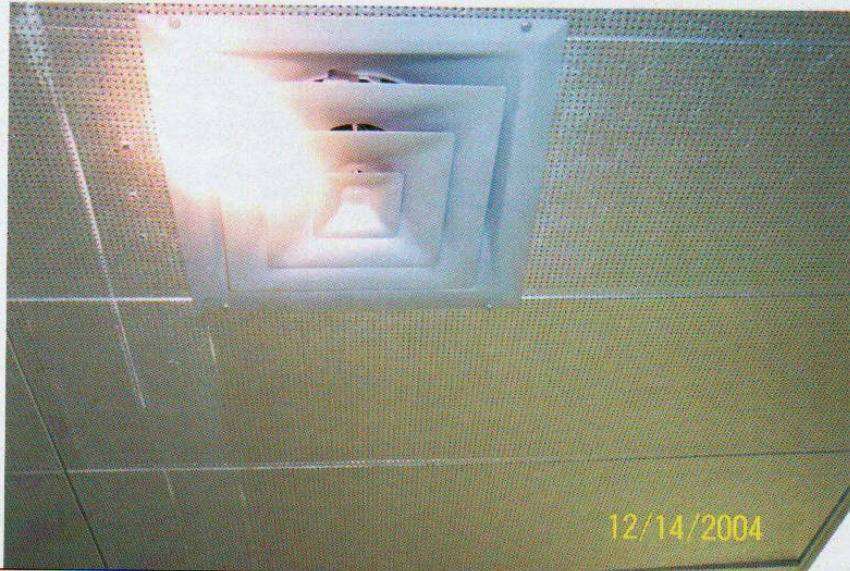
Photo No. 11 View of ceiling air diffuser located on 4th floor. Diffuser appears to be relatively clean with no evidence of fungal growth. Typical of all diffusers on 4th floor.

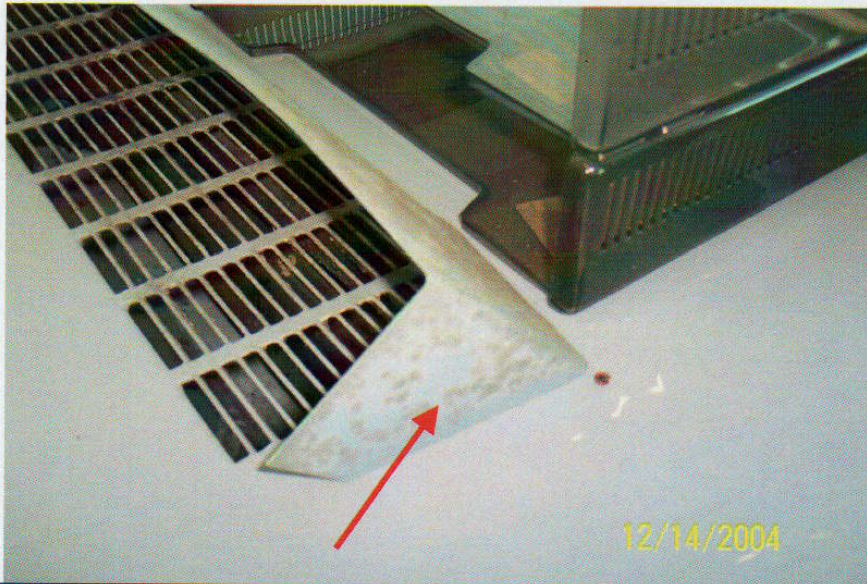
Photo No. 13	View of diffuser on 4 th floor ventilator. Note discoloration on diffuser. Arrow denotes location of sample T-10.
---------------------	--

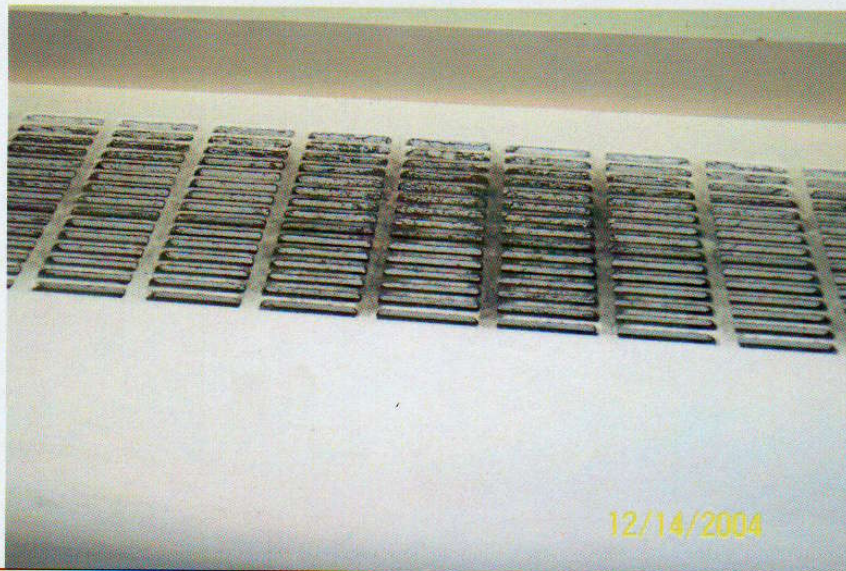
Photo No. 14	View of diffuser on 4 th floor ventilator. Note discoloration on diffuser.
---------------------	---

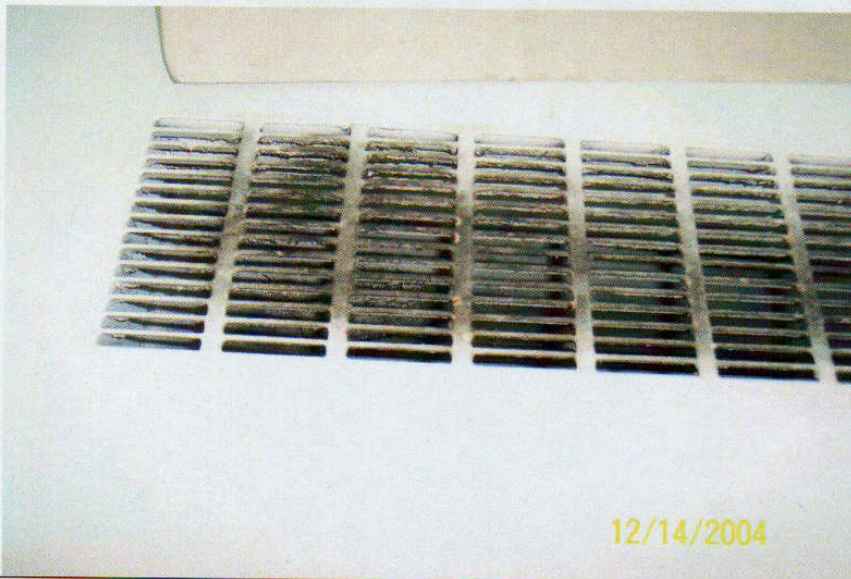
Photo No. 16

View of diffuser on 4th floor ventilator. Note discoloration on diffuser.

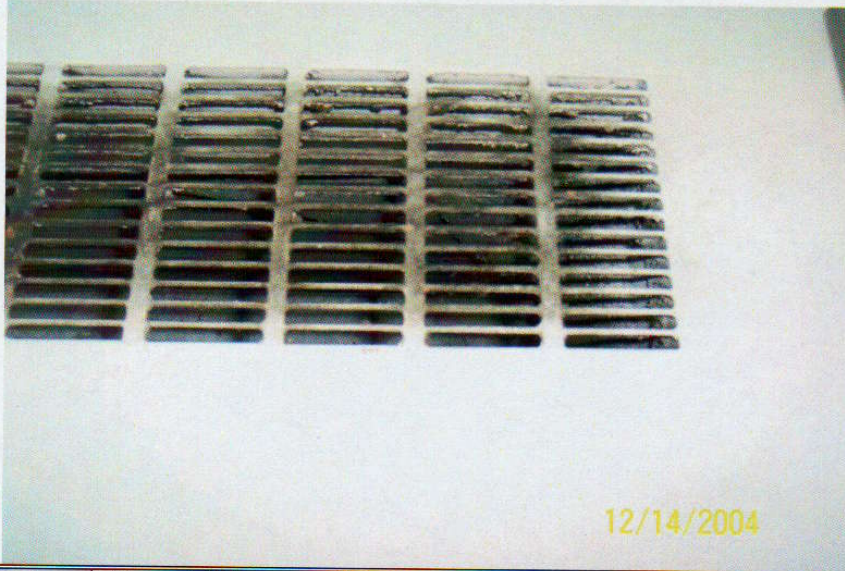
Photo No. 17	View of diffuser on 4 th floor ventilator. Note discoloration on diffuser.
---------------------	---

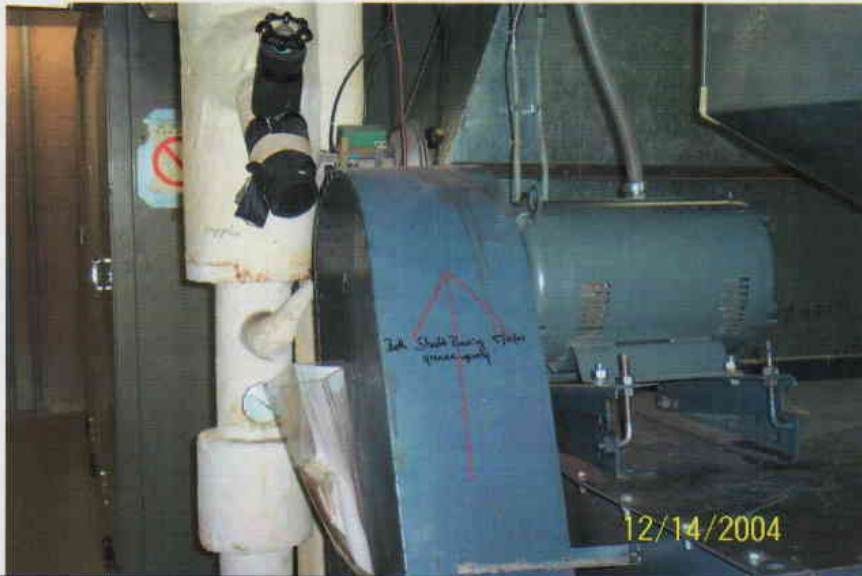
Photo No. 1	View of air handling unit in 10 th floor mechanical room.
--------------------	--

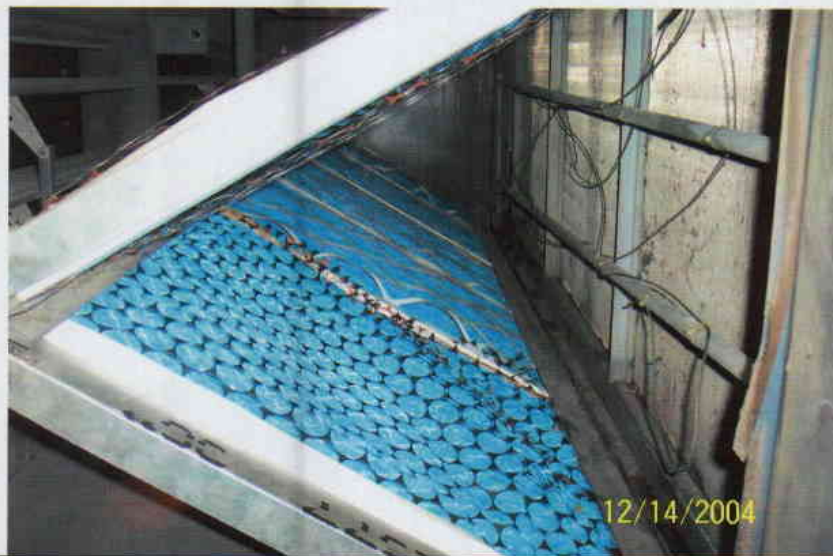
Photo No. 2	View of filters in 10 th floor air handling unit. Filters appear to be well maintained with no build-up of excessive dust or debris.
--------------------	---

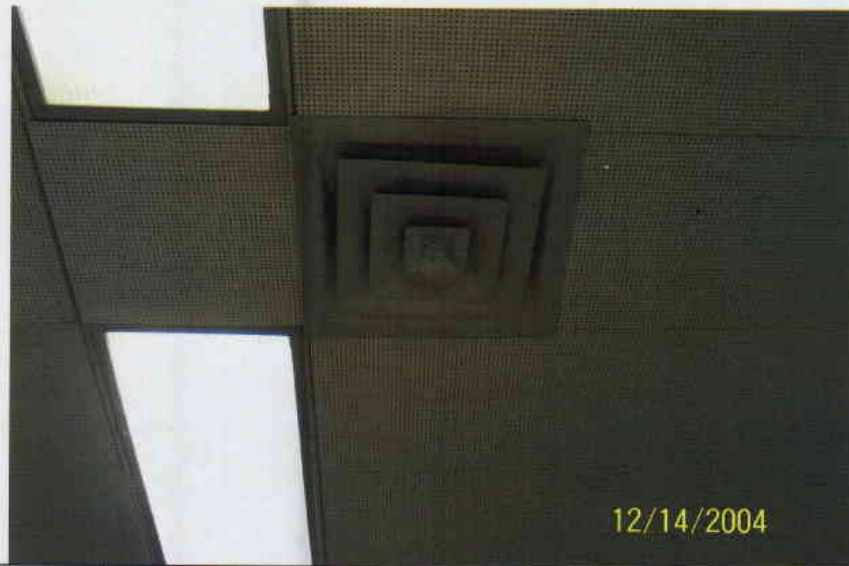
Photo No. 3	View of ceiling air diffuser located on 10 th floor. Diffuser appears to be relatively clean with no evidence of fungal growth. Typical of all diffusers on 10 th floor.
--------------------	--

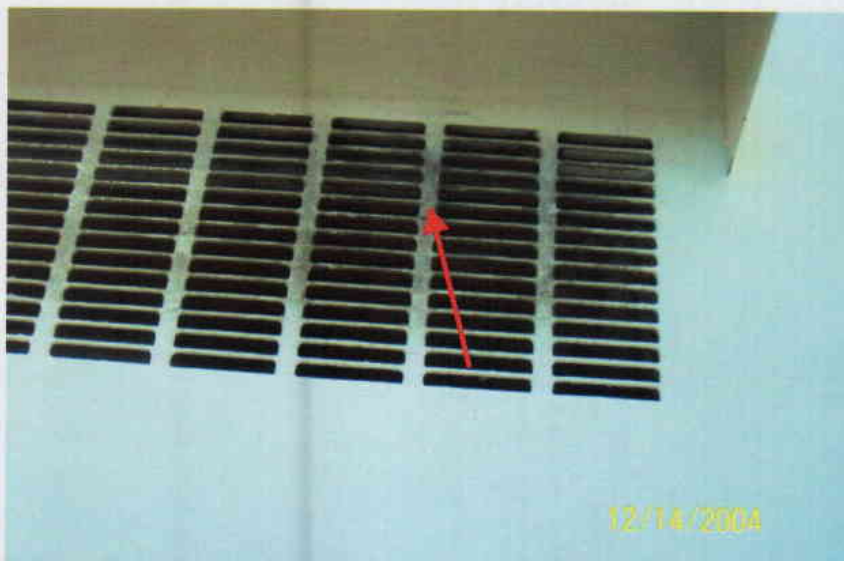
Photo No. 4	View of diffuser on 10 th floor ventilator. Note discoloration on diffuser. Arrow denotes location of sample T-11.
--------------------	---

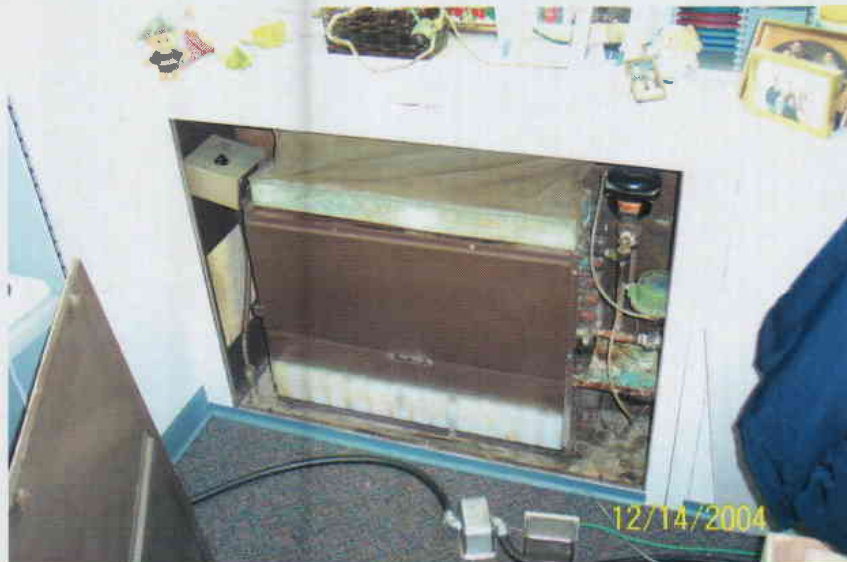
Photo No. 5 View inside 10th floor ventilator unit.

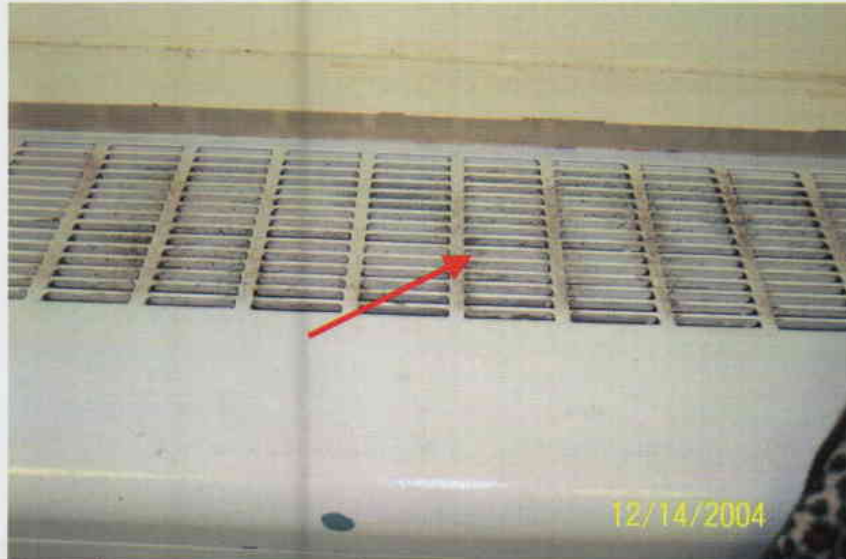
Photo No. 7	View of diffuser on 10 th floor ventilator. Note discoloration on diffuser. Arrow denotes location of sample T-13.
--------------------	---

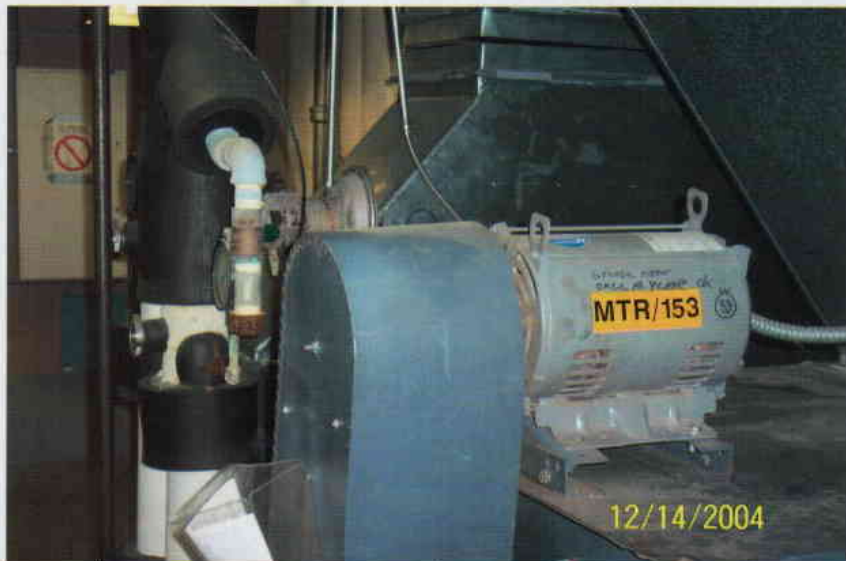
Photo No. 8	View of air handling unit in 4 th floor mechanical room.
--------------------	---

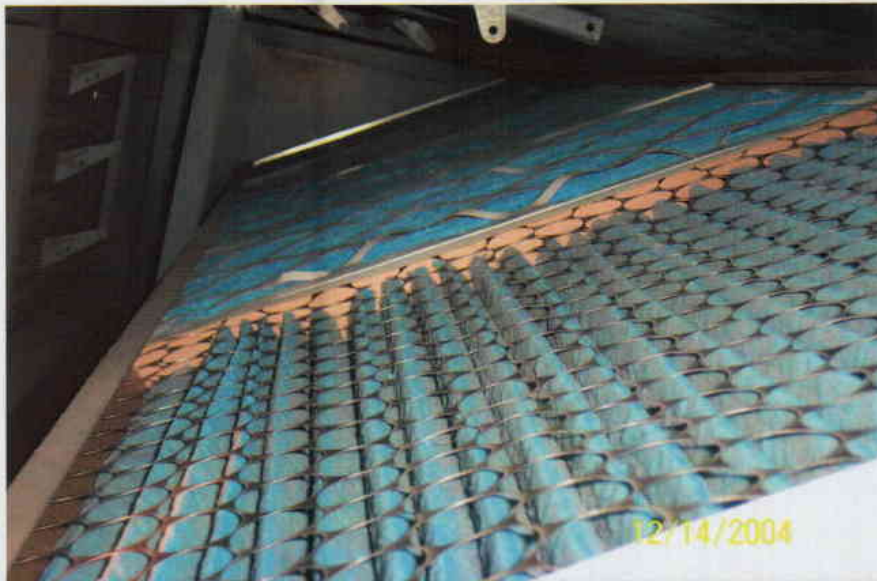
Photo No. 9 View of filters in 4th floor air handling unit. Filters appear to be well maintained with no build-up of excessive dust or debris.

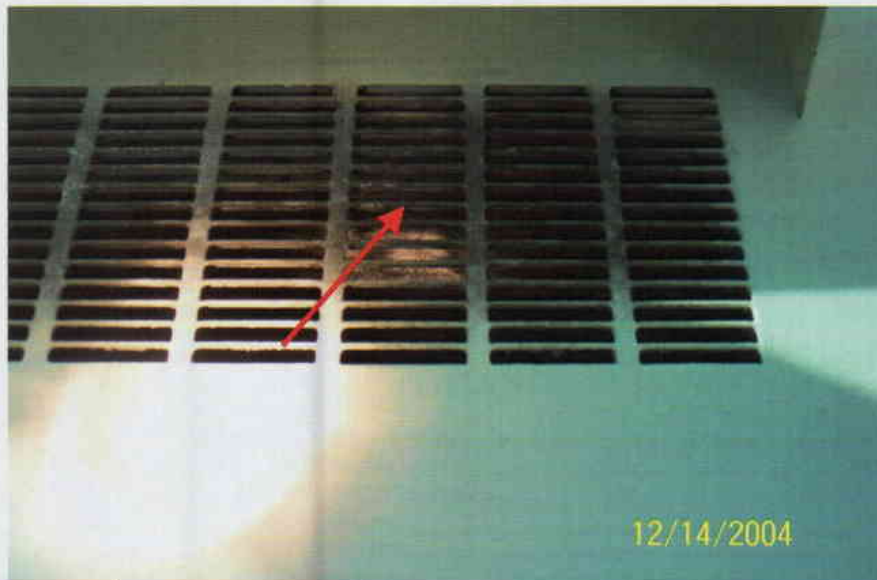
Photo No. 10 View of diffuser on 4th floor ventilator. Note discoloration on diffuser. Arrow denotes location of sample T-08.

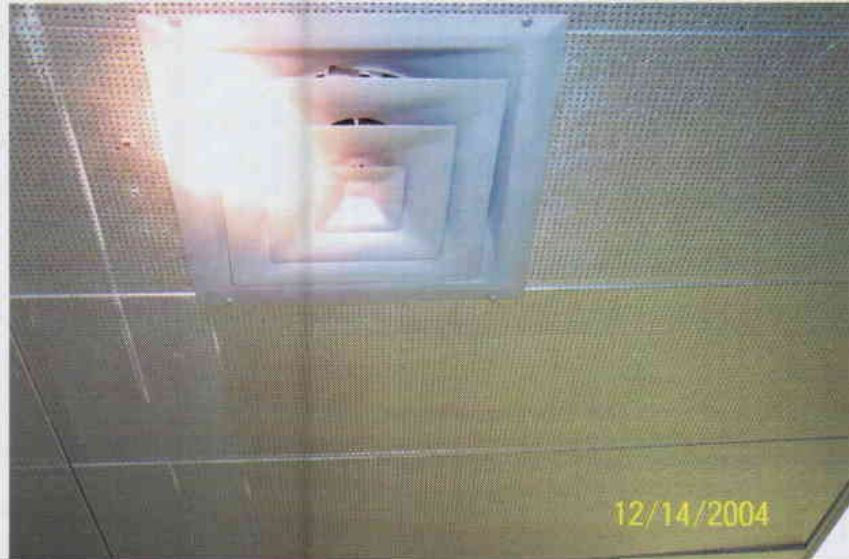
Photo No. 11	View of ceiling air diffuser located on 4 th floor. Diffuser appears to be relatively clean with no evidence of fungal growth. Typical of all diffusers on 4 th floor.
---------------------	--

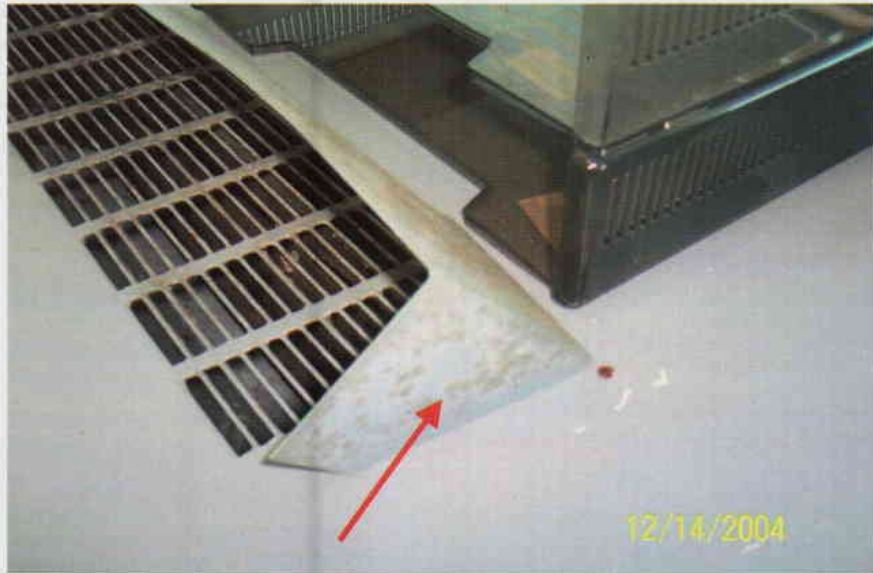
Photo No. 13	View of diffuser on 4 th floor ventilator. Note discoloration on diffuser. Arrow denotes location of sample T-10.
---------------------	--

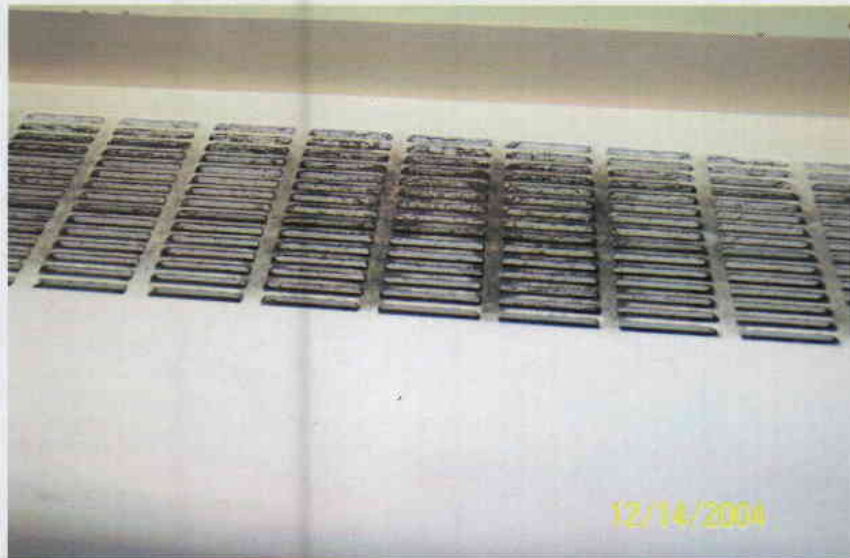
Photo No. 14	View of diffuser on 4 th floor ventilator. Note discoloration on diffuser.
---------------------	---

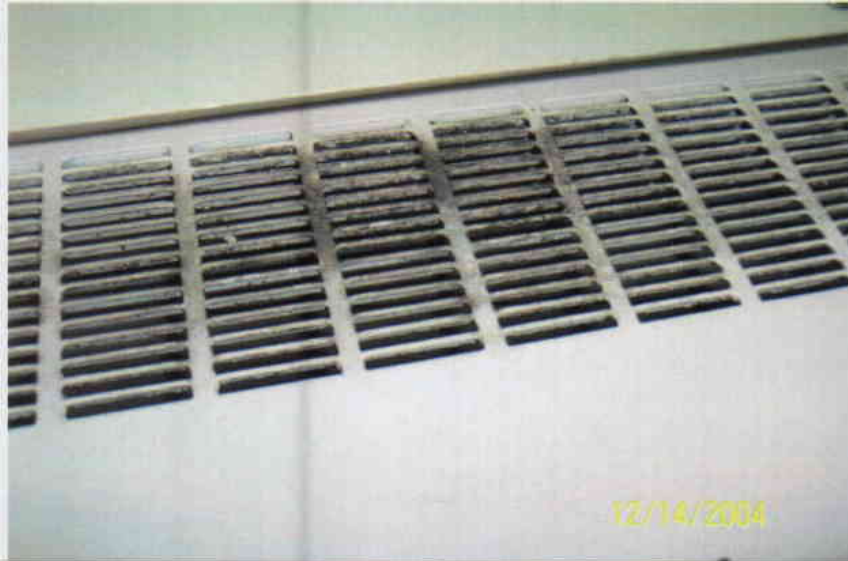
Photo No. 15	View of diffuser on 4 th floor ventilator. Note discoloration on diffuser.
---------------------	---

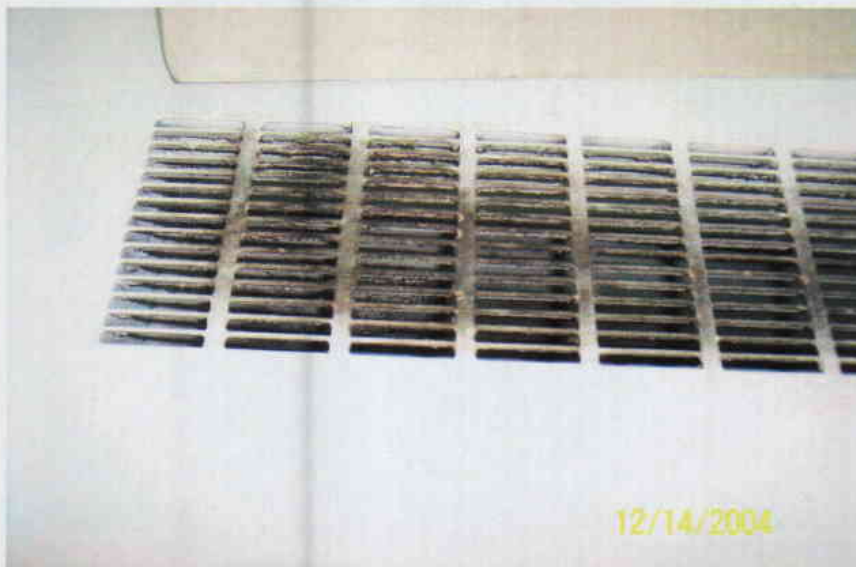
Photo No. 16	View of diffuser on 4 th floor ventilator. Note discoloration on diffuser.
---------------------	---

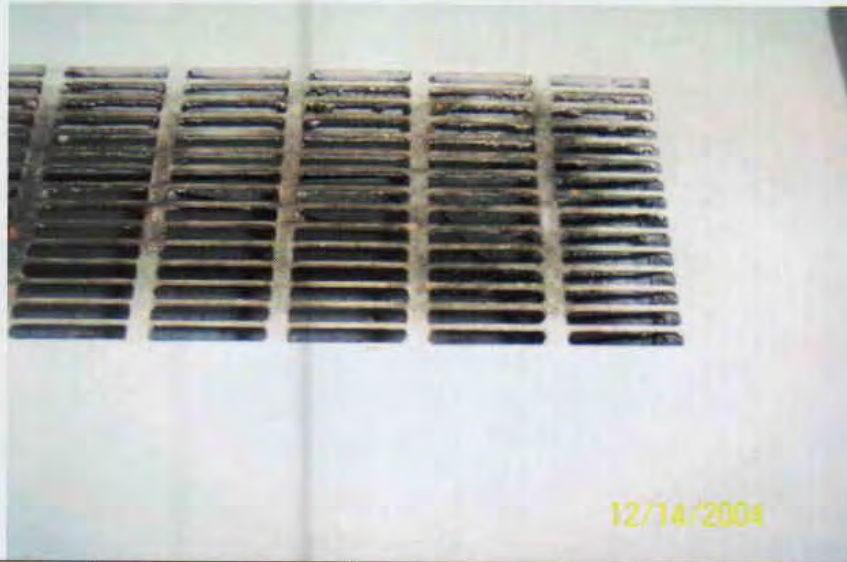
Photo No. 17	View of diffuser on 4 th floor ventilator. Note discoloration on diffuser.
---------------------	---

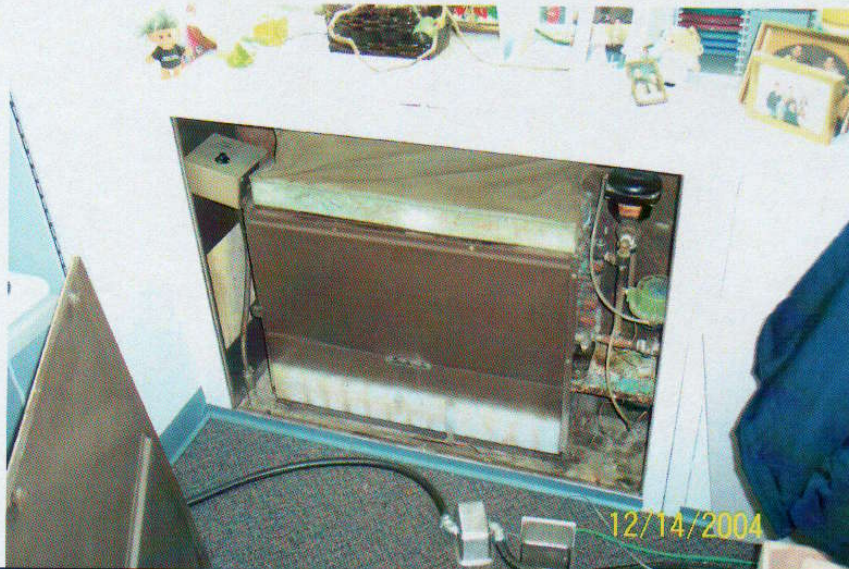
Photo No. 5 View inside 10th floor ventilator unit.

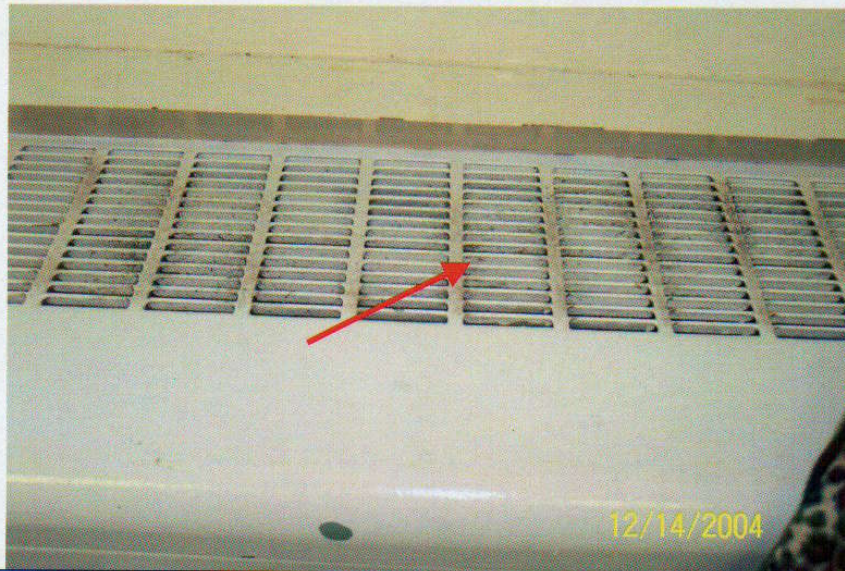
Photo No. 7	View of diffuser on 10 th floor ventilator. Note discoloration on diffuser. Arrow denotes location of sample T-13.
--------------------	---

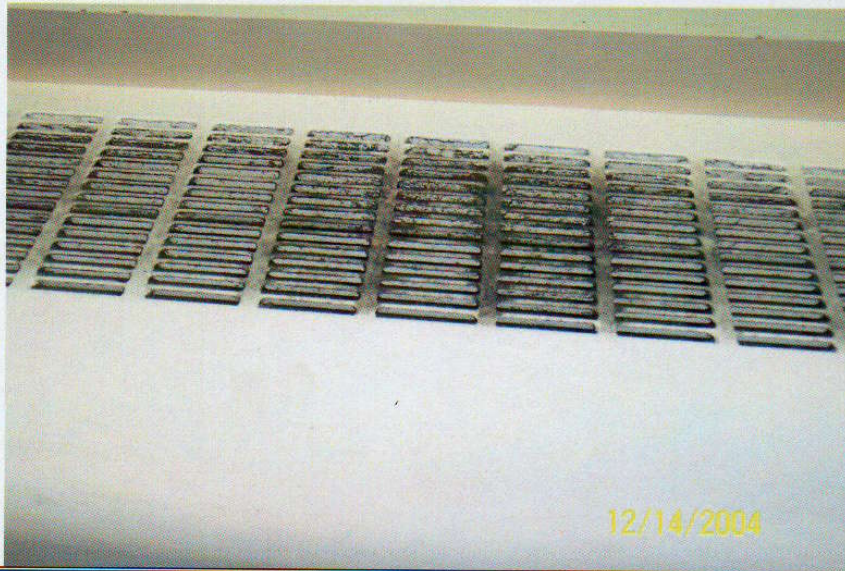
Photo No. 14	View of diffuser on 4 th floor ventilator. Note discoloration on diffuser.
---------------------	---

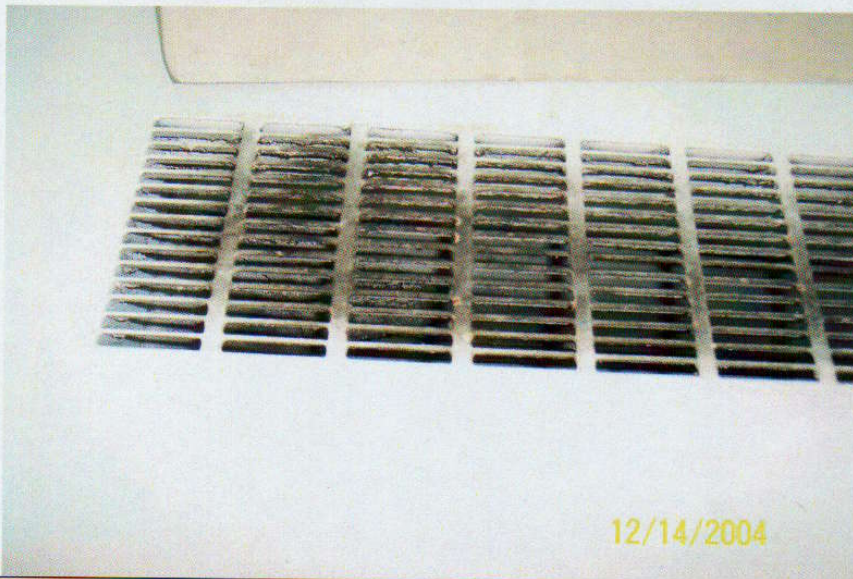
Photo No. 16

View of diffuser on 4th floor ventilator. Note discoloration on diffuser.

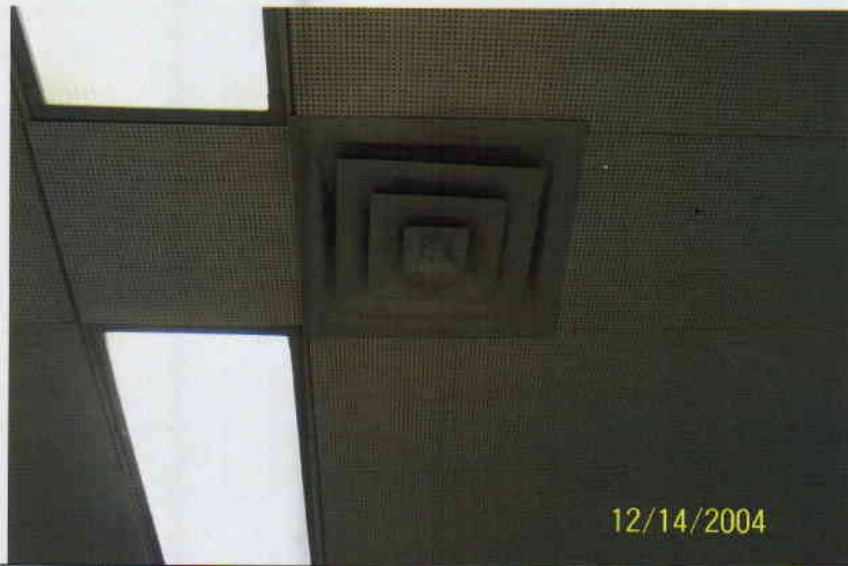
Photo No. 3	View of ceiling air diffuser located on 10 th floor. Diffuser appears to be relatively clean with no evidence of fungal growth. Typical of all diffusers on 10 th floor.
--------------------	--

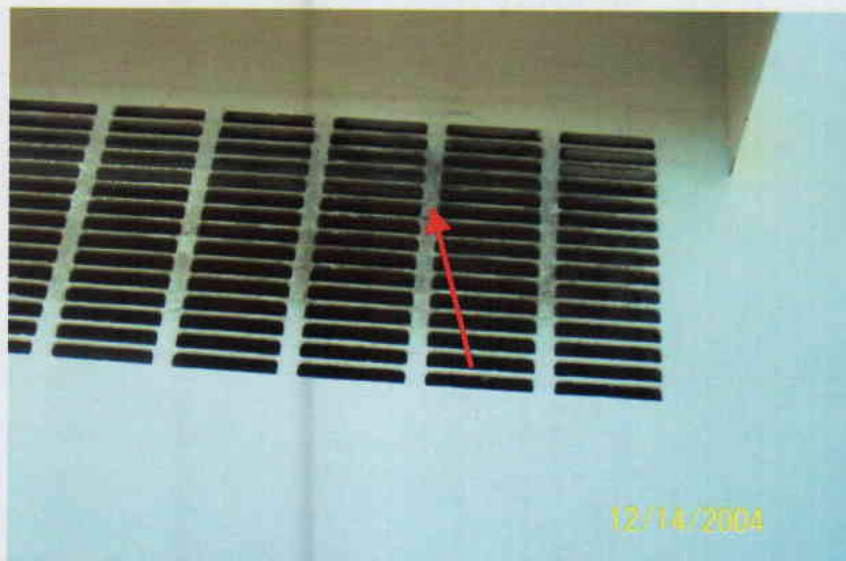
Photo No. 4	View of diffuser on 10 th floor ventilator. Note discoloration on diffuser. Arrow denotes location of sample T-11.
--------------------	---

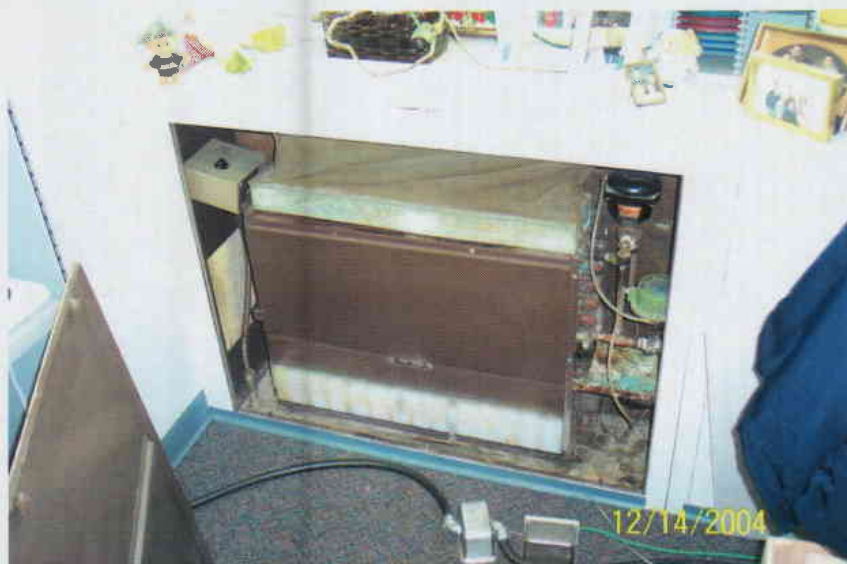
Photo No. 5	View inside 10 th floor ventilator unit.
--------------------	---

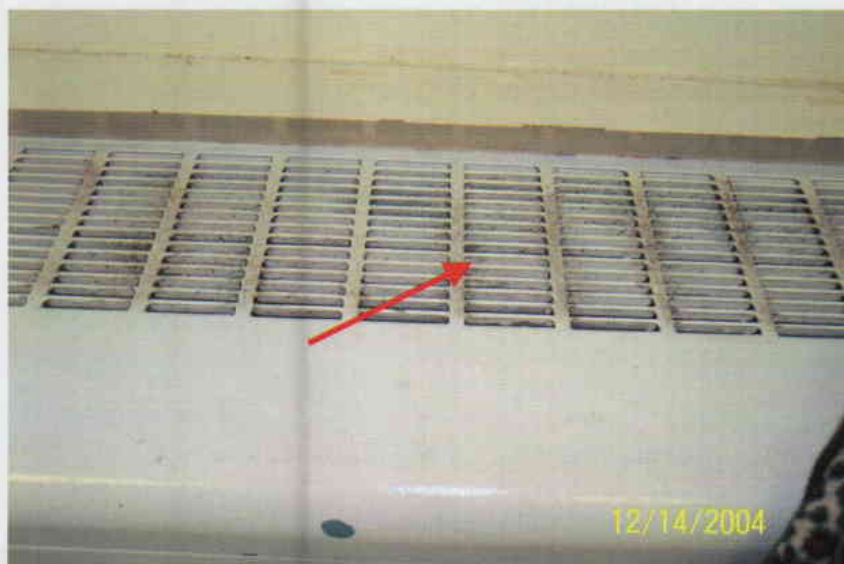
Photo No. 7	View of diffuser on 10 th floor ventilator. Note discoloration on diffuser. Arrow denotes location of sample T-13.
--------------------	---

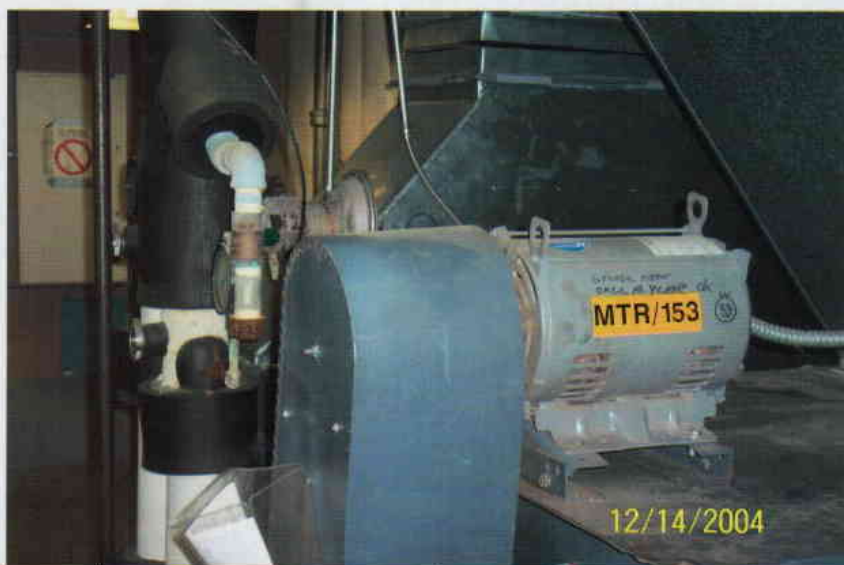
Photo No. 8	View of air handling unit in 4 th floor mechanical room.
--------------------	---

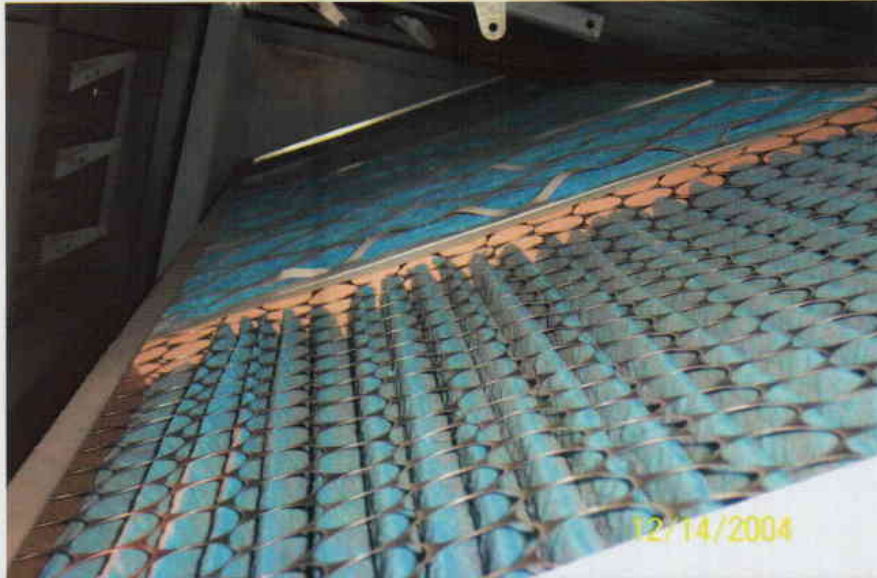
Photo No. 9 View of filters in 4th floor air handling unit. Filters appear to be well maintained with no build-up of excessive dust or debris.

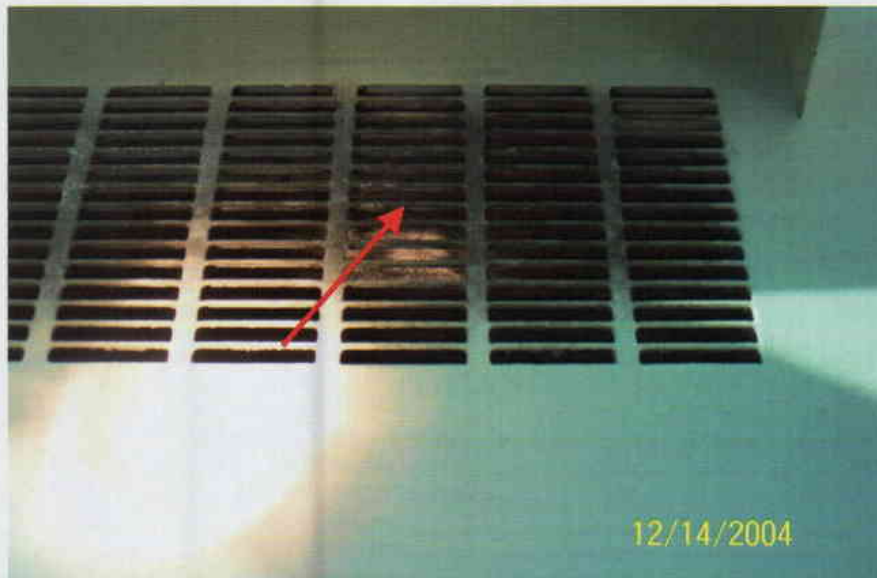
Photo No. 10 View of diffuser on 4th floor ventilator. Note discoloration on diffuser. Arrow denotes location of sample T-08.

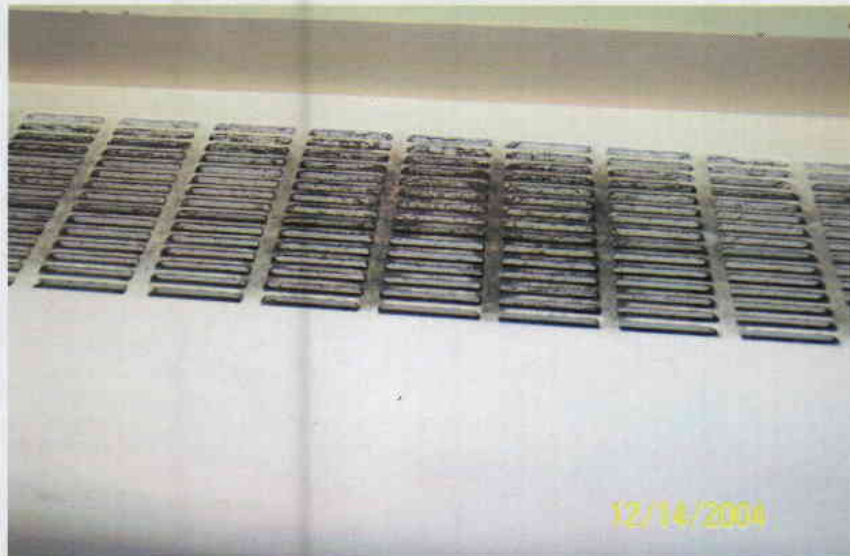
Photo No. 14	View of diffuser on 4 th floor ventilator. Note discoloration on diffuser.
---------------------	---

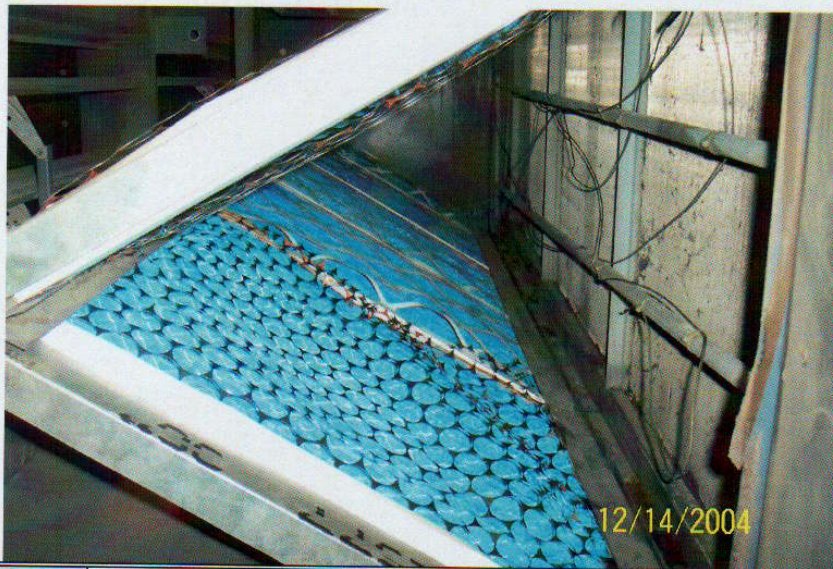
View of filters in 10th floor air handling unit. Filters appear to be well maintained with no build-up of excessive dust or debris.

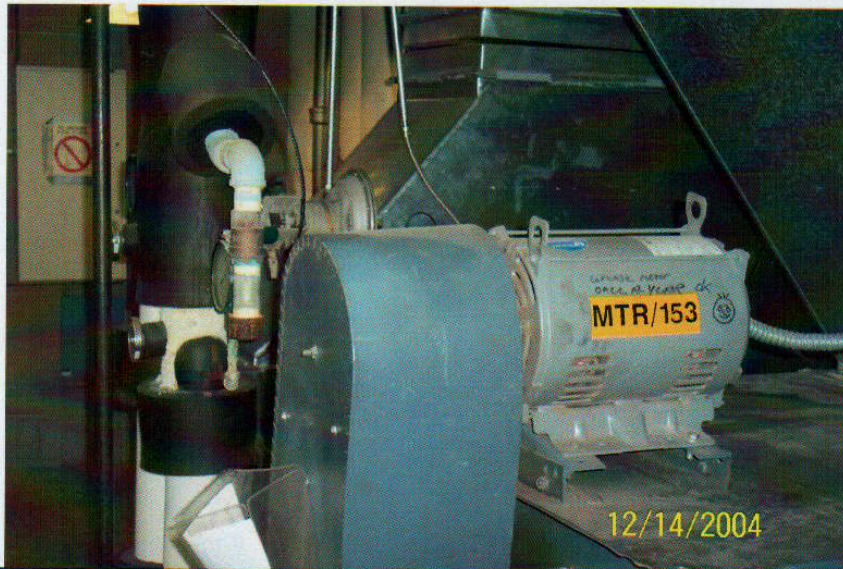
Photo No. 8	View of air handling unit in 4 th floor mechanical room.
--------------------	---

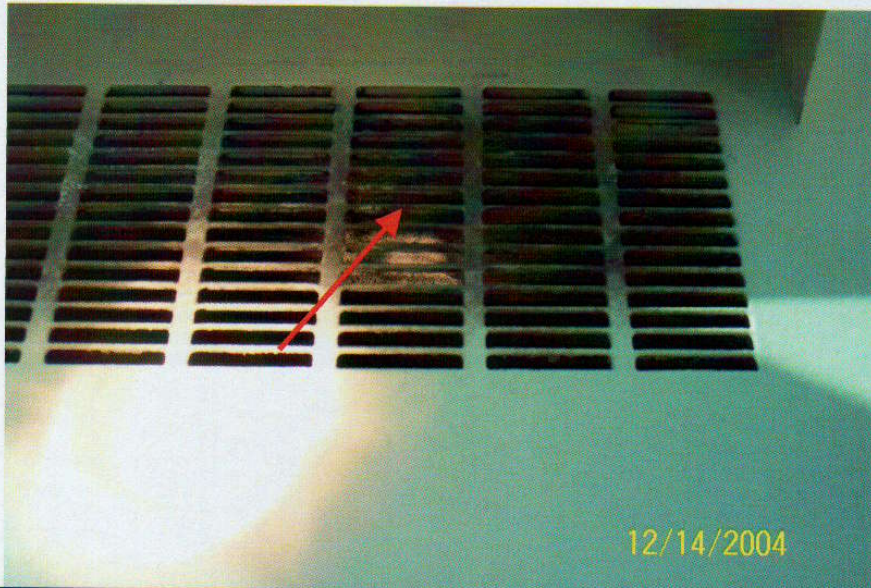
Photo No. 10	View of diffuser on 4 th floor ventilator. Note discoloration on diffuser. Arrow denotes location of sample T-08.
---------------------	--

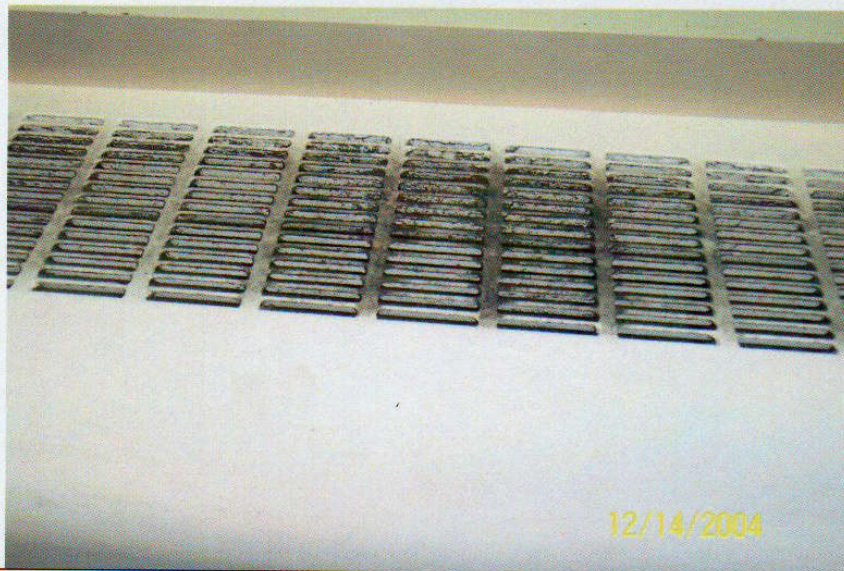
Photo No. 14	View of diffuser on 4 th floor ventilator. Note discoloration on diffuser.
---------------------	---
