Inspection Number: 865708002

INDOOR AIR QUALITY ASSESSMENT REPORT

This report provides the results of an Indoor Air Quality Health Inspection of the Docking State Office Building located 915 Harrison St. in Topeka, KS. On July 24, 2007 Helen Cook, Certified Industrial Hygienist, and Betsy Gaydness, Industrial Hygiene Consultant Trainee, conducted an indoor air quality inspection, in response to employee concerns relative to indoor air quality to determine if any unhealthy conditions were present relative to indoor air quality. The inspection consisted of a visual inspection and a review of material safety data sheets (MSDSs). At the time of the inspection the Kansas Department of Labor found no problem regarding indoor air quality at Docking State Office Building facility.

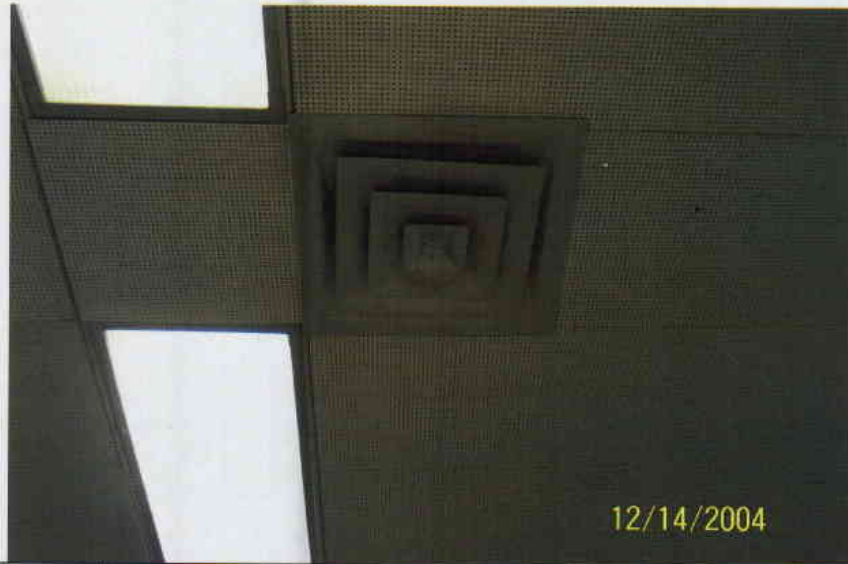
Photo No. 3	View of ceiling air diffuser located on 10 th floor. Diffuser appears to be relatively clean with no evidence of fungal growth. Typical of all diffusers on 10 th floor.
--------------------	--
