MARCH 2000

DOCKING & LANDON STATE OFFICE BUILDINGS CODE REVIEW

FireDynamics

Docking and Landon State Office Buildings

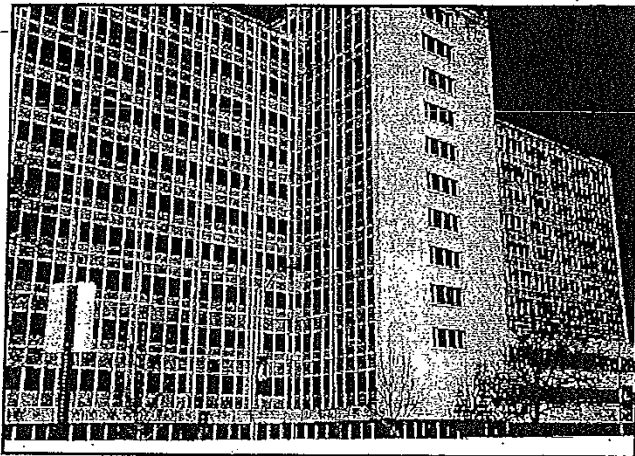
constructed in 1955 with additions in 1969 and 1980. The approximately 542,000 sq. ft. building is located west of the State Capitol Building and houses several branches of the state government including the Department of Transportation, Department of Revenue and Capitol Police. This building also supplies steam and chilled water to the State Capitol Building and steam only to the Landon State Office Building, Memorial Hall and the Kansas Judicial Center.

This building is a twelve-story high-rise of Type II-Fire Resistive construction in conformance with the 1997 Uniform Building Code. The top two floors are a penthouse with mechanical equipment on the lower level and elevator equipment on the upper. The building has subbasement and basement levels. The subbasement level is used for mechanical equipment including chillers and boilers, generator and fire pump. Other sub-basement areas are used for general storage, the Maintenance Shop, Wood Shop, Plumbing Shop, Paint Shop and Housekeeping Storage. The basement level contains the Kitchen and Dining Area, Service Dock, Print Shop, Photo Shop and offices. The remainder of the building is typical office space.

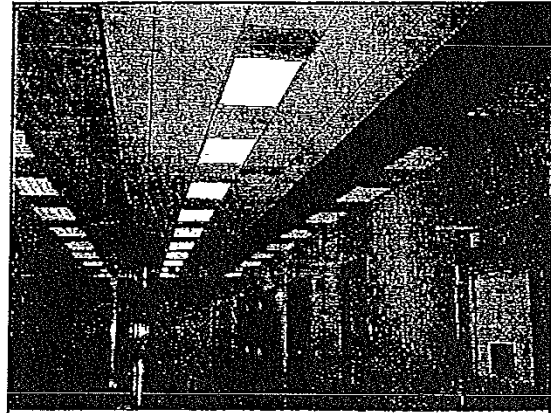
The north, south and west exit stairways discharge directly outside and the center stairway discharges into the south hallway. The walls of the hallway are a single layer of gypsum with metal studs. There is a suspended ceiling at approximately 12 feet. This hallway is not required to be fire-rated with the installation of a complete automatic sprinkler system on this floor. The hallway is separated from the lobby by double 90-minute rated automatic-closing fire doors.

Smoke detectors are installed in the hallways, adjacent to the automatic-closing doors leading in the Main Lobby. Doors are 90-minute rated throughout the floor with the exception of the double doors of the Department of Revenue, an area in the east wing that was recently renovated. These new doors are 20 minute rated fire doors with non-wired glazing.

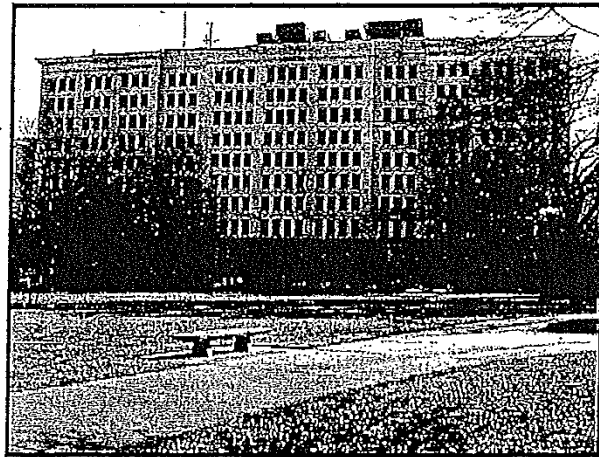
The Landon building is an eleven story office building of Type II Fire Resistive (II-FR) construction, in accordance with the 1997 Uniform Building Code. The building includes a basement space with maintenance and housekeeping offices, shops, storage areas, boiler rooms, chiller plant and mechanical/electrical rooms. Floors 1 through 10 are general office areas with typical corridors and restroom and service core areas. Floors 6, 7 and 8 have large data processing computer rooms with dedicated fire sprinkler and fire alarm systems. Floor 11 is a storage penthouse with locked, non-separated storage areas. This level is not normally occupied.

The building structure is reinforced concrete for major structural elements, columns, beams and floors, with masonry, plaster and lath or gypsum board walls and ceilings. Attic roof beams are unprotected steel supporting a concrete roof deck. Wood is used for stair rails in both interior stair towers as well as for wire cage walls in storage areas. The concrete deck between floors is approximately six inches thick. The floor slab carries a minimum of 2-hour fire resistance rating in conformance with the 1997 Uniform Building Code.
