**Subject:** Summary of work performed on electrical distribution system in the Docking Building.

Capital Electric Construction was contracted to perform maintenance and cleaning of the 13.2kV electrical distribution system in the Docking Building. The work was started on Wednesday, November 24 and completed on Saturday, November 27. This report summarizes our findings.

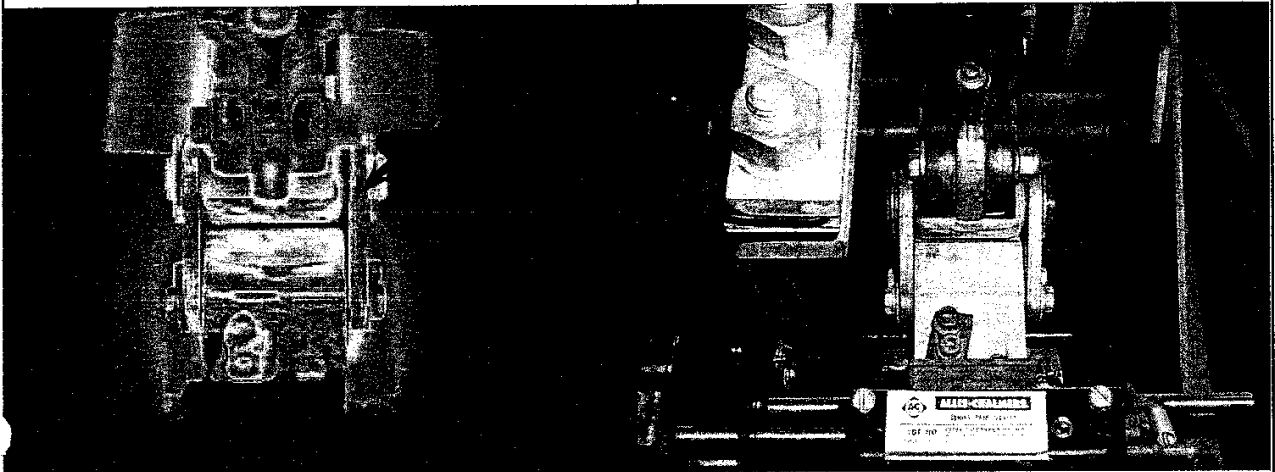
| EQUIPMENT IDENTIFICATION:<br><b>DSOB CHILLER #1</b> | LOCATION:<br><b>CHILLER ROOM</b> | |

| ITEM:<br><b>CIRCUIT BREAKER C-PHASE CONTACT</b> | OBJECT TEMPERATURE:<br><b>120F</b> | REFERENCE TEMPERATURE.:<br><b>109F</b> |

COMMENTS:  
Main switchboard circuit breaker DSOB Chiller #1 was found with a higher than normal operating temperature on the C-phase circuit breaker contact. A higher operating temperature indicates a higher contact resistance and high resistance contacts can cause contact failure due to overheating and also may provide an ignition source to any flammable substance.

RECOMMENDATIONS:  
It is recommended that the switch contact be inspected, cleaned and checked for sufficient contact pressure according to manufacturer's specifications.

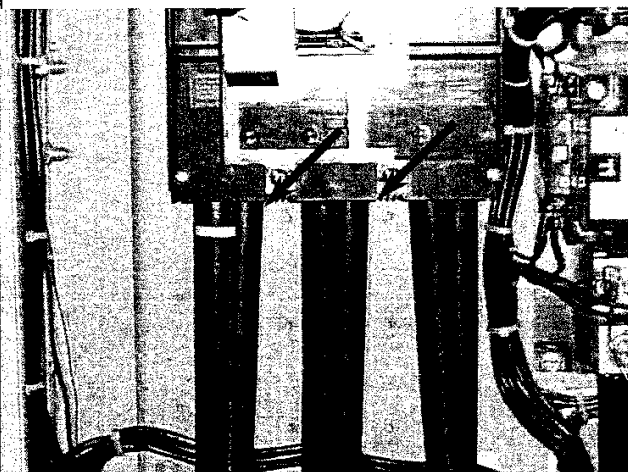
| EQUIPMENT IDENTIFICATION:<br><b>CHILLER #1 CONTROL PANEL</b> | LOCATION:<br><b>CHILLER ROOM</b> | |

| ITEM:<br><b>CIRCUIT BREAKER WIRE TERMINATIONS</b> | OBJECT TEMPERATURE:<br><b>118F</b> | REFERENCE TEMPERATURE:<br><b>110F</b> |

Chiller #1 control panel was found with a higher than normal operating temperature at the main circuit breaker load side A & B phase conductor terminations. A higher operating temperature indicates a higher resistance and high resistance terminations can cause insulation and/or termination failure due to overheating and also may provide an ignition source to any flammable substance.

It is recommended that the conductor terminations be inspected, cleaned and tightened to the manufacturer's torque specifications.

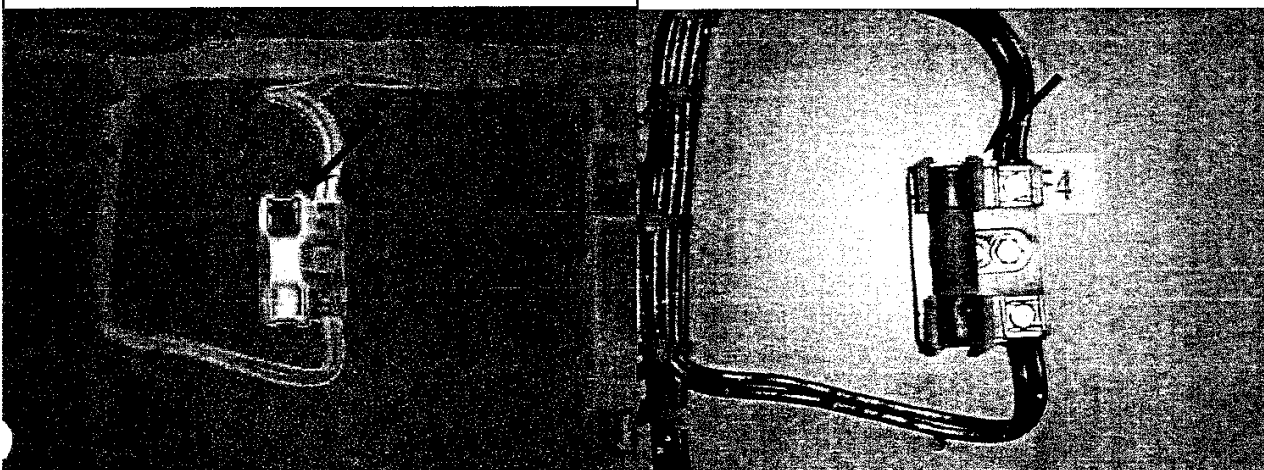
| EQUIPMENT IDENTIFICATION:<br><b>CHILLER #3 CONTROL PANEL</b> | LOCATION:<br><b>CHILLER ROOM</b> | |

| ITEM:<br><b>FUSE F4 LINE SIDE FUSE CLIP</b> | OBJECT TEMPERATURE:<br><b>268F</b> | REFERENCE TEMPERATURE:<br><b>128F</b> |

**COMMENTS:**  
Chiller #3 was found with a higher than normal operating temperature at the control power fuse F4 line side fuse clip. A higher operating temperature indicates a higher resistance and high resistance fuse clips can cause fuse and/or fuse clip failure due to overheating and also may provide an ignition source to any flammable substance.

**RECOMMENDATIONS:**  
It is recommended that the fuse and fuse clip be inspected, cleaned and checked for sufficient clip tension according to the manufacturer's specifications and replaced if necessary.

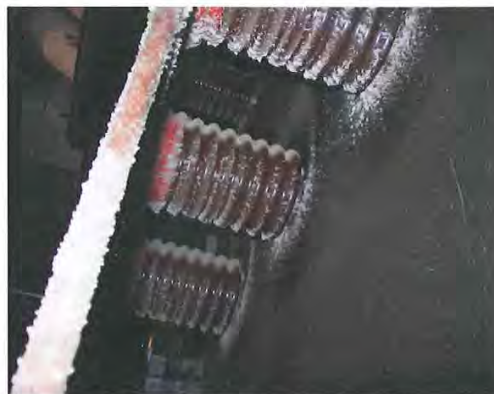
The dangers presented with the existing equipment include the possibility for an arc to be started with the displacement of the existing dust. Refer to Photographs 1 and 2 for pictorial representation of the extent of dirt/dust accumulation. The dust itself is explosive. If an electrical arc is started due to the conductivity of the dust particles, the addition of the fault electrical current could lead to an explosion in the electrical bus duct causing sever damage to the electrical equipment and harm to any personnel in the area.

Photograph 2: 15 kV Copper Bus (Bottom view)

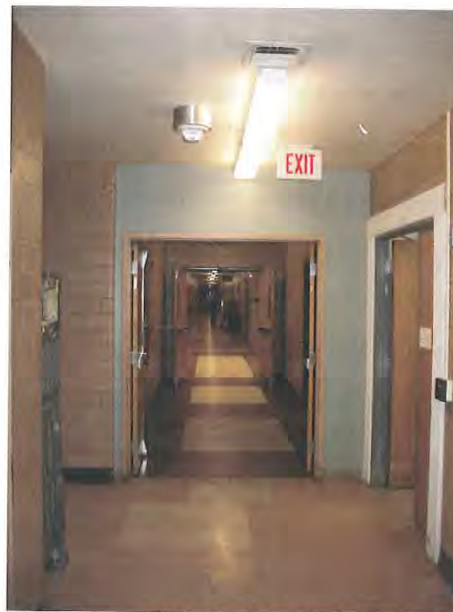
The biggest concern is being able to place the transformers in the basement room. The transformers are approximately 5-feet wide and 8-feet long. This becomes a problem to navigate the transformer through the building. The transformer is 102-inches tall and would require the removal of lighting fixtures, smoke detectors, and the opening of several doorways to allow for passage. Additionally, each transformer weighs approximately 10 tons. The existing floor design of the basement hallway will not support this great of a load without shoring up the floor from below. Photograph 10 shows one of the doorways that would need to be opened to make room for the transformers. Additionally, the existing lighting fixture, exit sign, and fire alarm annunciator would need to be removed to allow for passage of the 102-inch tall transformer.

Photograph 10: North-South Hallway,  
Basement Level, Looking North

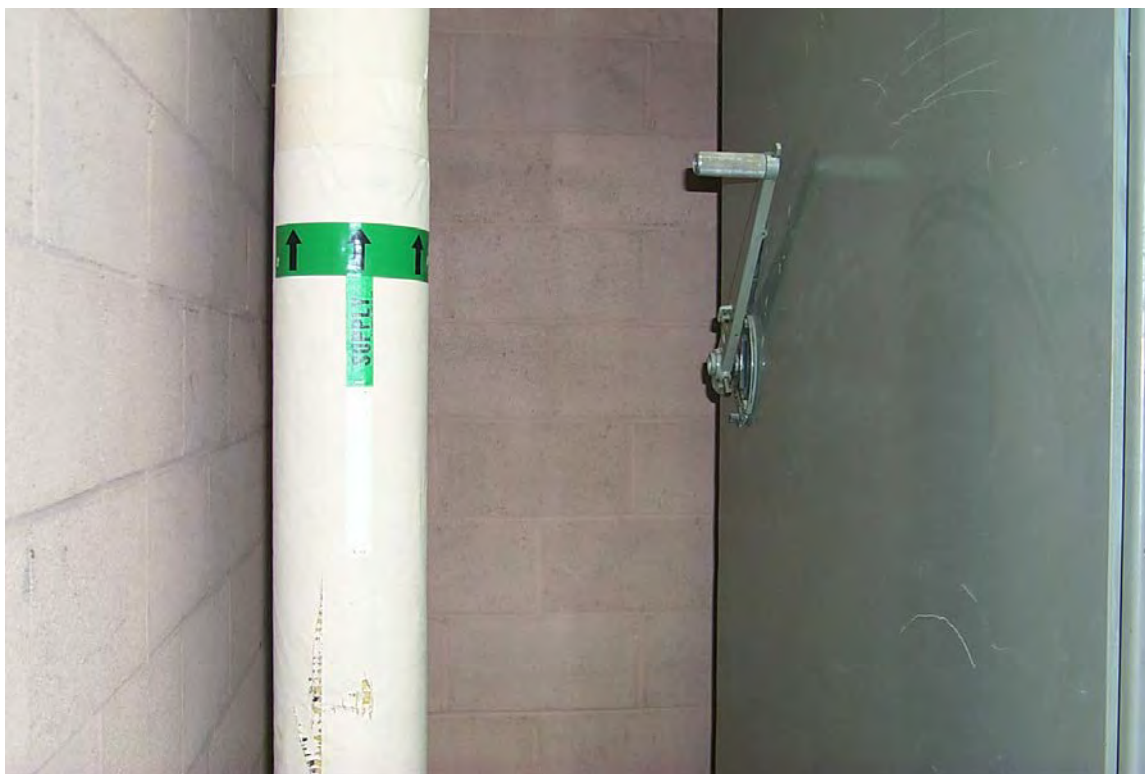
Picture #3535

Disconnect for LCUS-14 (TRN-00060)  
13200V  
15A  
10<sup>th</sup> Floor Mech. Room

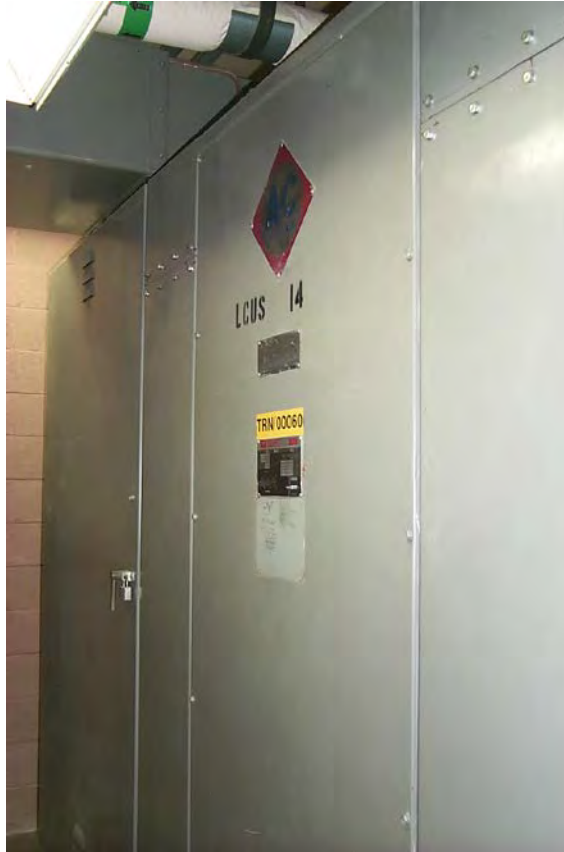
Picture #3536

Transformer LCUS-14 (TRN-00069)

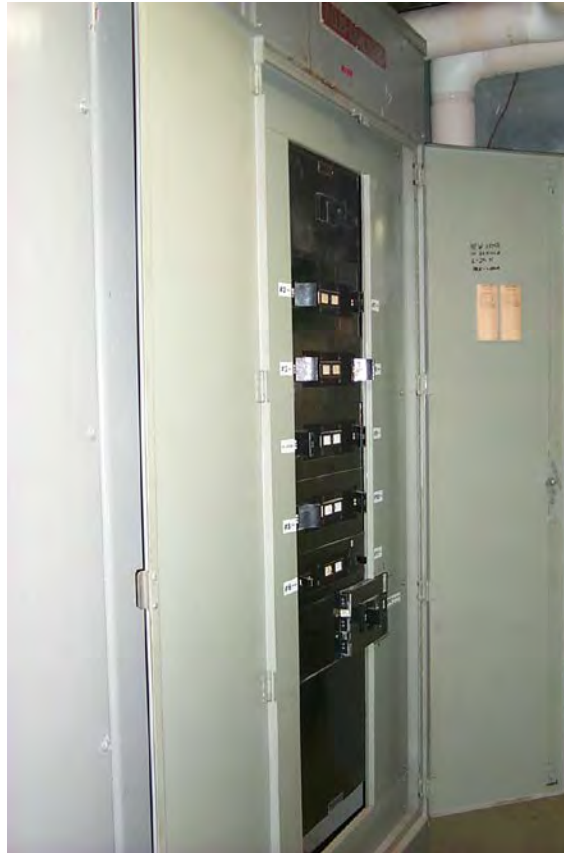
Picture #3537

Switchboard for LCUS-14 (TRN-00060)  
208V  
10<sup>th</sup> Floor Mech. Room

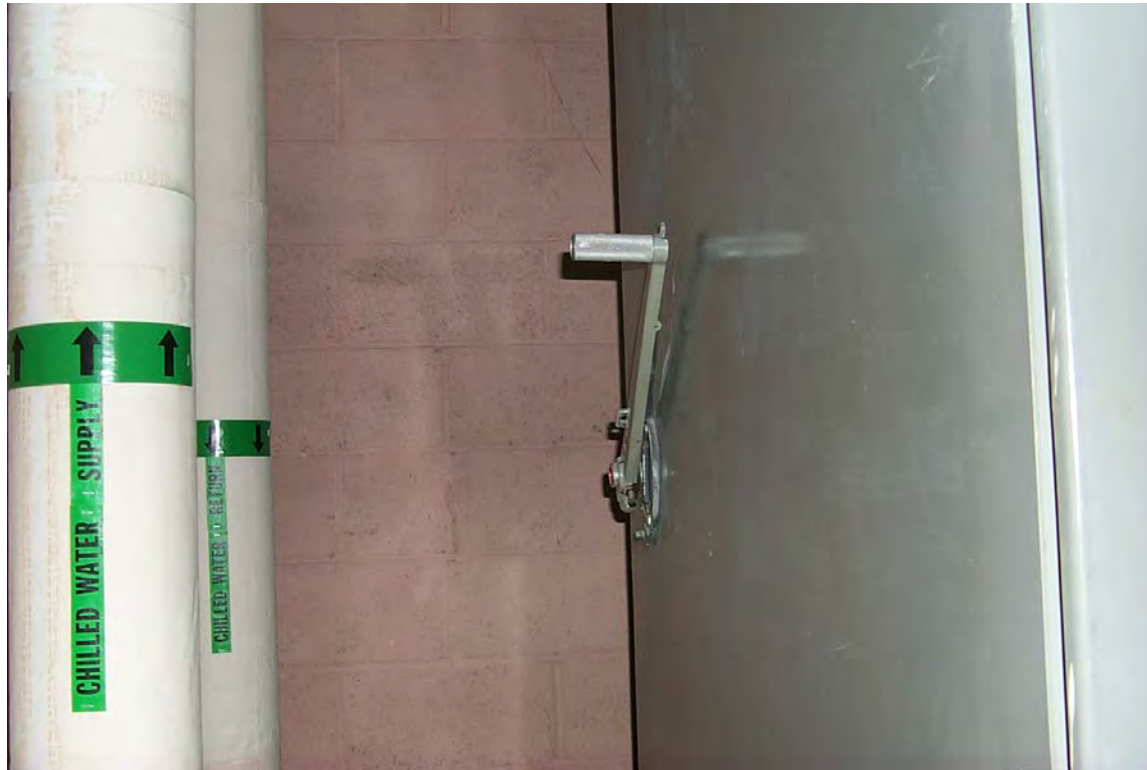
Picture #3538

Disconnect for LCUS-15 (TRN-00061)  
13200V  
15A  
11<sup>th</sup> Floor Mech. Room

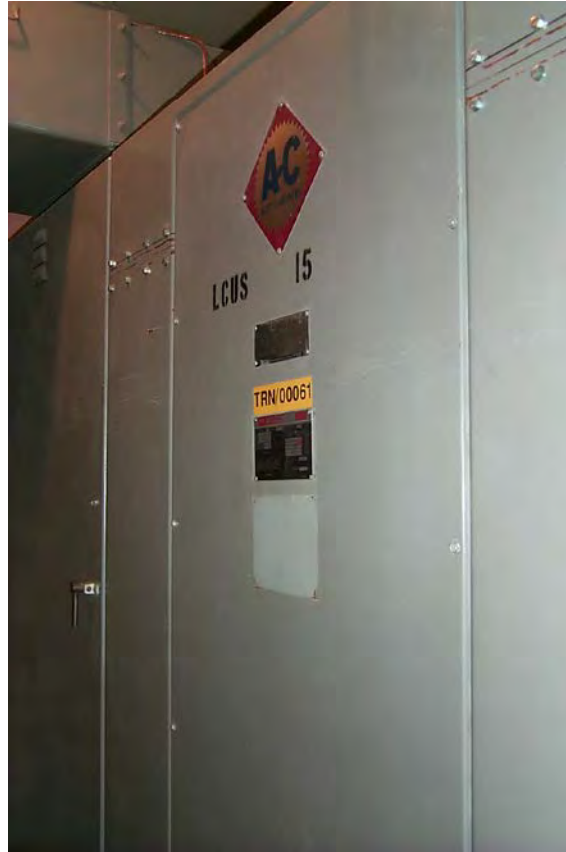
Picture #3538

Transformer LCUS-15 (TRN-00061)

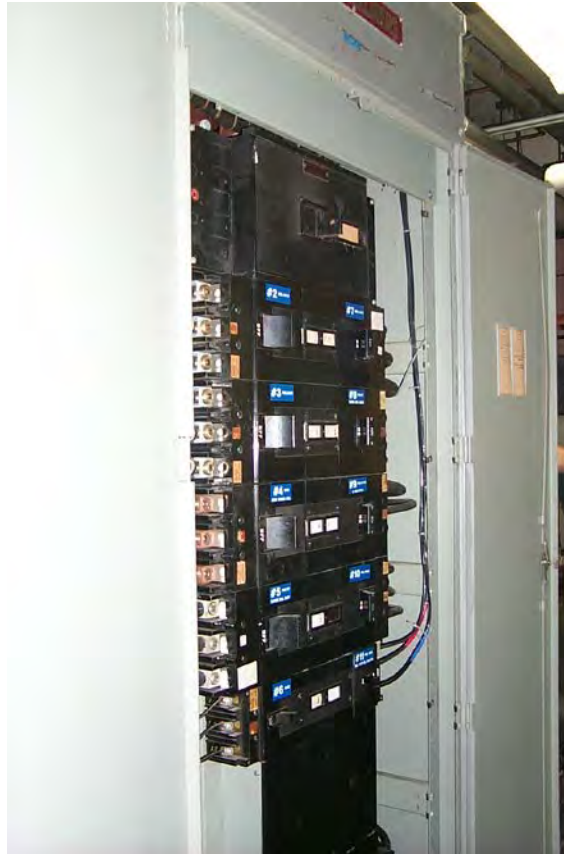
Picture #3540

Switchboard for LCUS-15 (TRN-00061)  
208V  
11<sup>th</sup> Floor Mech. Room

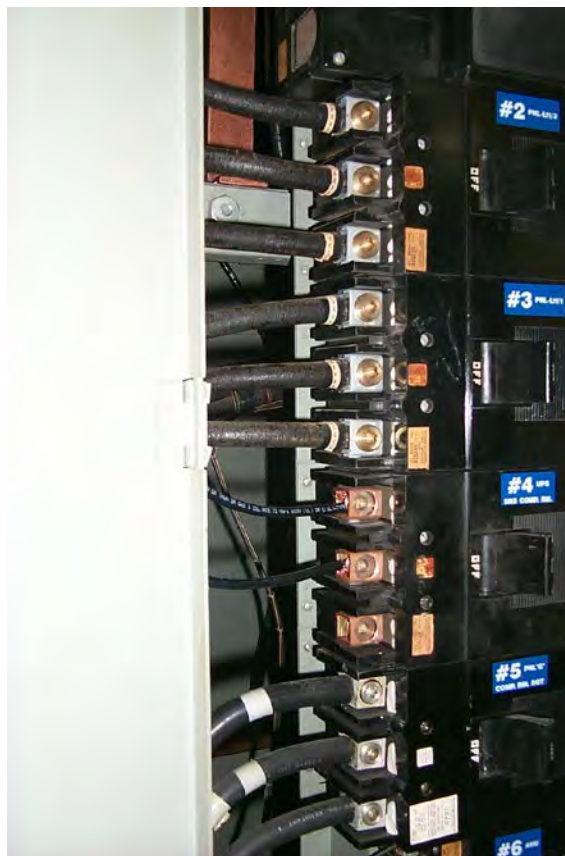
Picture #3541

Switchboard for LCUS-15 (TRN-00061) Continued  
208V  
11<sup>th</sup> Floor Mech. Room

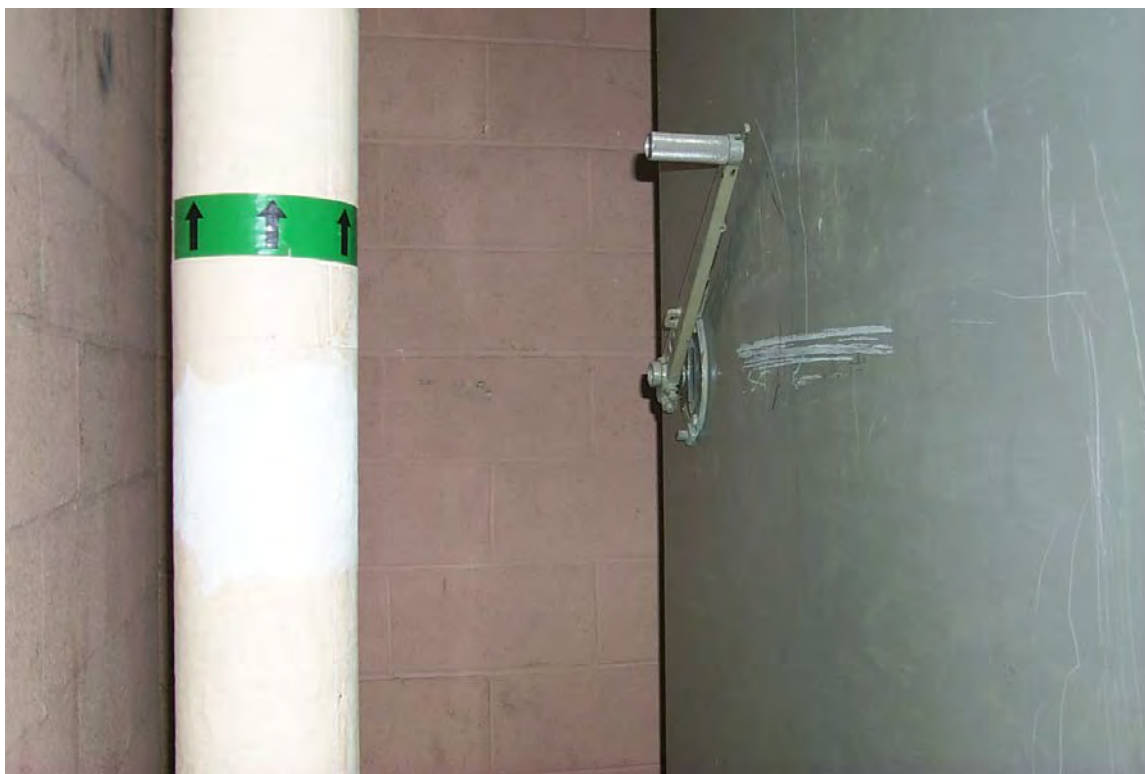
Picture #3544

Disconnect for LCUS-16 (TRN-00043)  
13200V  
15A  
12<sup>th</sup> Floor Mech. Room

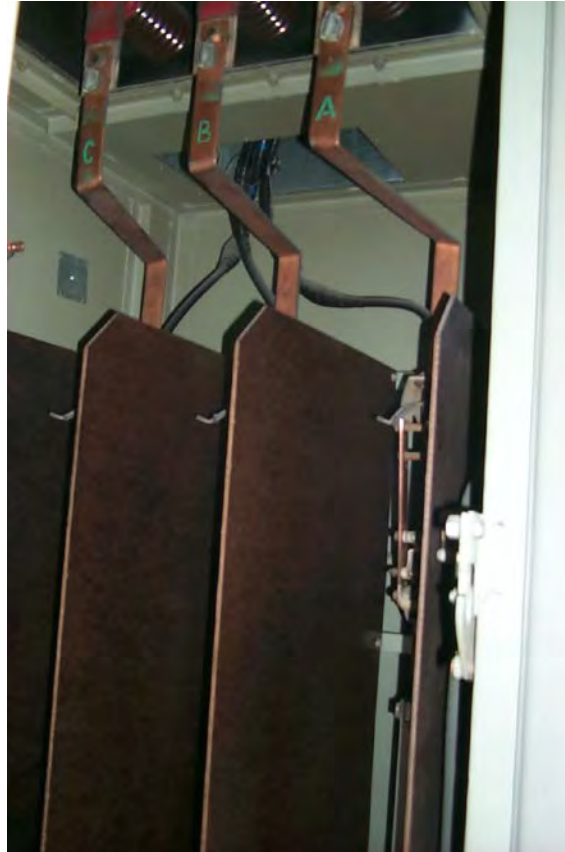
Picture #3542

Disconnect for LCUS-16 (TRN-00043) Continued  
13200V  
15A  
12<sup>th</sup> Floor Mech. Room

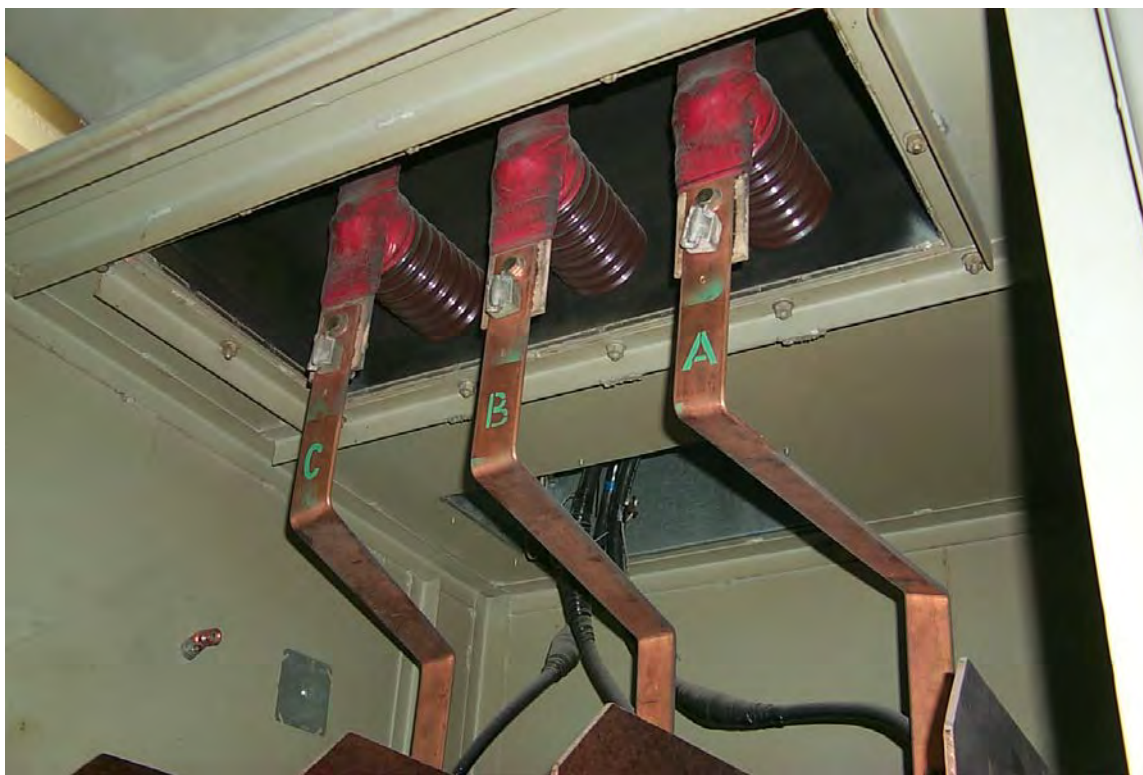
Picture #3543

Disconnect for LCUS-16 (TRN-00043) Continued  
13200V  
15A  
12<sup>th</sup> Floor Mech. Room

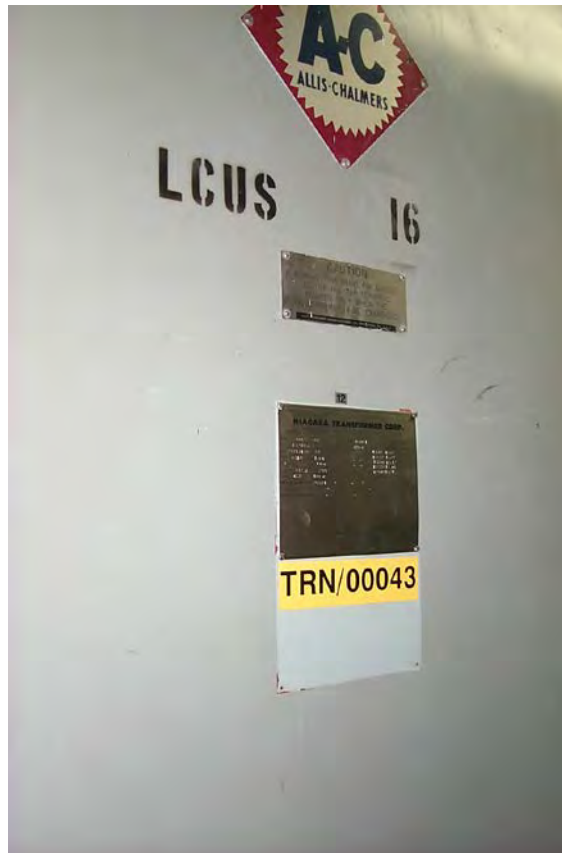
Picture #3545

Transformer LCUS-16 (TRN-00043)

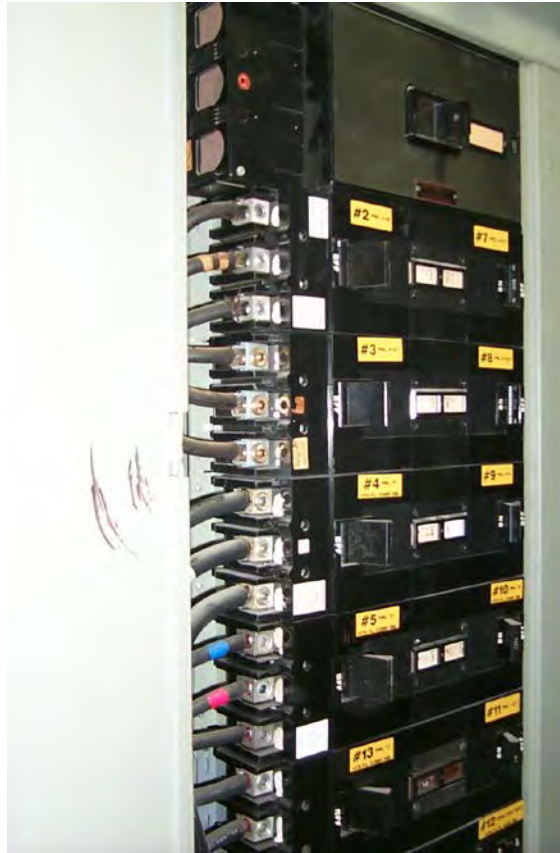
Picture #3547

Switchboard for LCUS-16 (TRN-00043)  
208V  
12<sup>th</sup> Floor Mech. Room

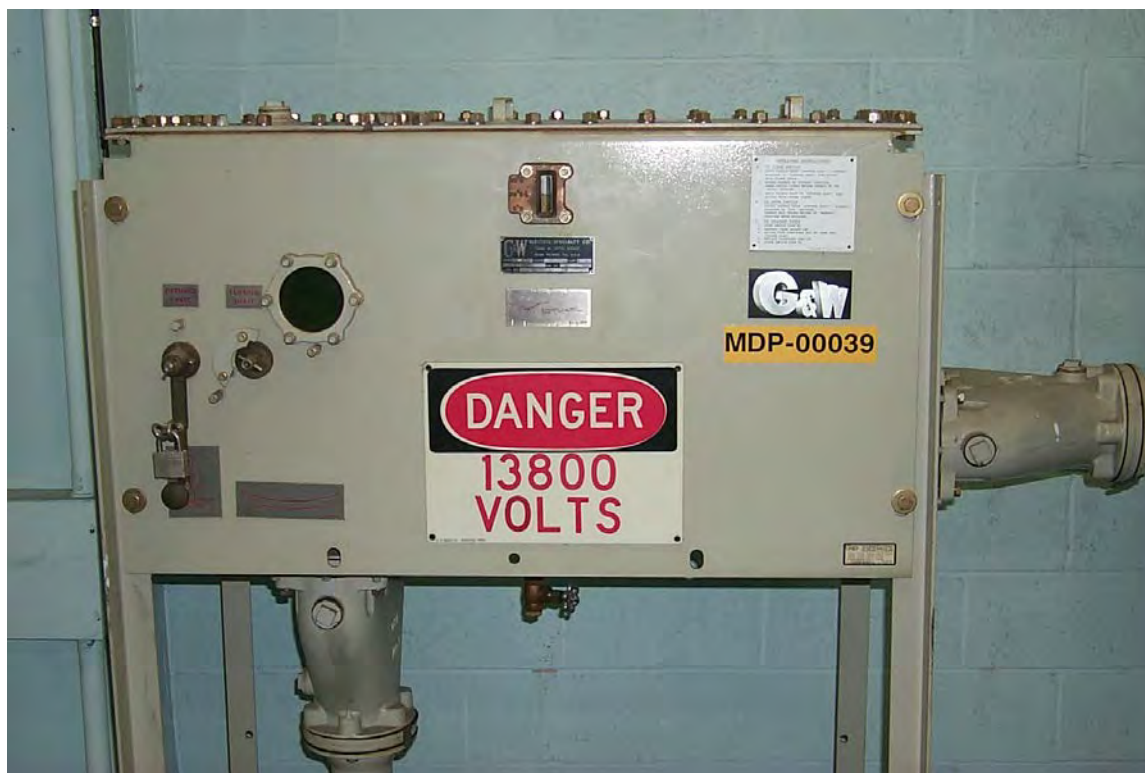
Picture #3549

Disconnect MDP-00039  
13800V  
15A  
13<sup>th</sup> Floor Mech. Room

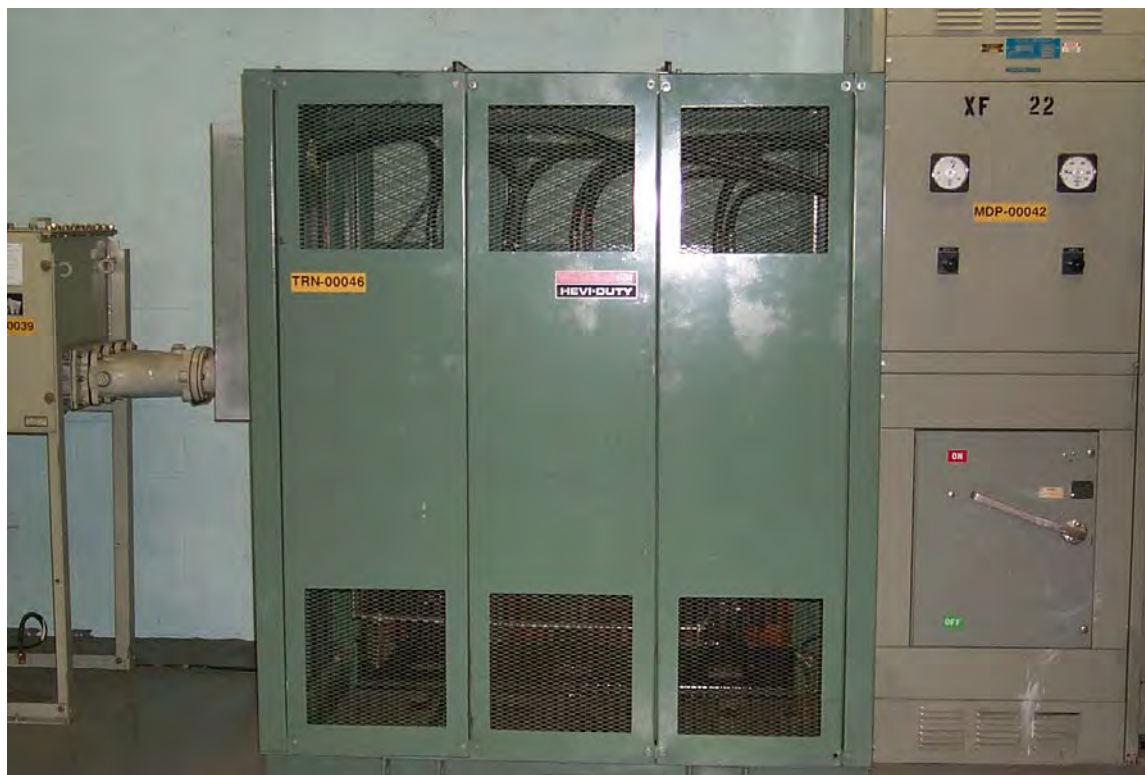
Picture #3550

Transformer TRN-00046  
300kva  
13800V  
208Y/120  
13<sup>th</sup> Floor Mech. Room

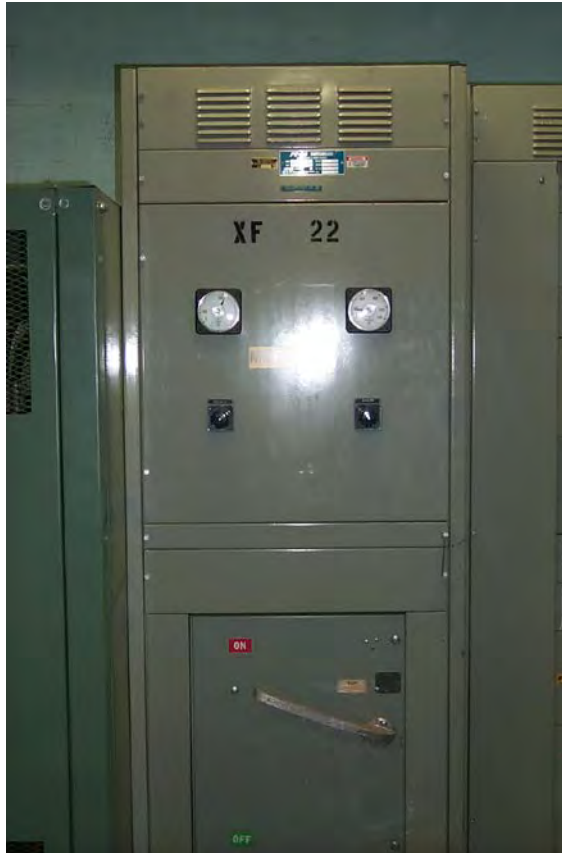
Picture #3548

Disconnect MDP-00042  
208V  
13<sup>th</sup> Floor Mech. Room

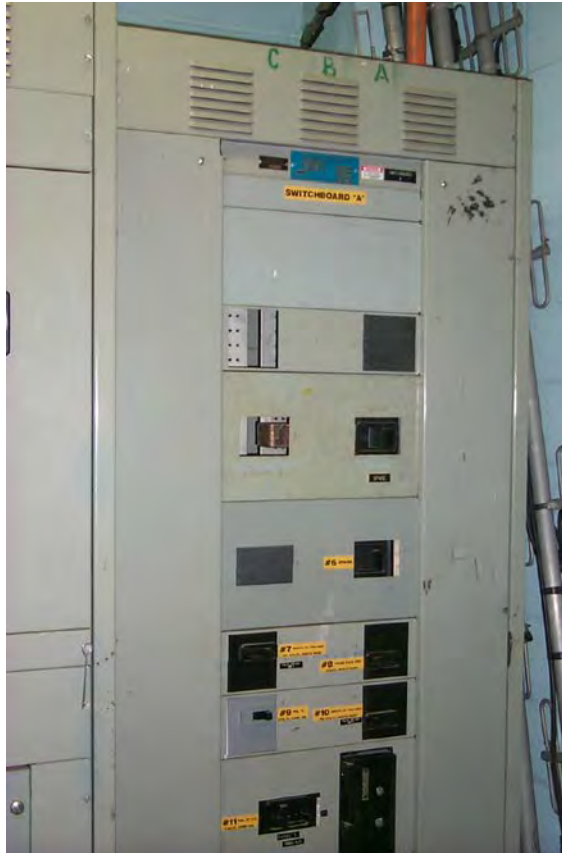
Picture #3552

Switchboard for LCUS-18  
208V  
13<sup>th</sup> Floor Mech. Room

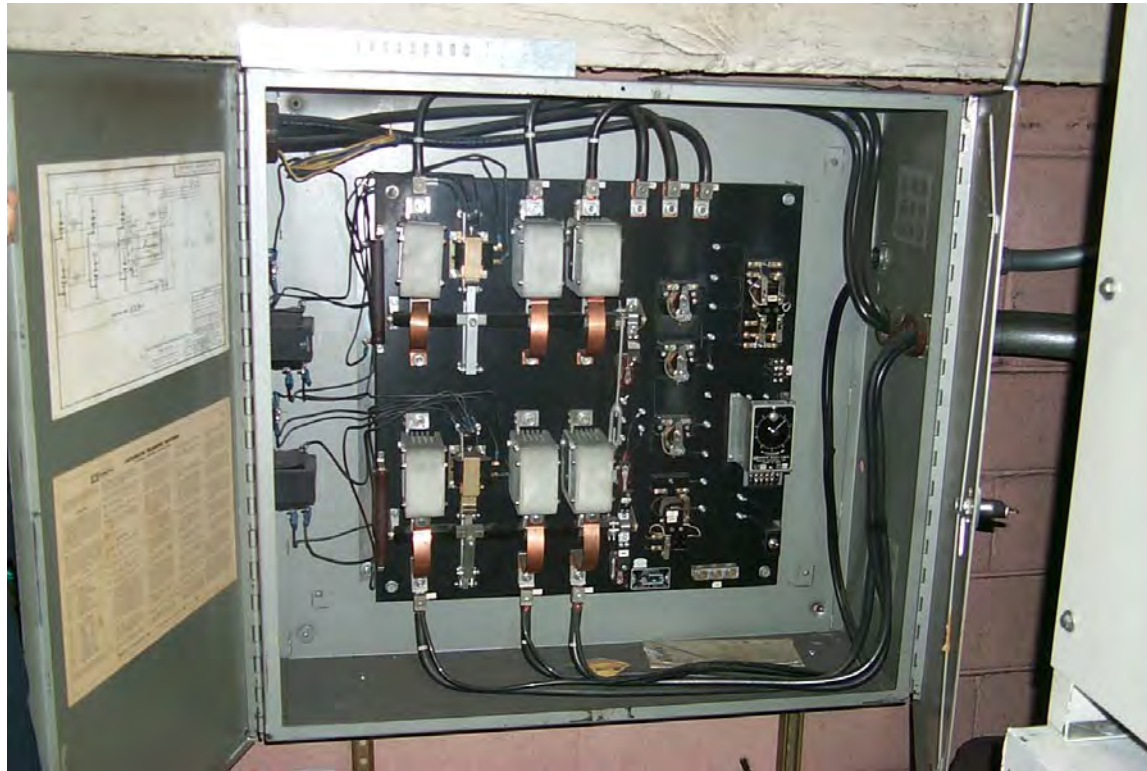
Picture # 3789

Automatic Transfer Switch (No number)  
(Freight Elevator)  
600V Rating, 208V  
200A  
13<sup>th</sup> Floor-Freight Elevator Head House

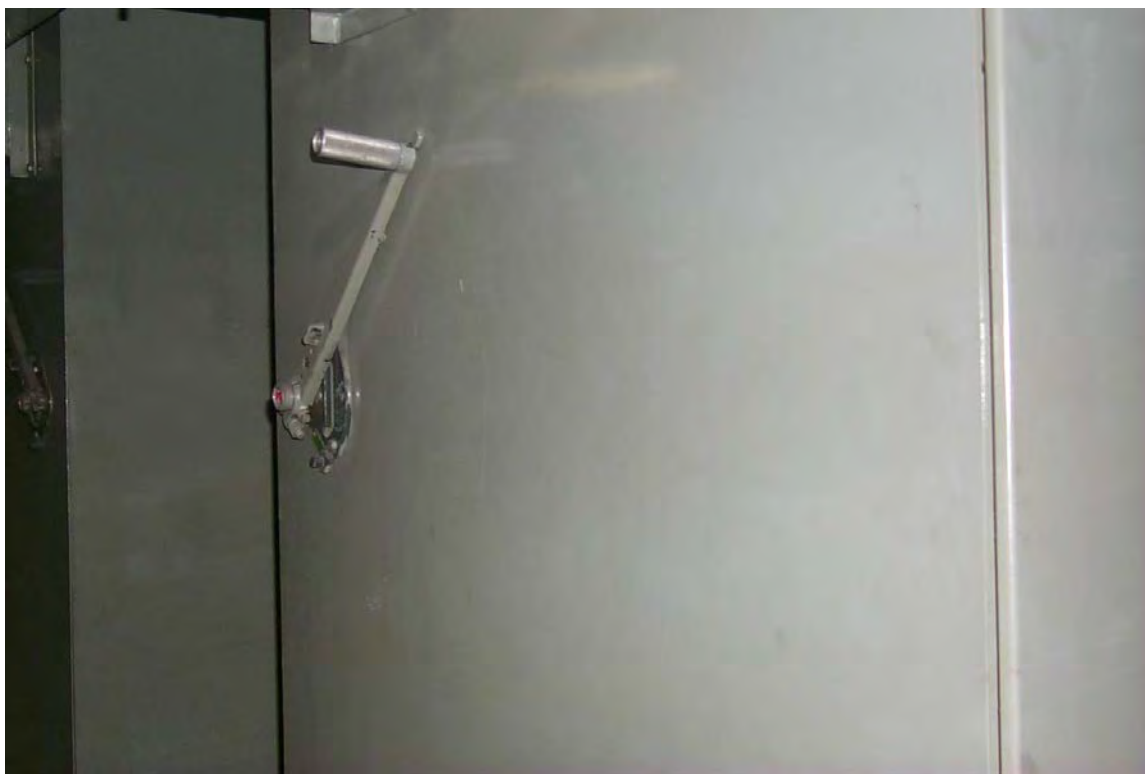
Picture #3553

Disconnect for LCUS-18 (TRN-00059)  
13200V  
15A  
14<sup>th</sup> Floor Mech. Room

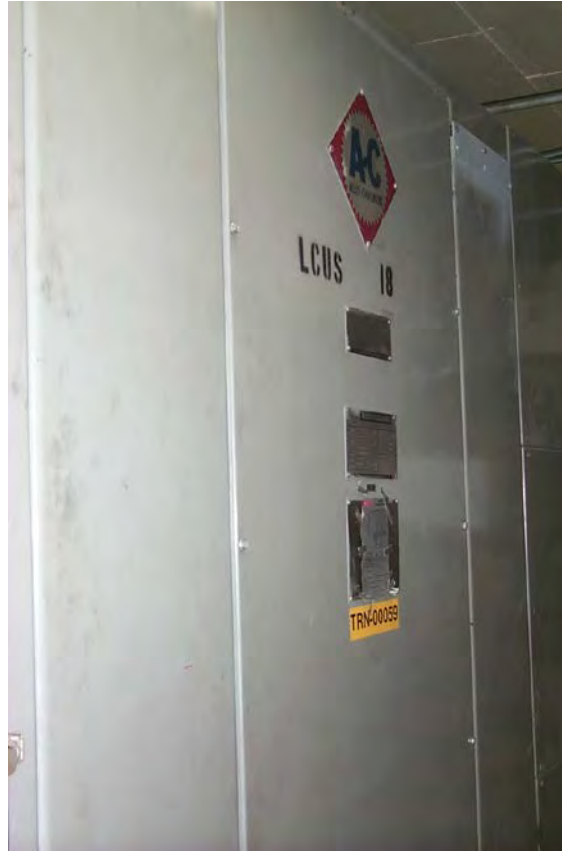
Picture #3554

Transformer LCUS-18 (TRN-00059)

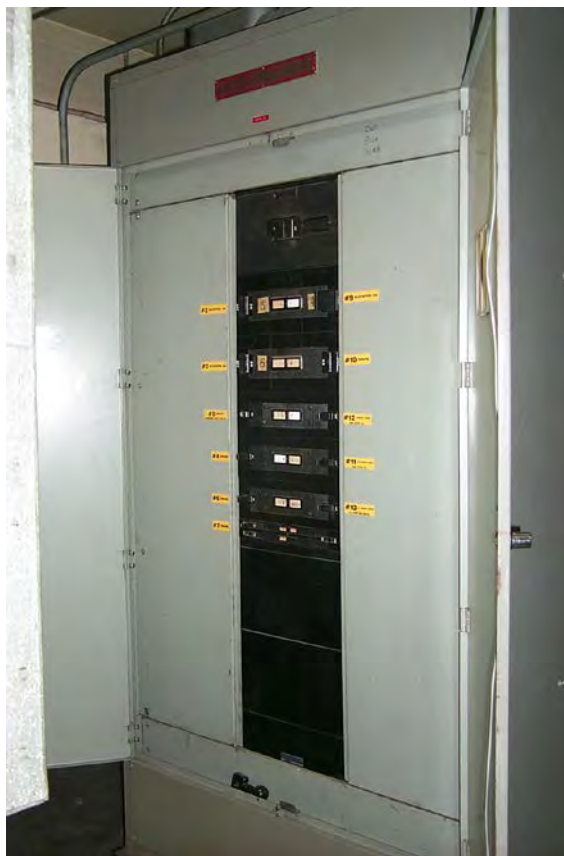
Picture #3555

Switchboard LCUS-18 (TRN-00059)  
208V  
14<sup>th</sup> Floor Mech. Room

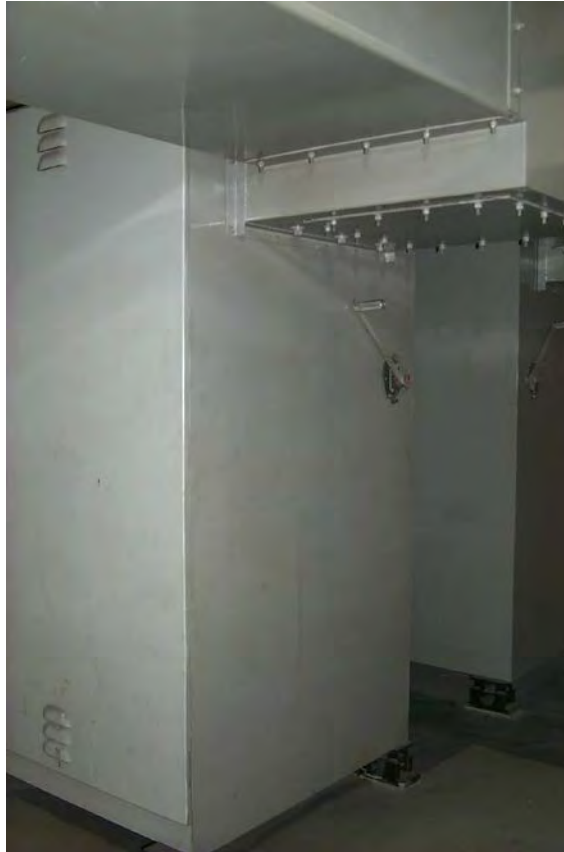
Picture #3556

Disconnect for LCUS-17 (TRN-00058)  
13200V  
15A  
14<sup>th</sup> Floor Mech. Room

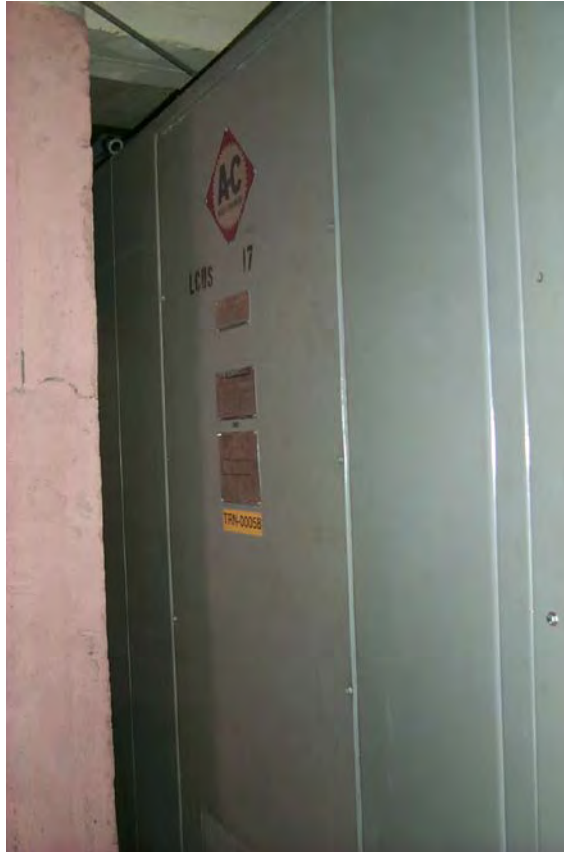
Picture #3557

Transformer LCUS-17 (TRN-00058)

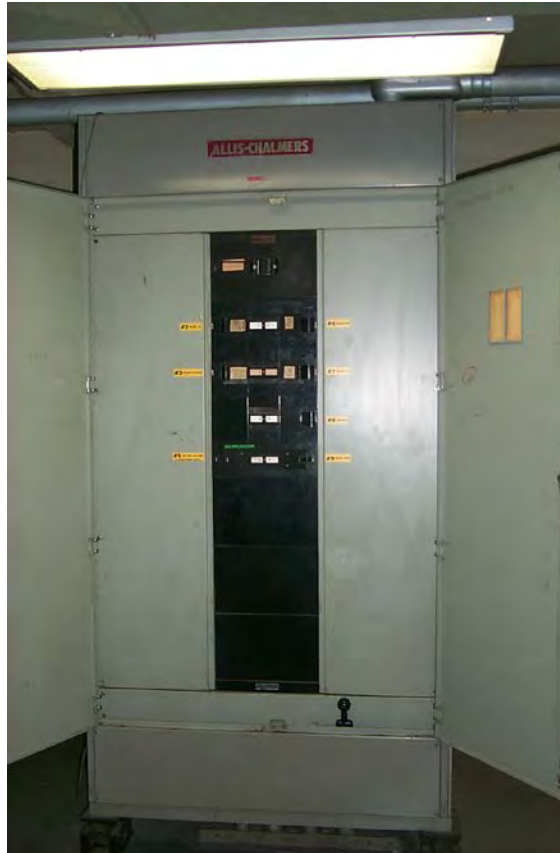
Picture #3557

Switchboard for LCUS-17 (TRN-00058)  
208V  
14<sup>th</sup> Floor Mech. Room

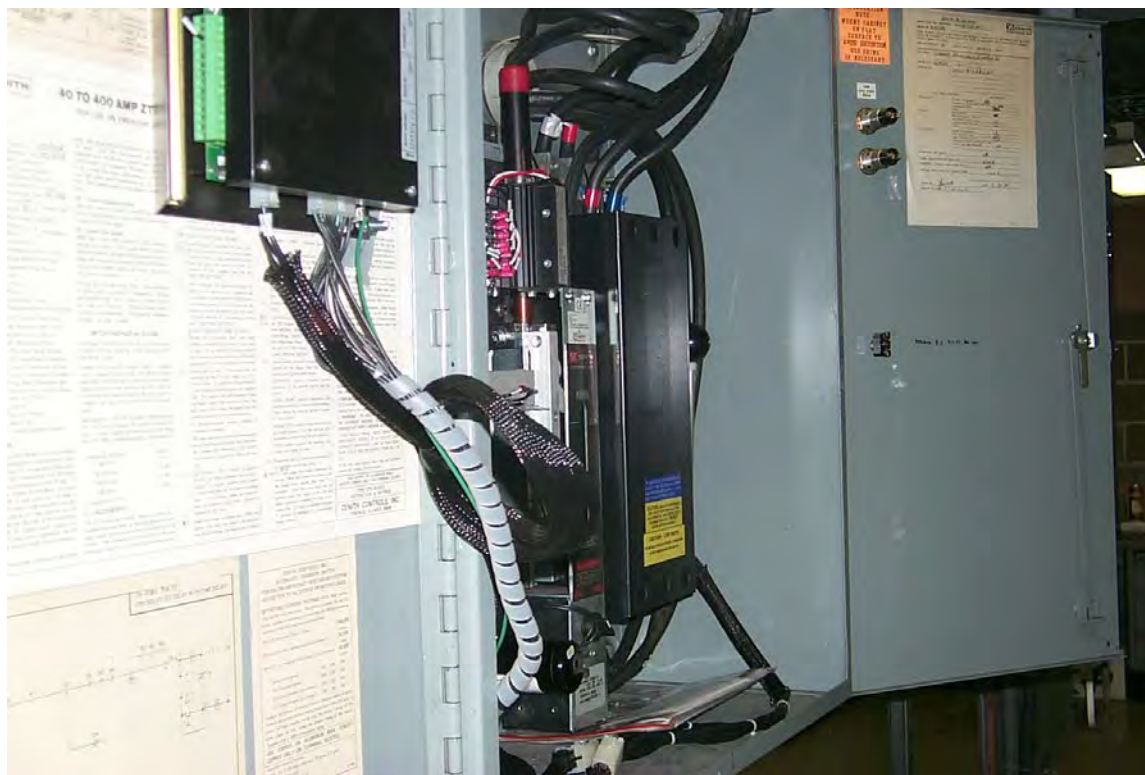
Picture # 3790

Automatic Transfer Switch (No number)  
(Elevator #2)  
480V rating, 208V  
225A  
14<sup>th</sup> Floor Mech. Room

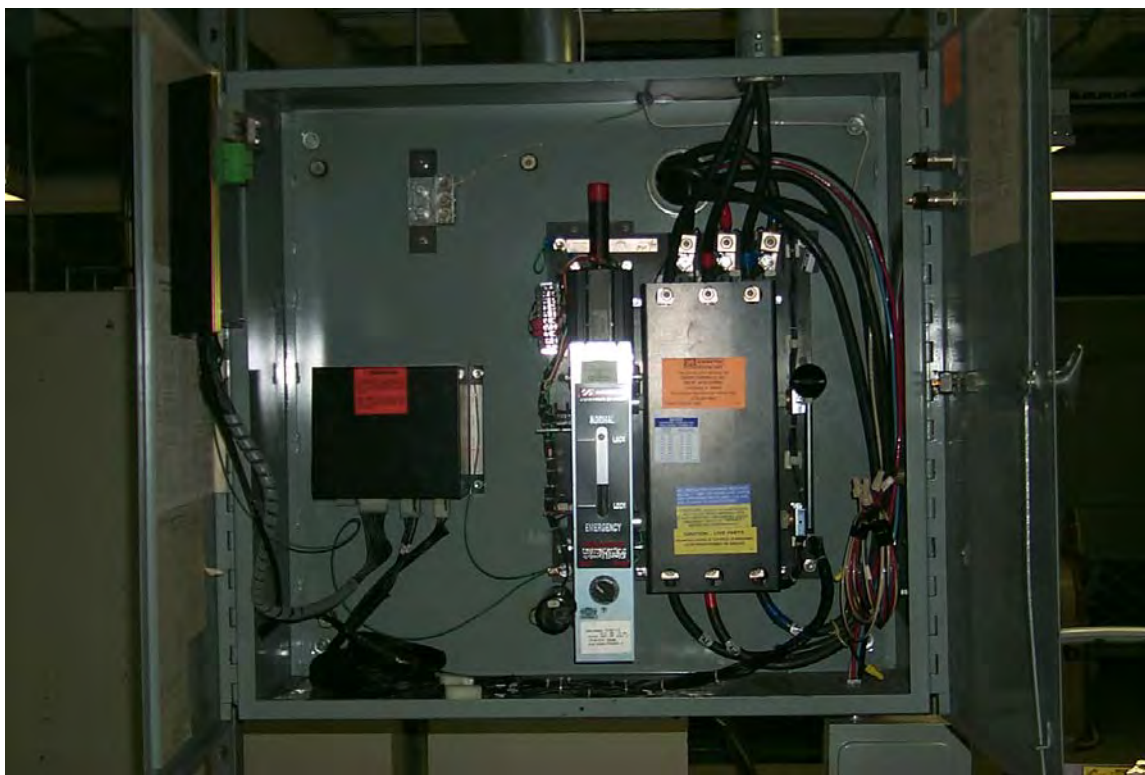
Picture # 3791

Automatic Transfer Switch ATS-17  
(Elevator # 5)  
480V Rating, 208V  
225A  
14<sup>th</sup> Floor Mech. Room

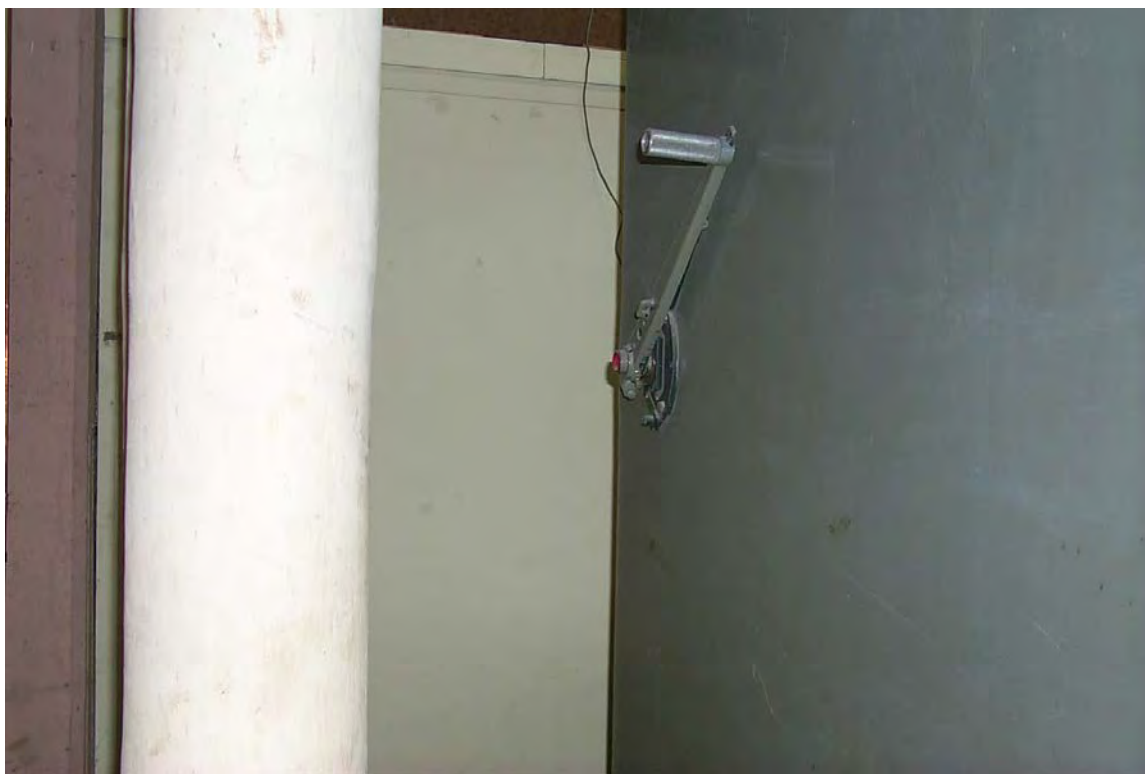
Picture #3501

Disconnect for LCUS-3 (TRN-00021)  
13200V  
15A  
1<sup>st</sup> Floor- North Mech. Room

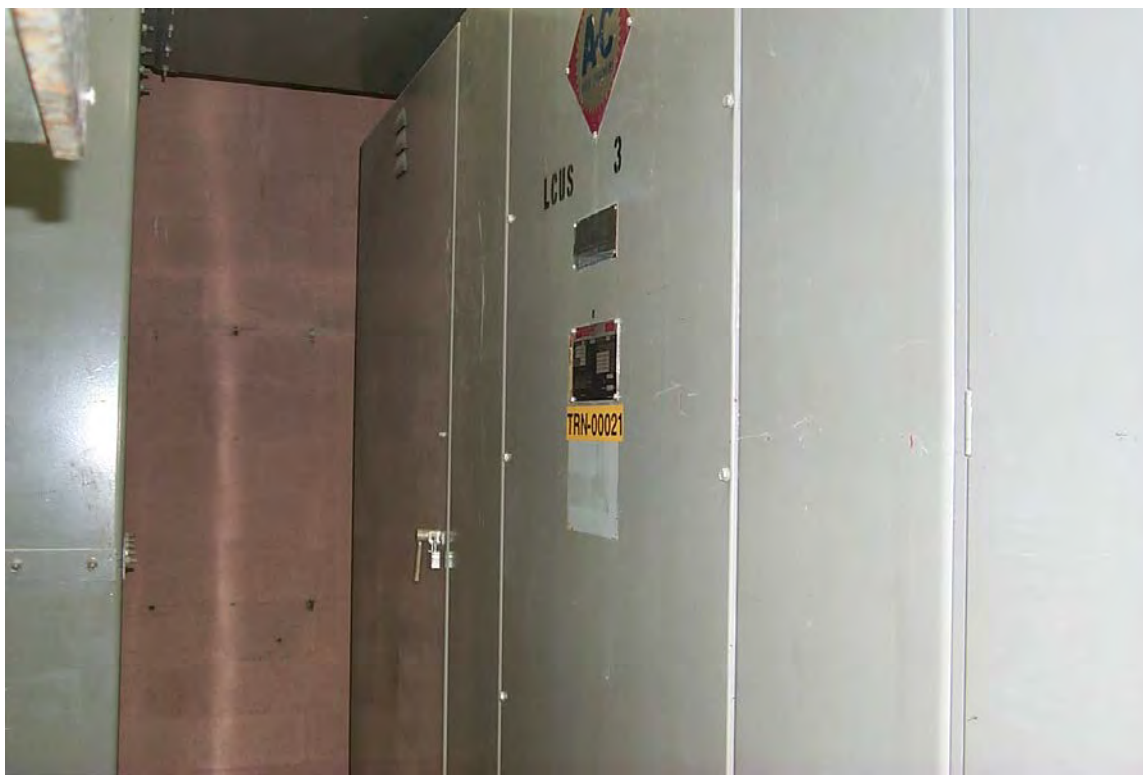
Picture #3502

Transformer LCUS-3 (TRN-00021)

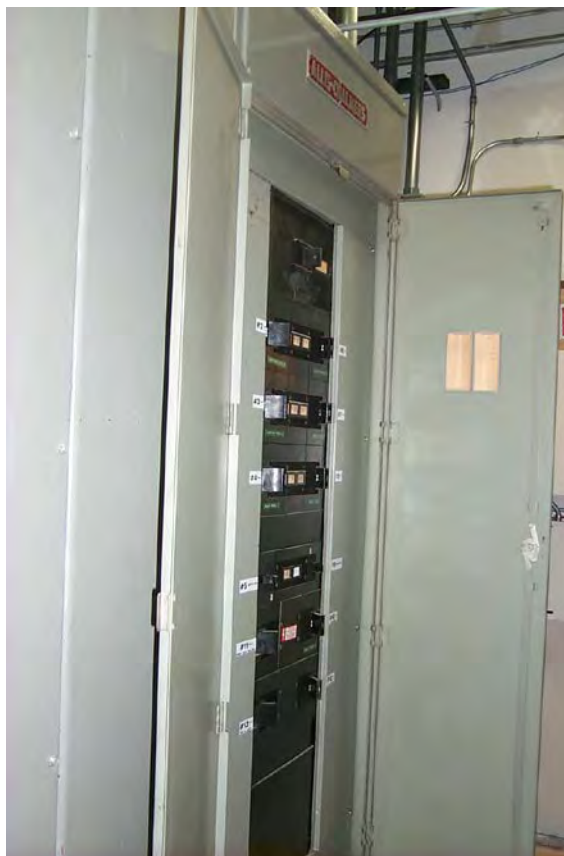
Picture #3503

Switchboard for LCUS-3 (TRN-00021)  
208V  
1<sup>st</sup> Floor-North Mech. Room

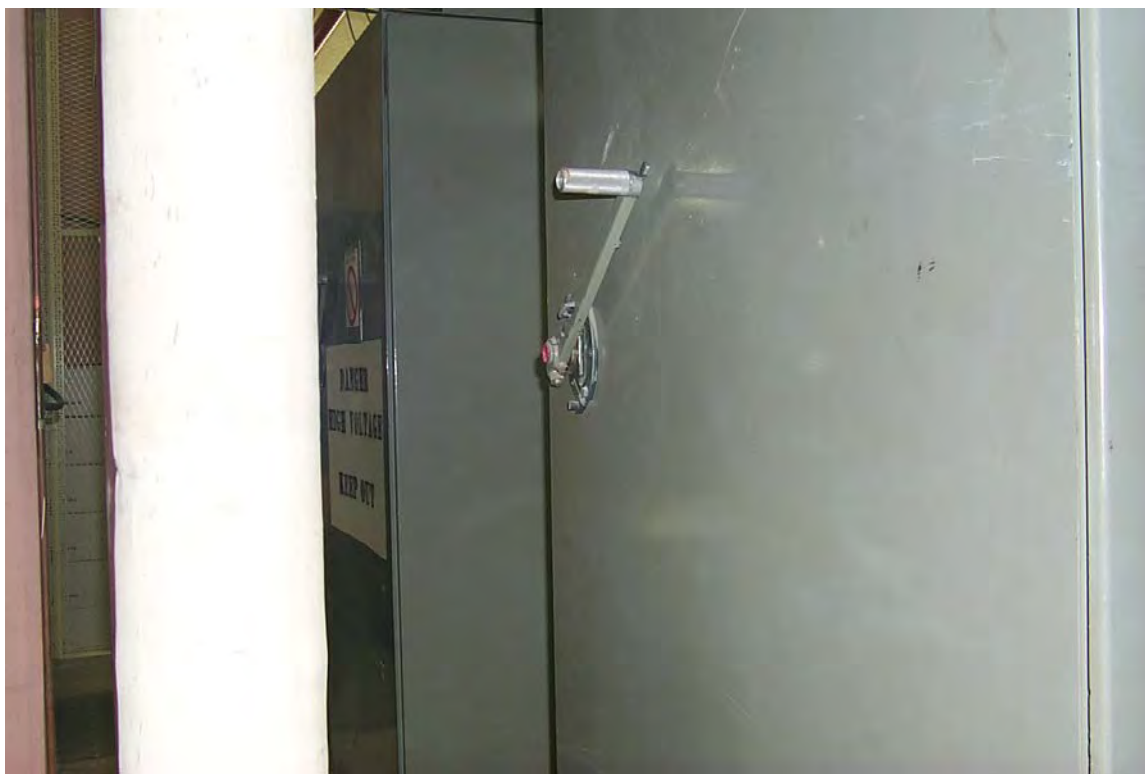
Picture #3504

Disconnect for LCUS-5 (TRN-00028)  
13200V  
15A  
2<sup>nd</sup> Floor-North Mech. Room
