**Subject:** Summary of work performed on electrical distribution system in the Docking Building.

Capital Electric Construction was contracted to perform maintenance and cleaning of the 13.2kV electrical distribution system in the Docking Building. The work was started on Wednesday, November 24 and completed on Saturday, November 27. This report summarizes our findings.

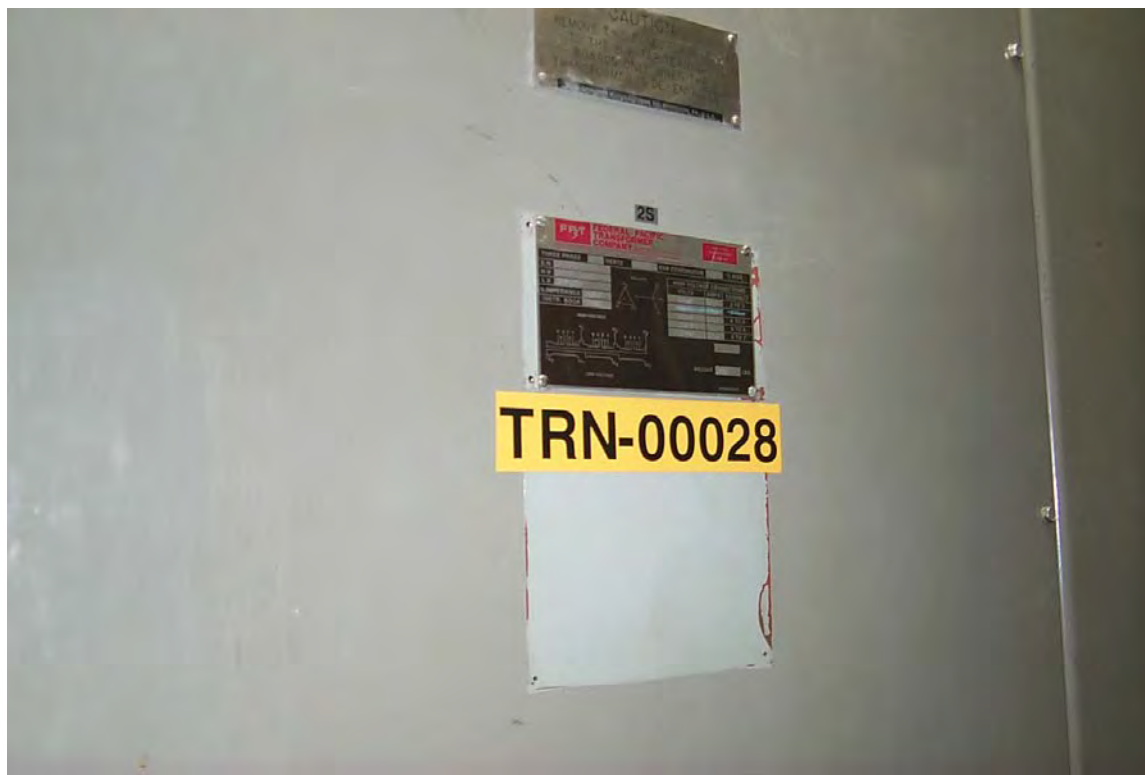
Picture #3503

Transformer LCUS-5 (TRN-00028)

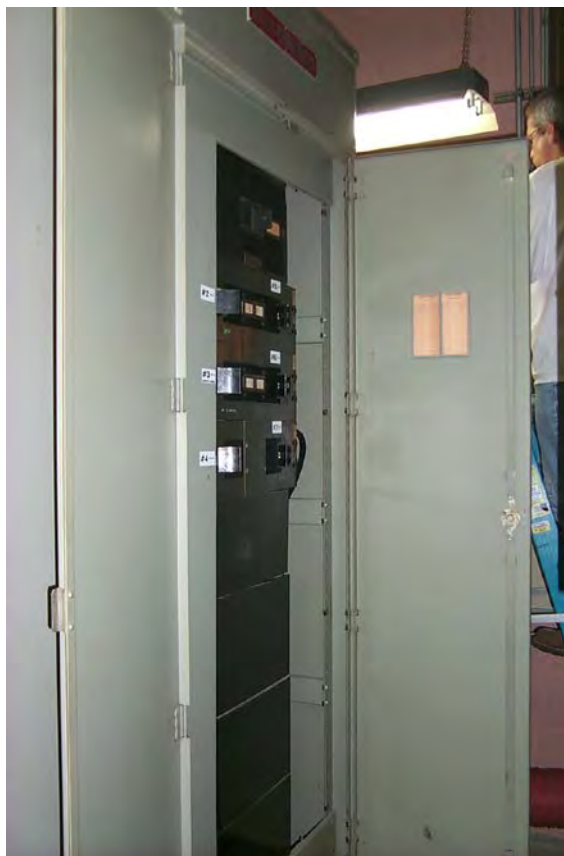
Picture #3506

Switchboard for LCUS-5 (TRN-00028)  
208V  
2<sup>nd</sup> Floor-North Mech. Room

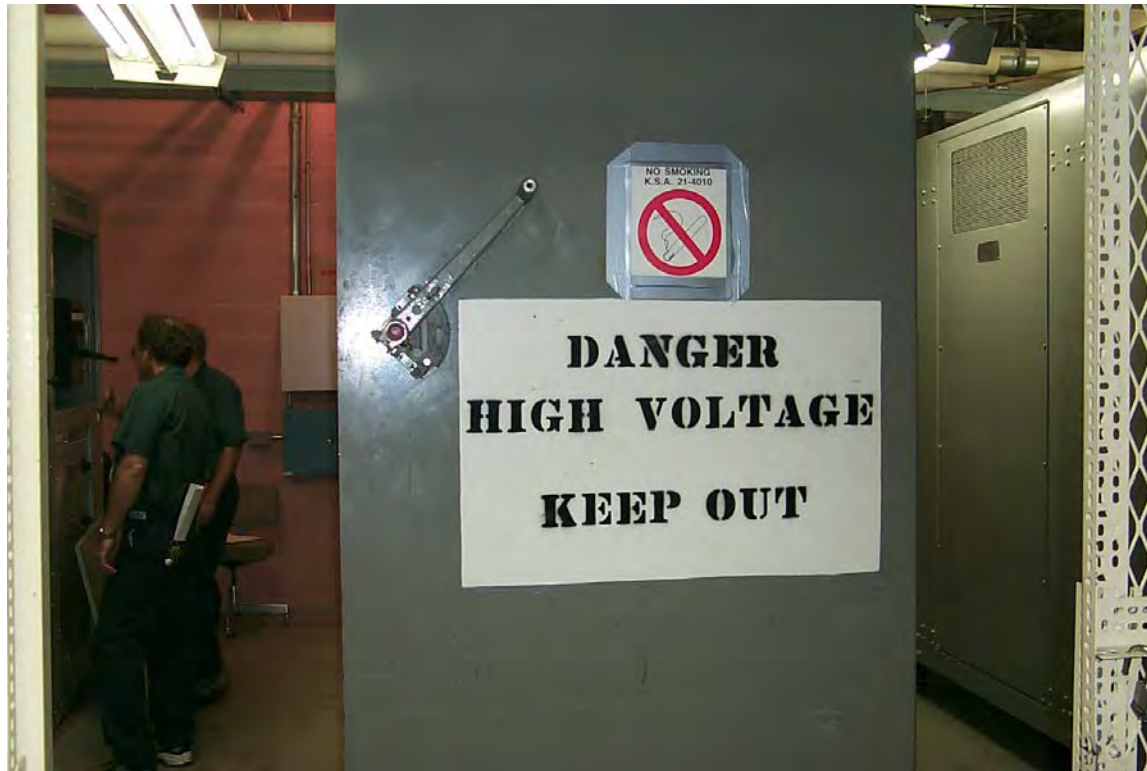
Picture #3507

Disconnect for LCUS-4 (TRN-00024)  
13200V  
15A  
2<sup>nd</sup> Floor-North Mech. Room

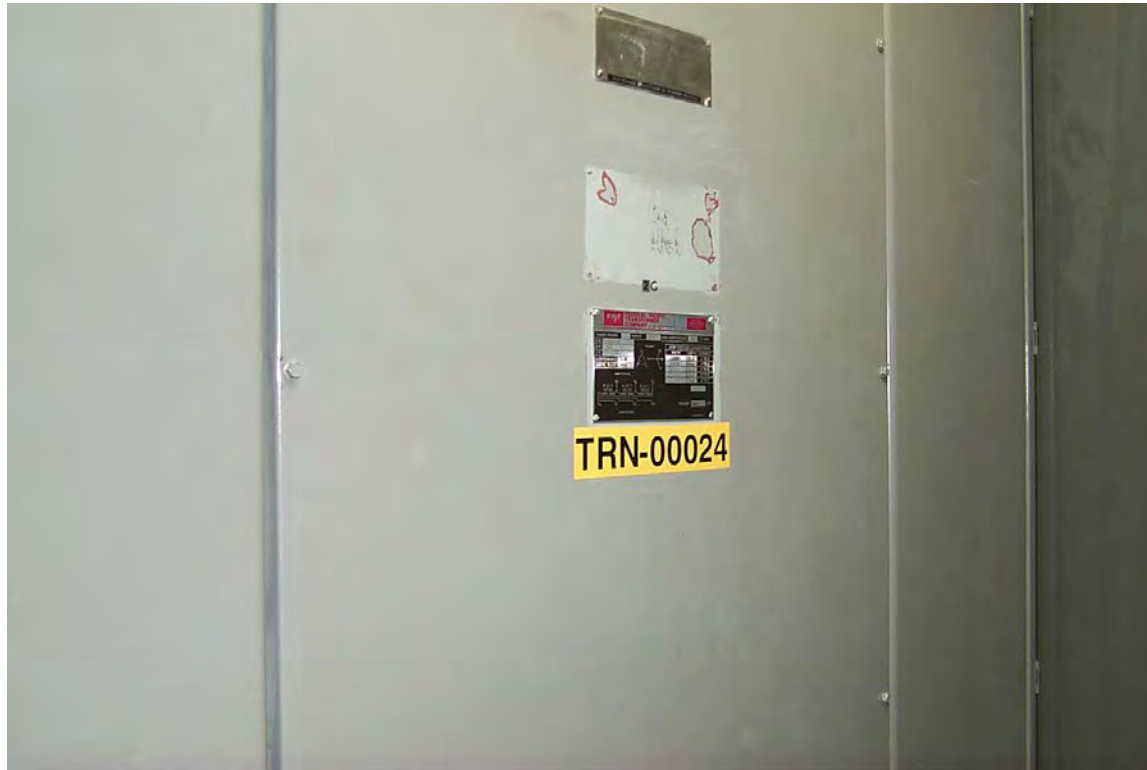
Picture #3508

Transformer LCUS-4 (TRN-00024)

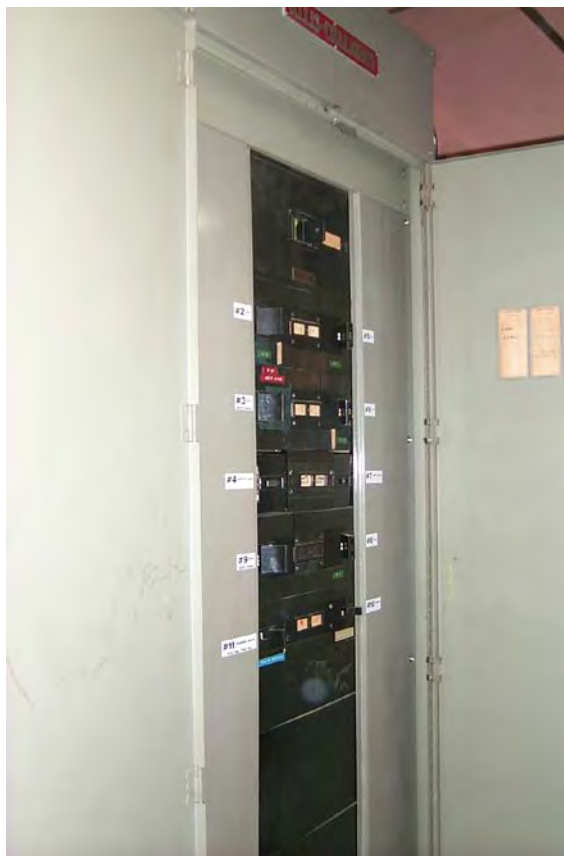
Picture #3509

Switchboard for LCUS-4 (TRN-00024)  
208V  
2<sup>nd</sup> Floor-North Mech. Room

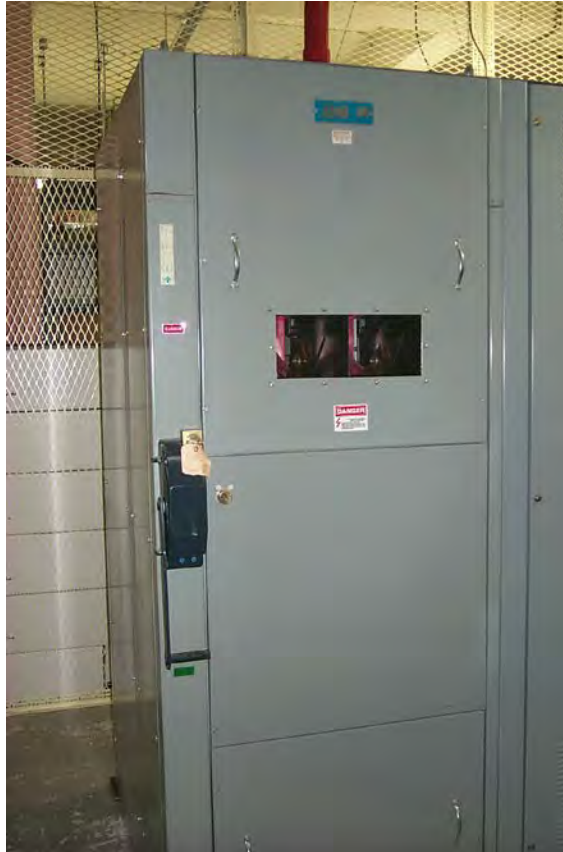
Picture #3510

Disconnect for TRN-00026  
13200V  
15A  
2<sup>nd</sup> floor-North Mech. Room

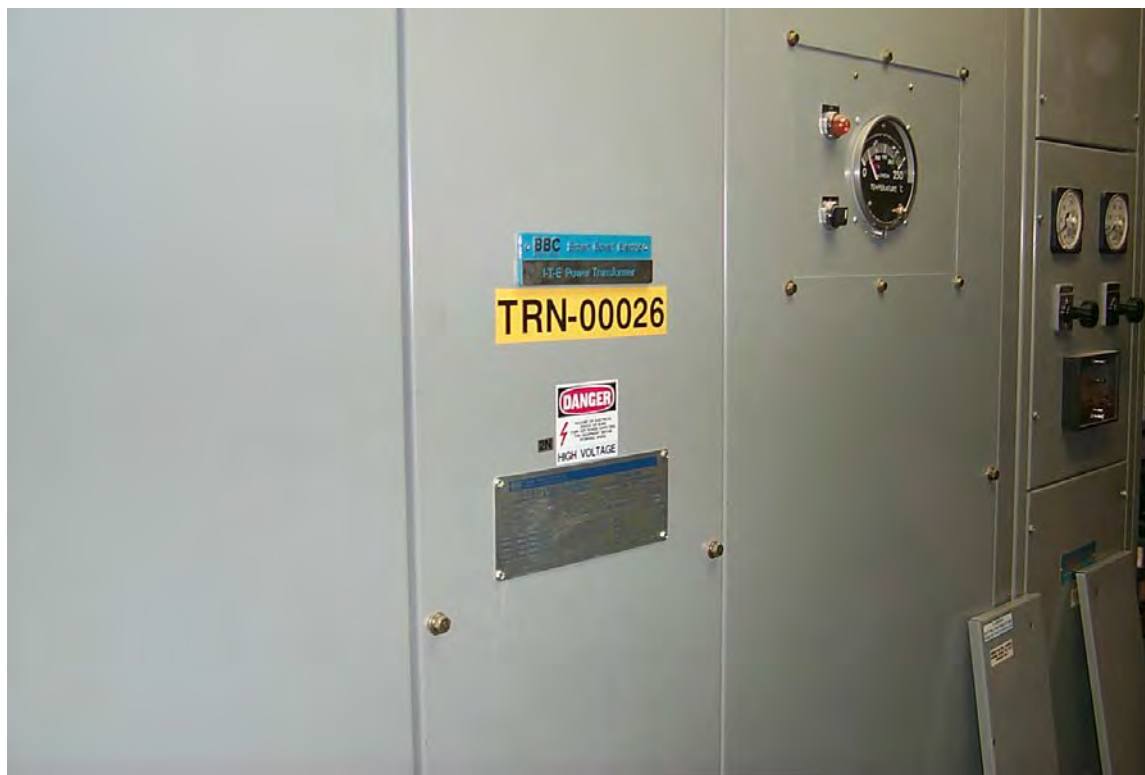
Picture #3511

Transformer TRN-00026

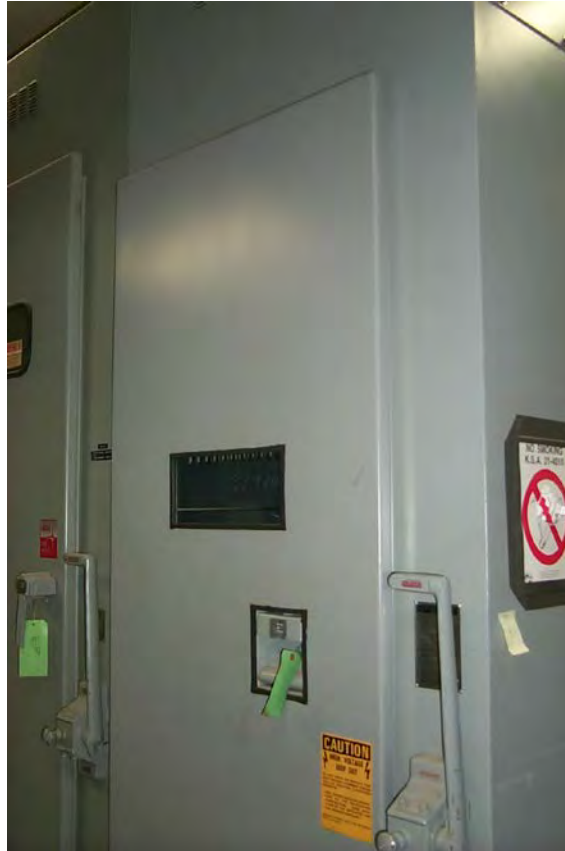
Picture #3472

| X | Item | Inspection Activity | NEC Reference | Comments |
|---|---|---|---|---|
| X | 2. | Check for broken or damaged parts and contamination by foreign materials. | 110-12( c) | Unable to open enclosure.<br>Western Resources provides maintenance. |

Switchgear CCM-1 (A) 4 Sections  
15000V  
Bay 3, Bay 6, Bay 7  
Basement-North Electrical Room

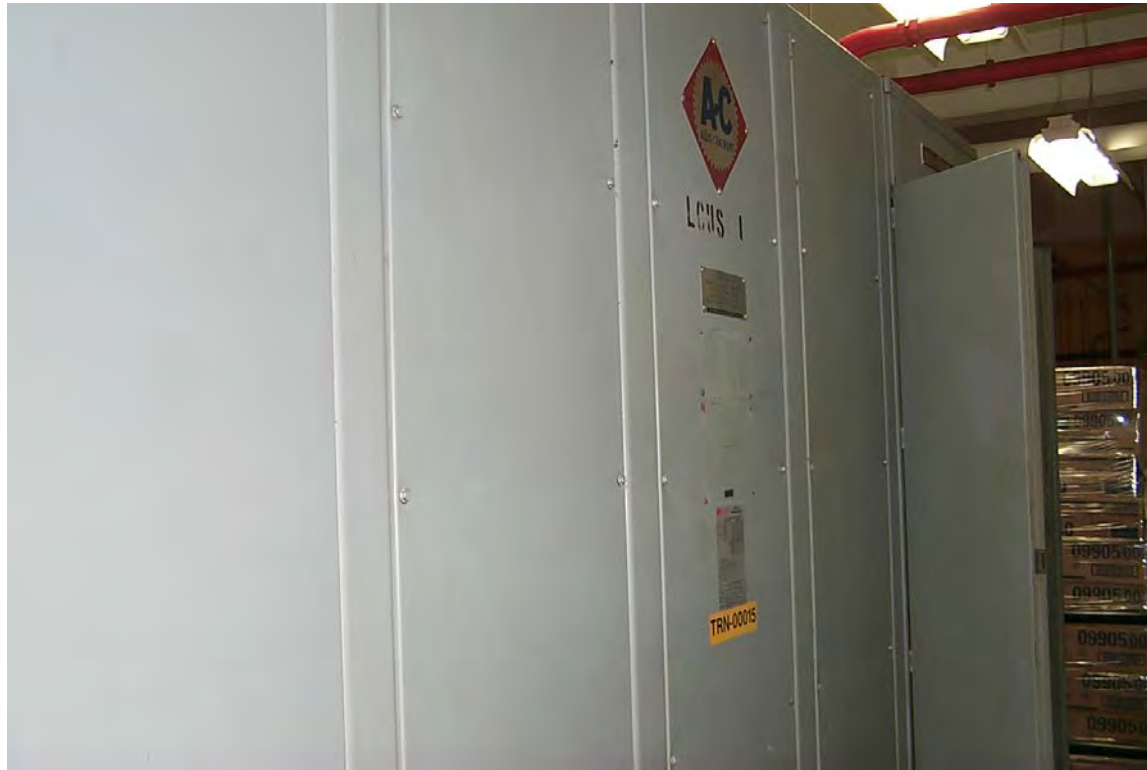
Picture #3474

| X | Item | Inspection Activity | NEC Reference | Comments |
|---|---|---|---|---|
| X | 6. | Check for broken or damaged parts and contamination by foreign materials. | 110-12( c) | Unable to open enclosure |

Disconnect for LCUS-1 (TRN-00015)  
13800V  
Basement-Center Mezzanine

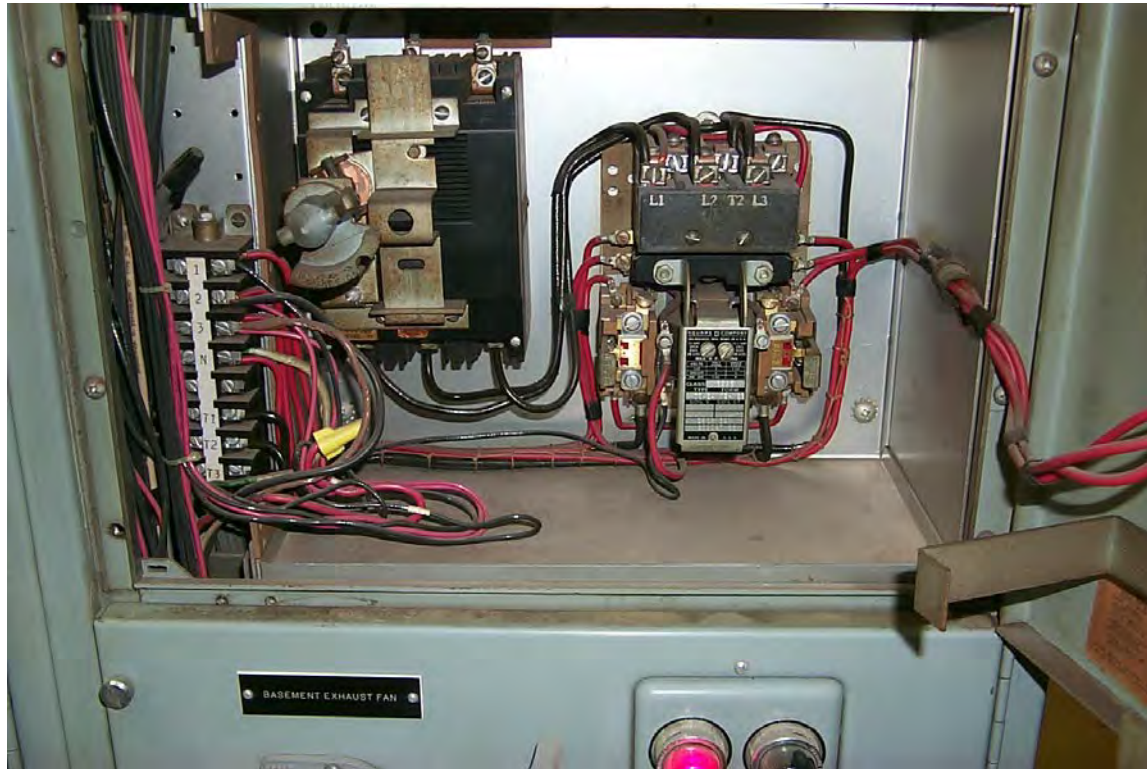
Picture #3477

| X | Item | Inspection Activity | NEC Reference | Comments |
|---|---|---|---|---|
| X | 2. | Check for broken or damaged parts and contamination by foreign materials. | 110-12( c ) | Inspected all compartments (but one)<br>main centravac control locked in off position<br>with keyed lock. All compartments dirty, dusty,<br>some have foreign debris. Several<br>compartments have wire ??? and splices. |
| X | 12. | Check for age and deterioration of equipment. | | Equipment is dirty, does not look as though it<br>has a maint. program. All compartments have<br>dust, dirt and foreign debris. Age is Unknown. |

Motor Control Center MCC-00016  
208V  
Basement-Center Mezzanine

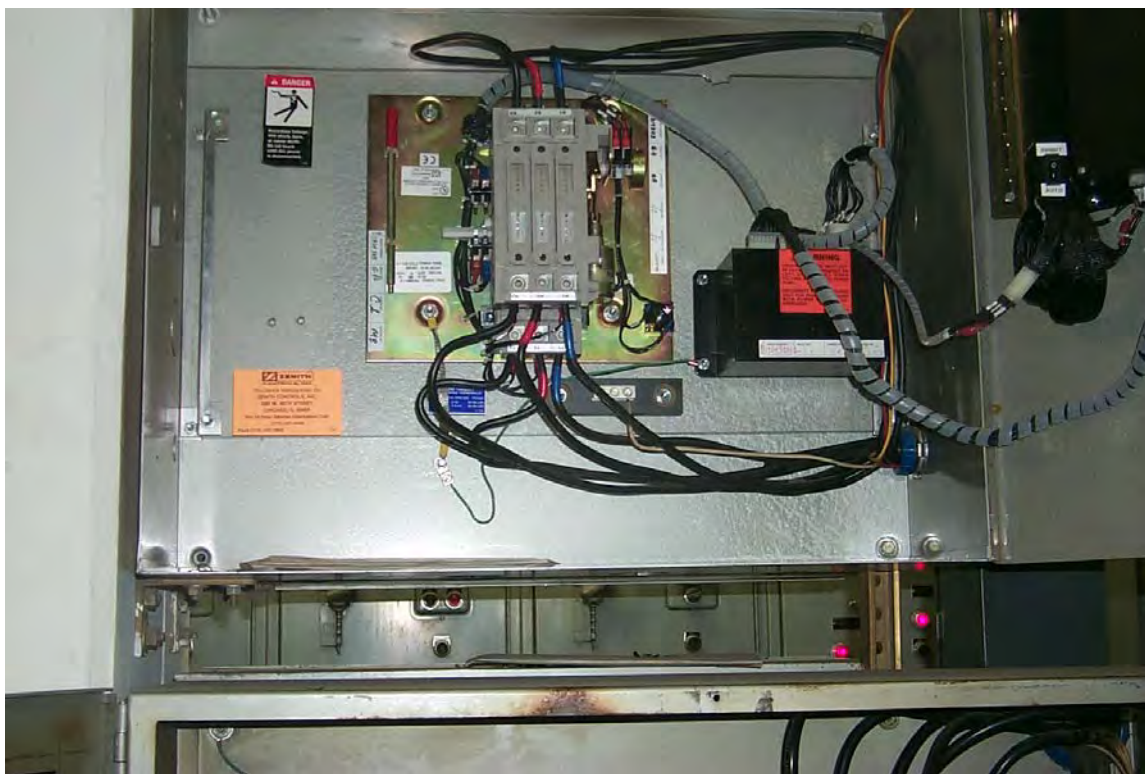
Picture #3478

Motor Control Center MCC-00016 (Continued)  
208V  
Basement-Center Mezzanine

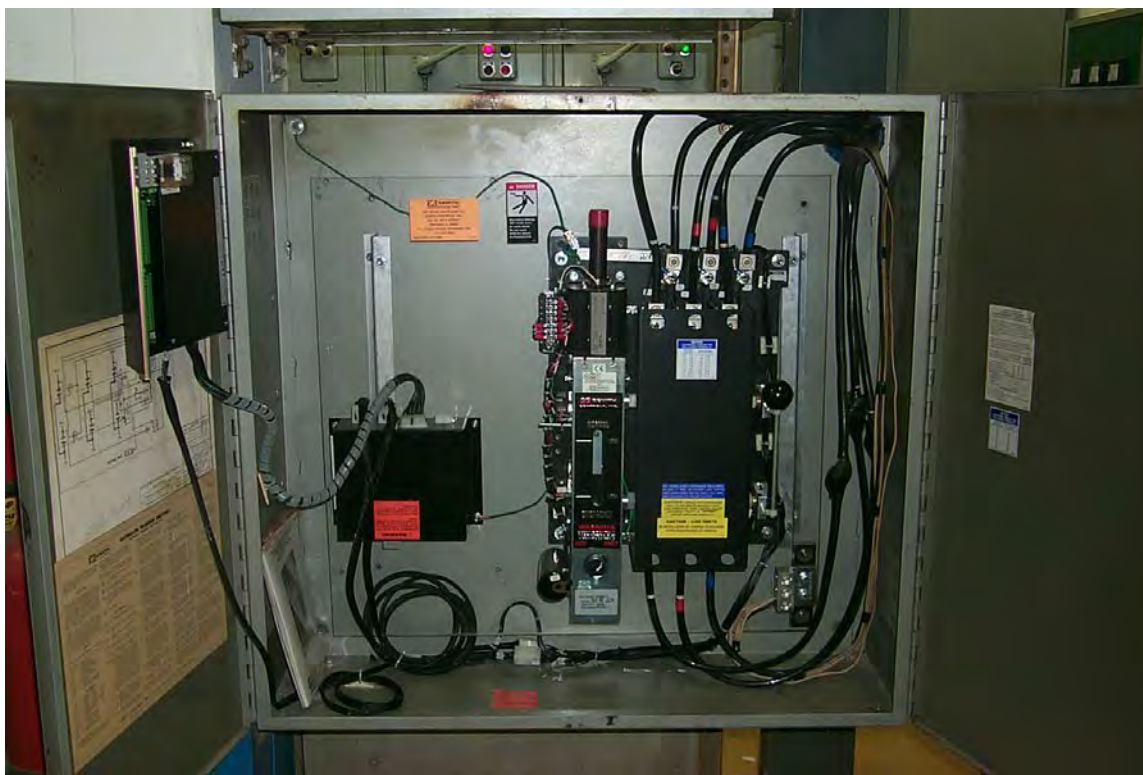
Picture #3776

Automatic Transfer Switch ATS-2 (Sump Pump)  
208V  
40A  
Basement Mezzanine

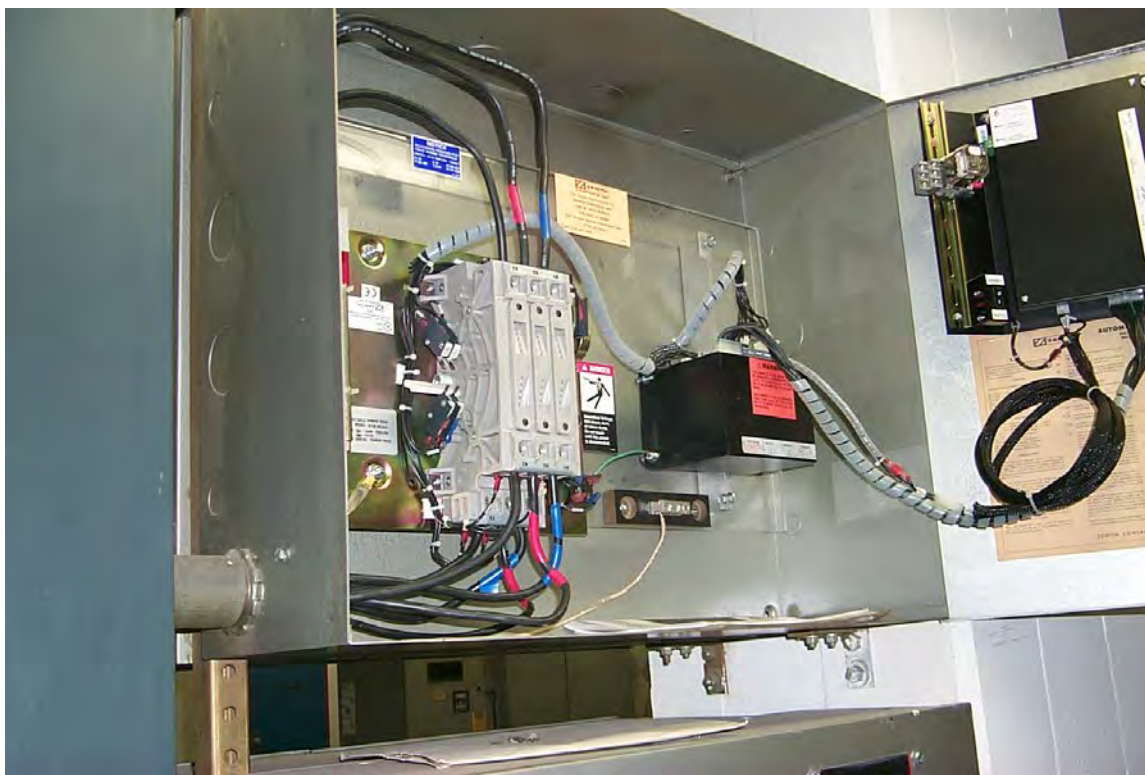
Picture # 3778

Automatic Transfer Switch ATS-1  
(Aux. Hot Water Pump)  
208V  
225A  
Basement Mezzanine

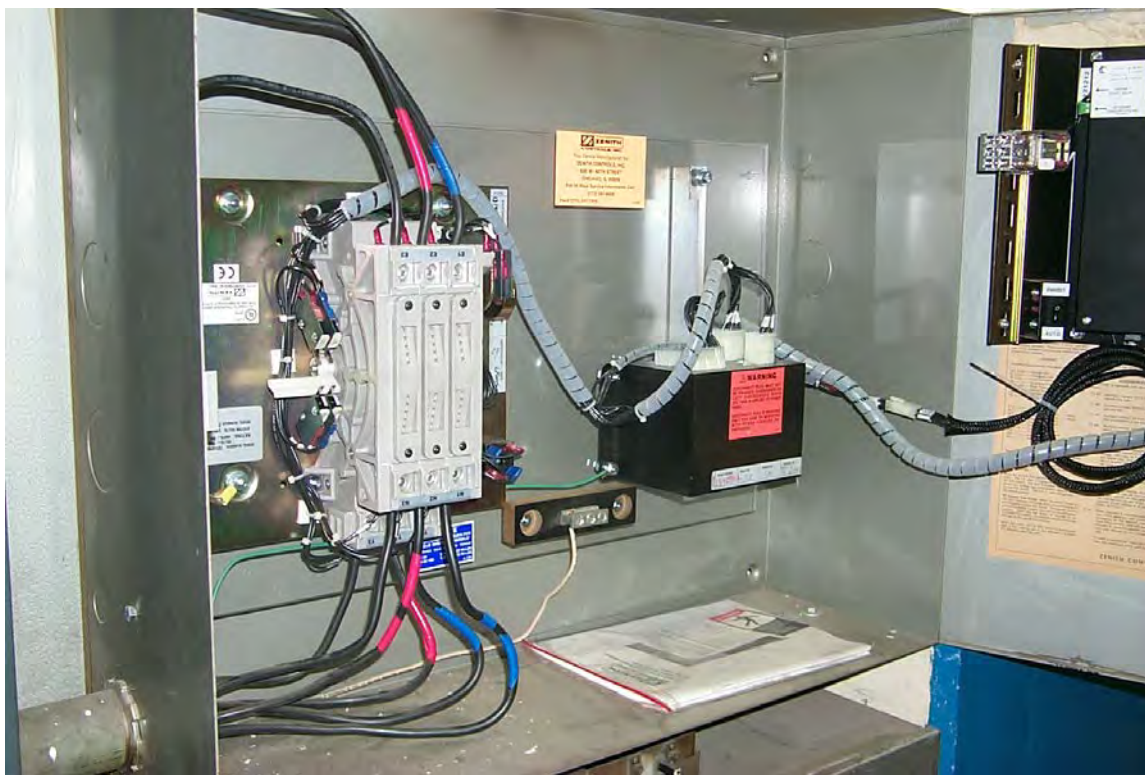
Picture # 3779

Automatic Transfer Switch ATS-3  
(Air Comp. #1 and #2)  
208V  
100A  
Basement Mezzanine

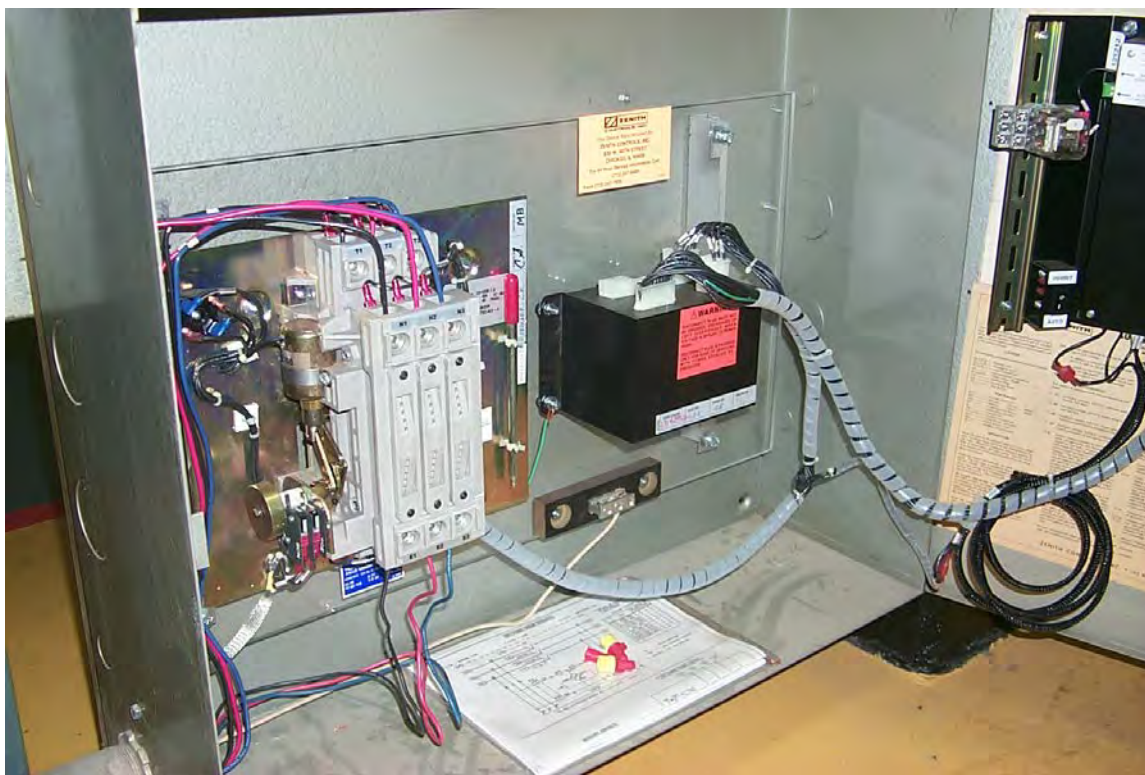
Picture # 3780

Automatic Transfer Switch ATS-4  
(Sewage Lift Pump)  
208V  
80A  
Basement Mezzanine

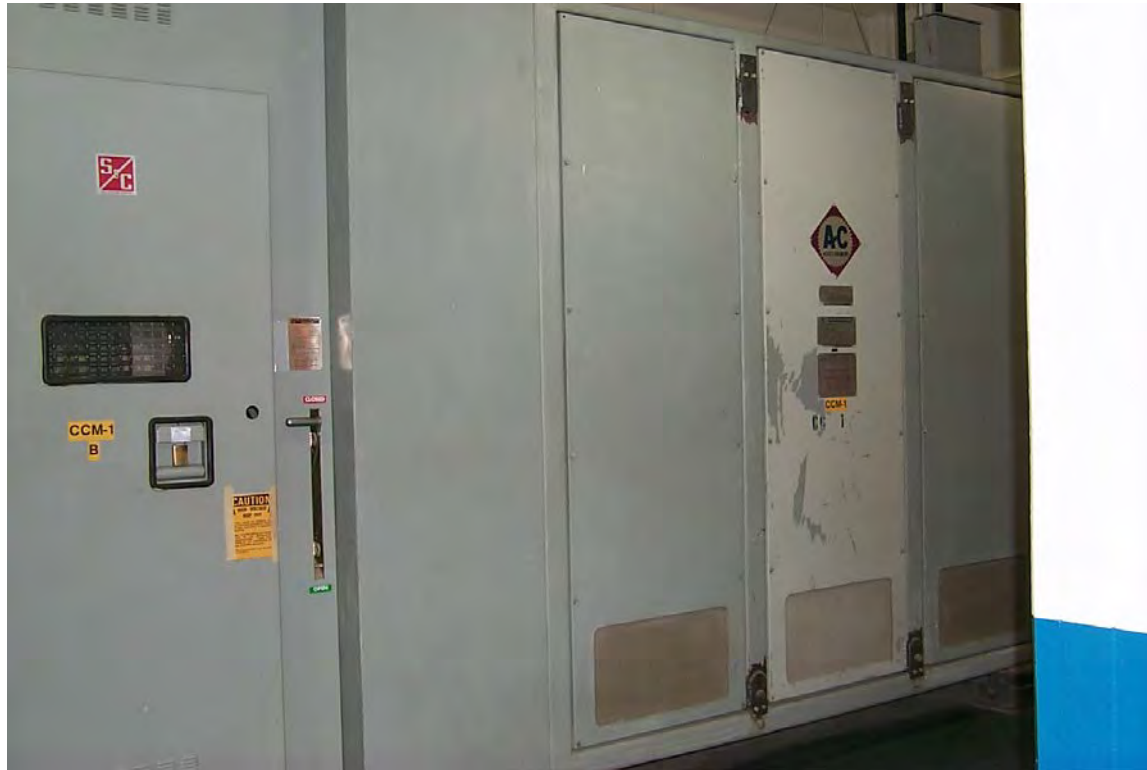
Picture #3469

Disconnect CCM-1 (B)  
13800V  
Basement-Mezzanine

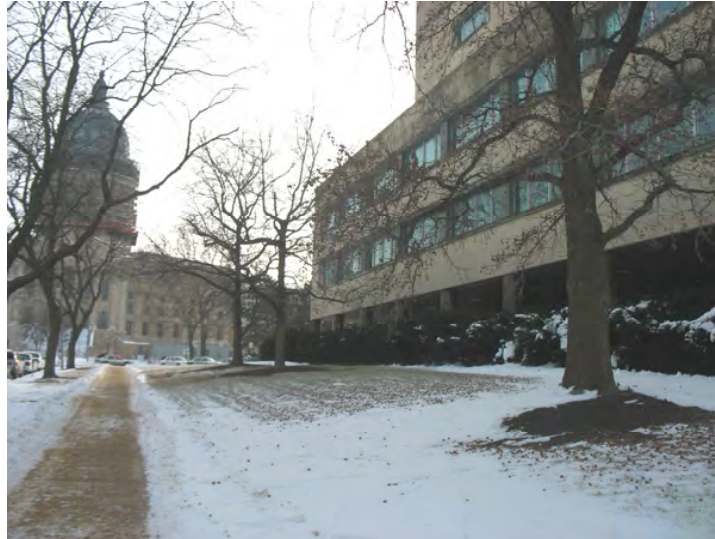
**Photograph 1: North Side Docking State Office Building**

This option involves the installation of two (2) new, 3,750 kVA, 13.2kV-480Y/277 Volt pad mounted transformers on the north side of the building. See Photograph 1 for approximate area for new transformers. The existing electrical, primary voltage feed is routed in a ductbank from a manhole at the northeast corner of Harrison and 9th Street. This ductbank consists of three (3) 6-inch conduits, concrete encased. To supply the new pad mounted transformers, a new ductbank, consisting of four (4) 6-inch conduits (two for conductors and two spares) would be routed from the existing manhole to the new transformers location.

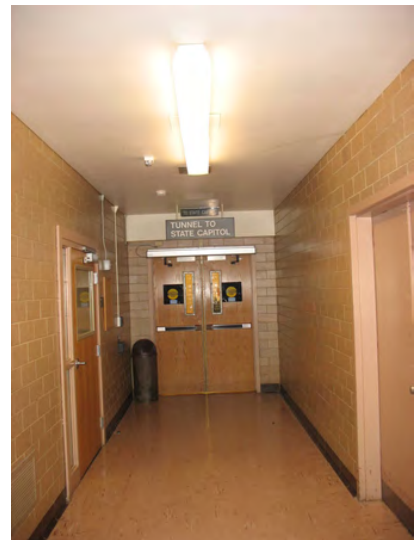
**Photograph 2: North End  
Basement Hallway**

Photograph 2 shows the existing electrical room door to the right, the existing doors to the tunnel in the center, and the existing door to the auditorium on the left.

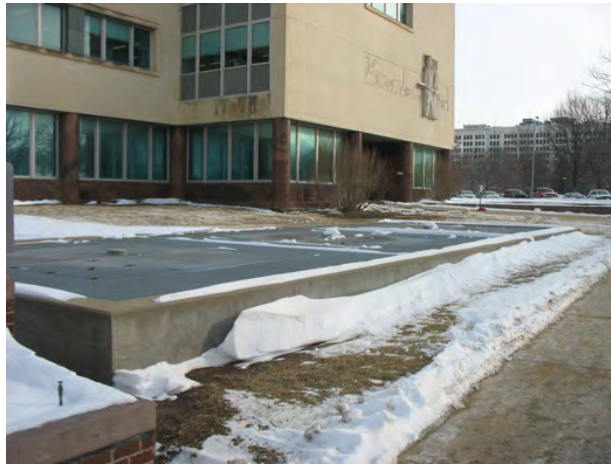
**Photograph 3: South Side of DSOB Areaway**

This option involves the installation of two (2) new, 3,750 kVA, 13.2 kV-480Y/277 Volt substation transformers in the existing areaway on the south side of the building. Photographs 3 and 4 show the existing areaway at the south end of the building. The existing electrical, primary voltage feed is routed in a ductbank from a manhole at the northeast corner of Harrison and 9th Street. This ductbank consists of three (3) 6-inch

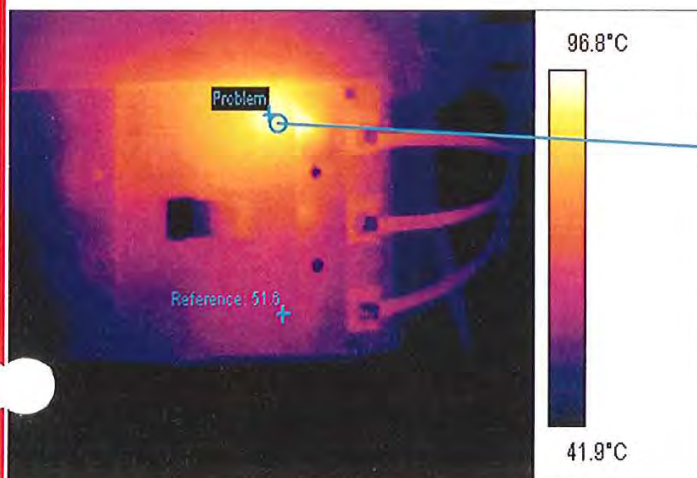
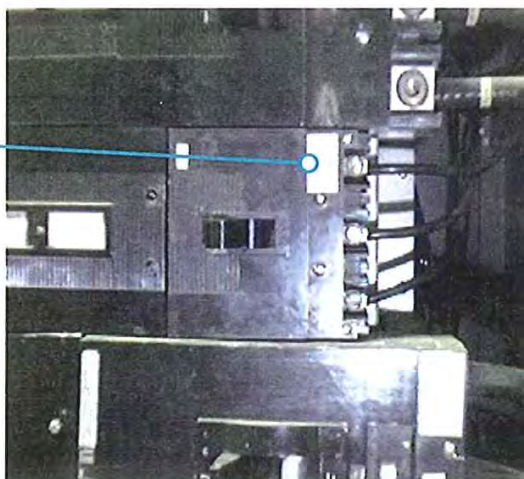
62\IR\_2961.jpg

☒ Equipment Failure ☒ Fire Hazard ☒ Safety Hazard ☒ Power/Business Interruption

Additional loading and continued exposure to this condition will more than likely accelerate a failure of this device.

Deenergize circuit, inspect and repair contacts as a matched set if applicable, or install properly rated replacement breaker.

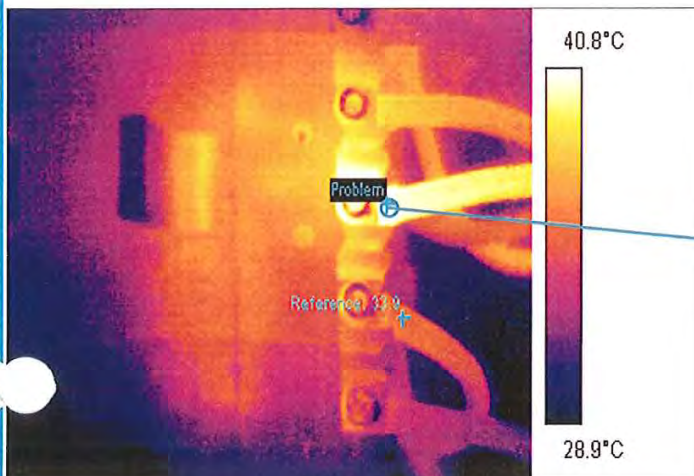
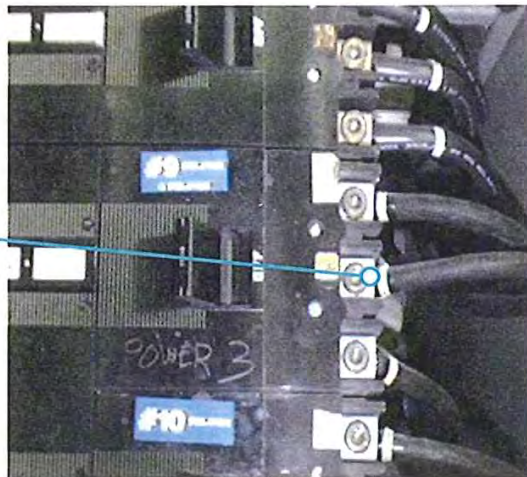
62VR\_2967.jpg

☒ Excessive Current Harmonics

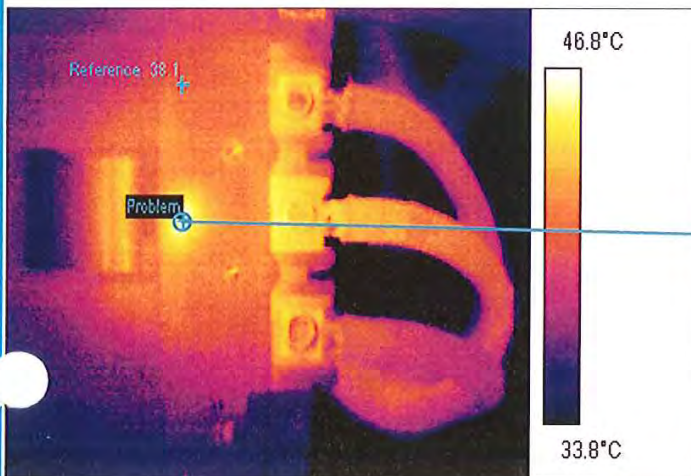
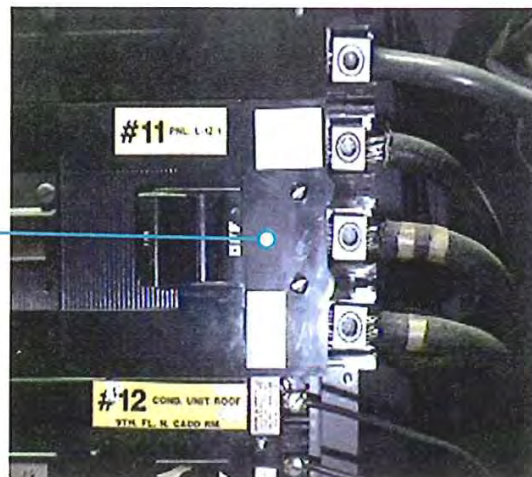
621IR\_2974.jpg

☒ Excessive Current Harmonics

Deenergize circuit, inspect and repair contacts as a matched set if applicable, or install properly rated replacement breaker.

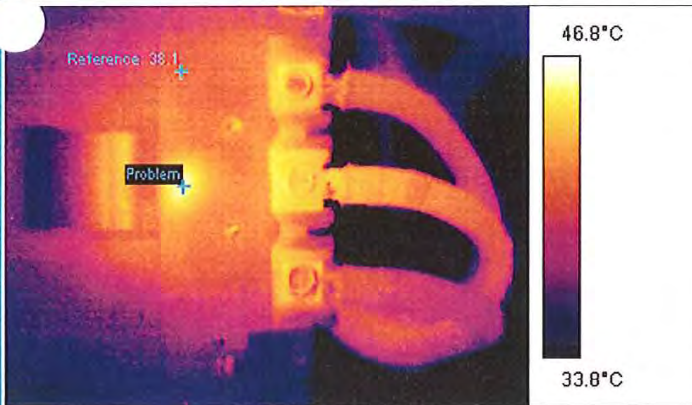
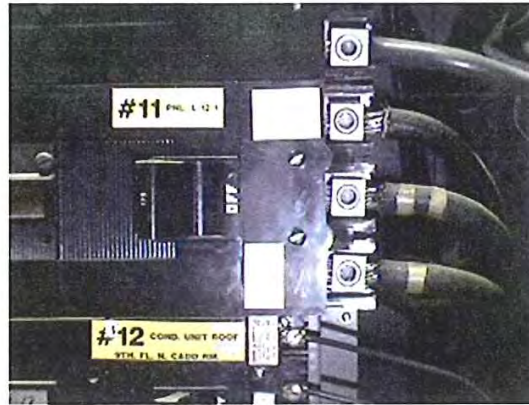
^[ PROBLEM ]^ - 62\IR\_2974.jpg

☒ Equipment Failure ☒ Fire Hazard ☒ Safety Hazard ☒ Power/Business Interruption

Additional loading and continued exposure to this condition will more than likely accelerate a failure of this device.

☐ Fixed During Visit ☐ Contractor Will Correct ☒ Customer Will Correct ☐ Estimate Required

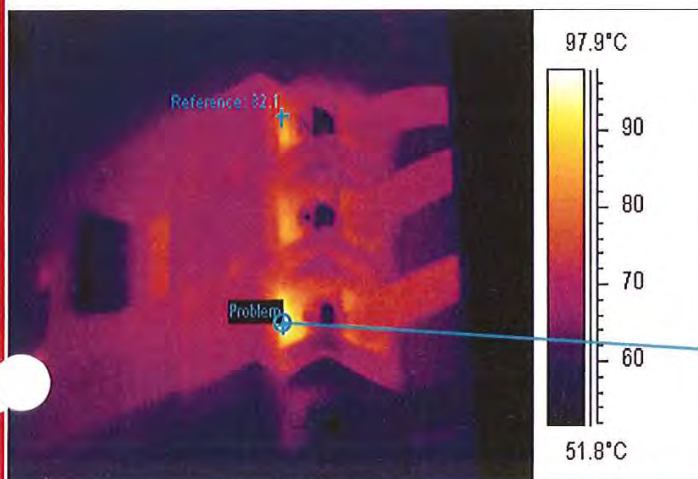
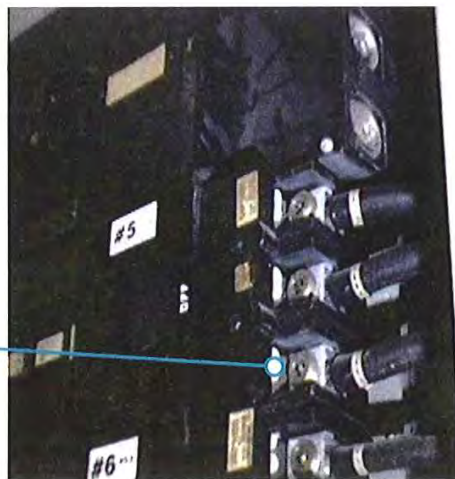
621R\_2898.jpg

☒ Excessive Current Harmonics

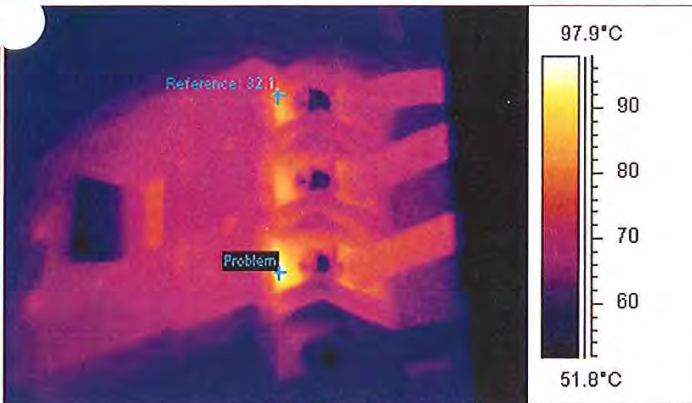
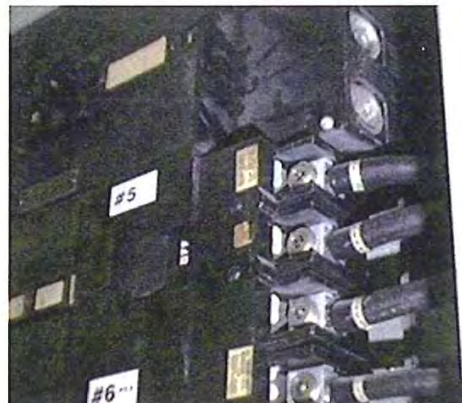
^{\text{PROBLEM}}^ - 62\IR\_2898.jpg

☒ Equipment Failure ☒ Fire Hazard ☒ Safety Hazard ☒ Power/Business Interruption

☐ Fixed During Visit ☐ Contractor Will Correct ☒ Customer Will Correct ☐ Estimate Required

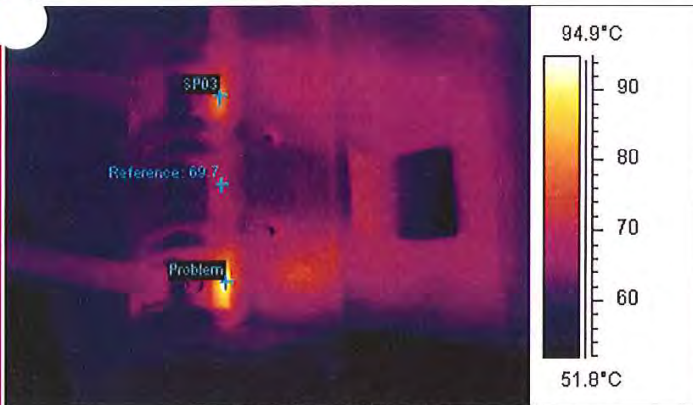
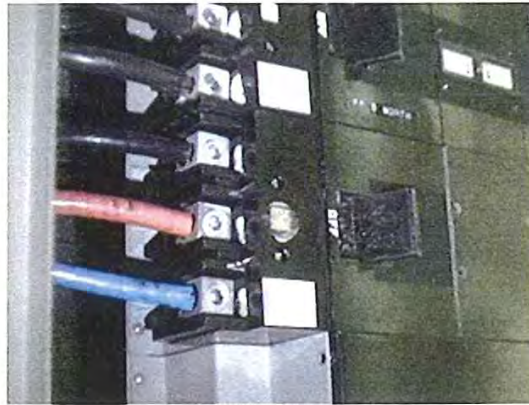
62\IR\_2900.jpg

☒ Equipment Failure ☒ Fire Hazard ☒ Safety Hazard ☒ Power/Business Interruption

Additional loading and continued exposure to this condition will more than likely accelerate a failure of this device.

☐ Fixed During Visit ☐ Contractor Will Correct ☒ Customer Will Correct ☐ Estimate Required

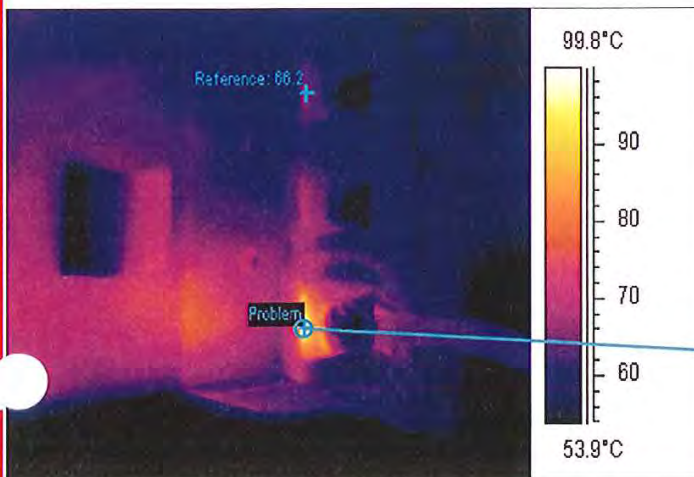
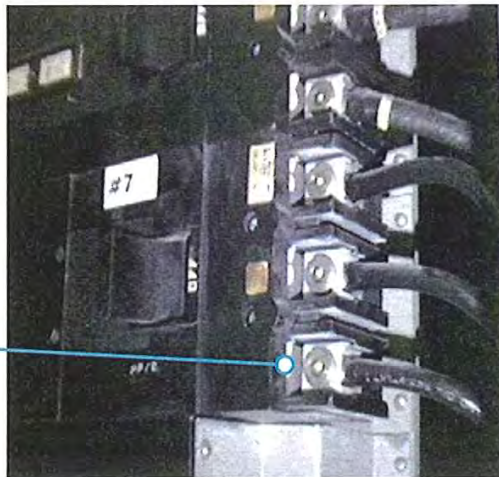
62\IR\_2902.jpg

☒ Excessive Current Harmonics

Deenergize circuit, inspect and repair contacts as a matched set if applicable, or install properly rated replacement breaker.

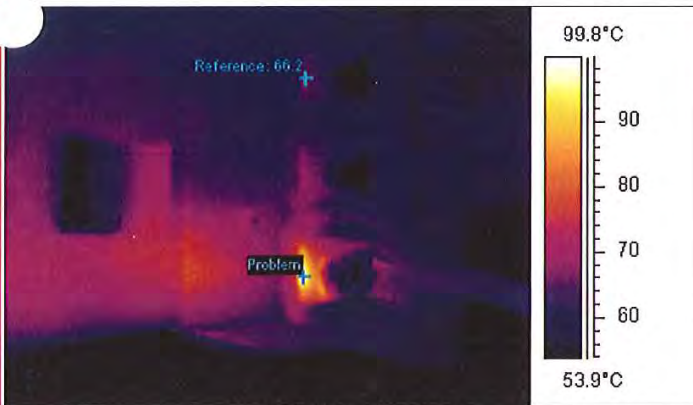
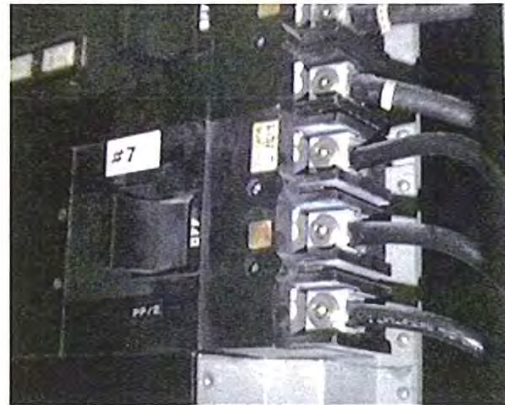
4[ PROBLEM ]^ - 62\IR\_2902.jpg

☒ Equipment Failure ☒ Fire Hazard ☒ Safety Hazard ☒ Power/Business Interruption

Additional loading and continued exposure to this condition will more than likely accelerate a failure of this device.

☐ Fixed During Visit ☐ Contractor Will Correct ☒ Customer Will Correct ☐ Estimate Required

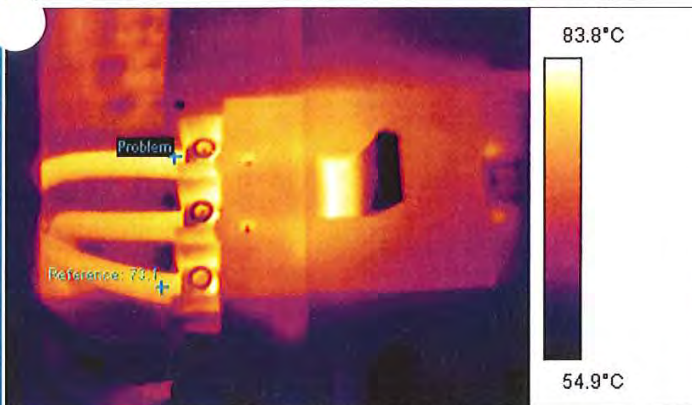
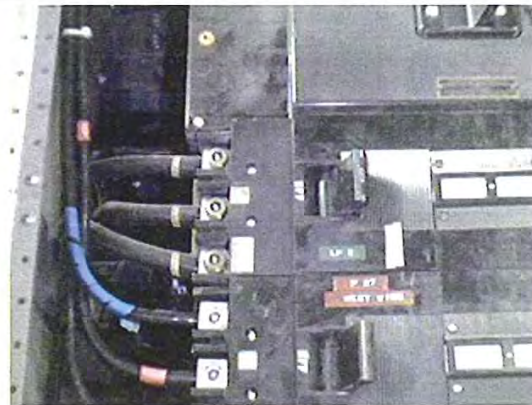
^{\text{PROBLEM}}^{\wedge} - 62\text{IIR}\_2906.jpg

☒ Equipment Failure ☒ Fire Hazard ☒ Safety Hazard ☒ Power/Business Interruption

Harmonic distortion can cause heat stress on electrical equipment, conductors, and transformers.

☐ Fixed During Visit ☐ Contractor Will Correct ☒ Customer Will Correct ☐ Estimate Required

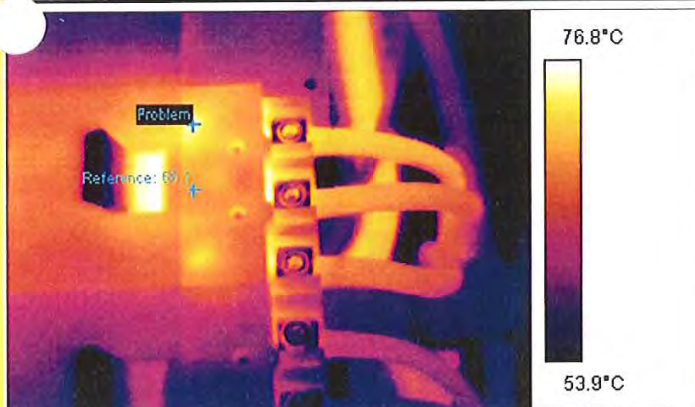
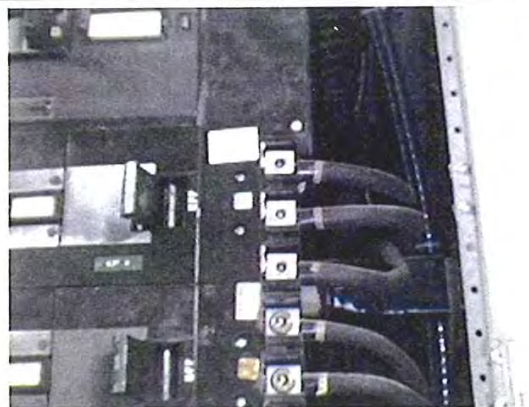
^[ PROBLEM ]^ - 62\IR\_2908.jpg

☒ Equipment Failure ☒ Fire Hazard ☒ Safety Hazard ☒ Power/Business Interruption

☐ Fixed During Visit ☐ Contractor Will Correct ☒ Customer Will Correct ☐ Estimate Required

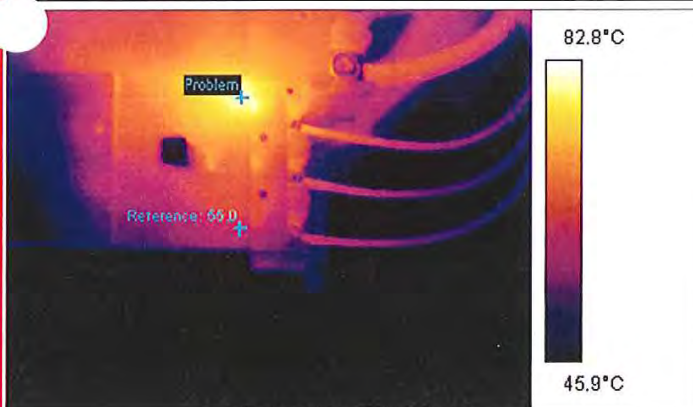
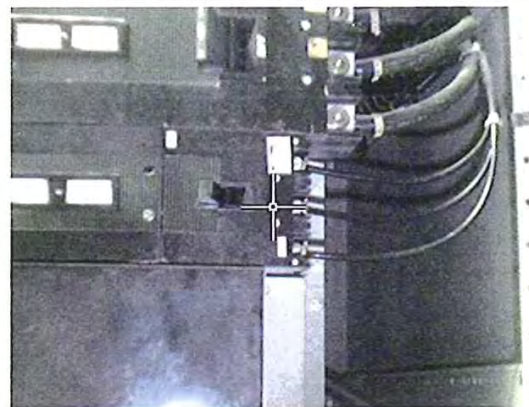
^[ PROBLEM ]^ - 62\IR\_2916.jpg

☒ Equipment Failure ☒ Fire Hazard ☒ Safety Hazard ☒ Power/Business Interruption

Additional loading and continued exposure to this condition will more than likely accelerate a failure of this device.

☐ Fixed During Visit ☐ Contractor Will Correct ☒ Customer Will Correct ☐ Estimate Required

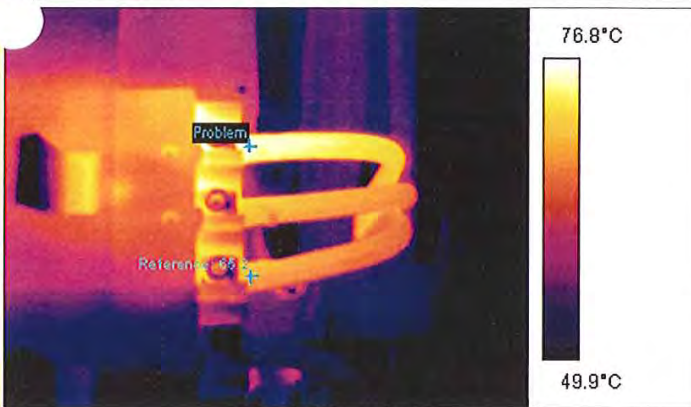
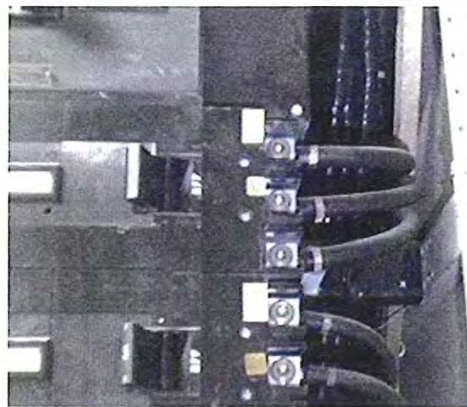
^[ PROBLEM ]^ - 62\IR\_2920.jpg

☒ Equipment Failure ☒ Fire Hazard ☒ Safety Hazard ☒ Power/Business Interruption

☐ Fixed During Visit ☐ Contractor Will Correct ☒ Customer Will Correct ☐ Estimate Required

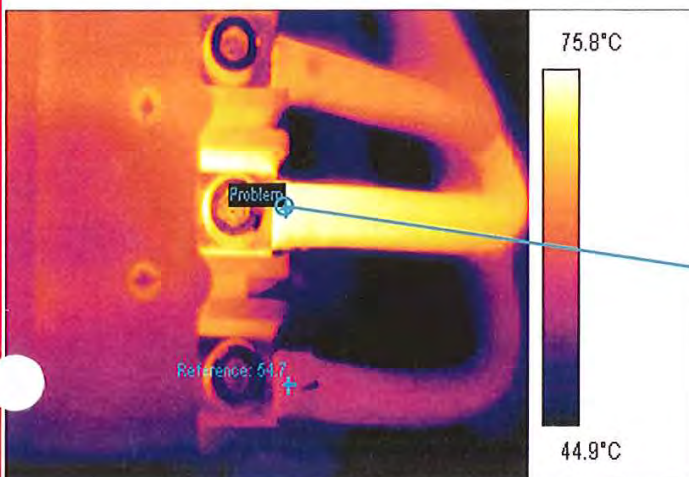
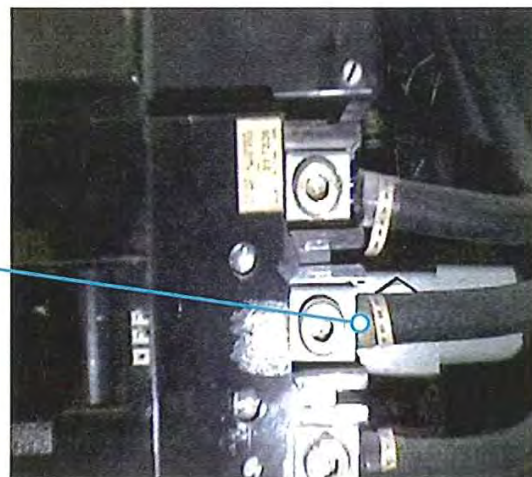
62\IR\_2937.jpg

Circuit #\_7\_ has a temperature rise greater that 10 degrees C over the ambient air surrounding it under normal operating conditions.

Properly repair the breaker lug do to cross threading or check the lugs connection internally or replace the breaker with a new breaker.
