**Subject:** Summary of work performed on electrical distribution system in the Docking Building.

Capital Electric Construction was contracted to perform maintenance and cleaning of the 13.2kV electrical distribution system in the Docking Building. The work was started on Wednesday, November 24 and completed on Saturday, November 27. This report summarizes our findings.

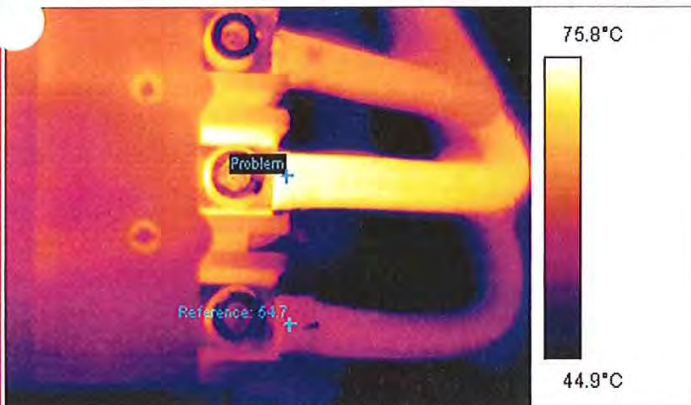
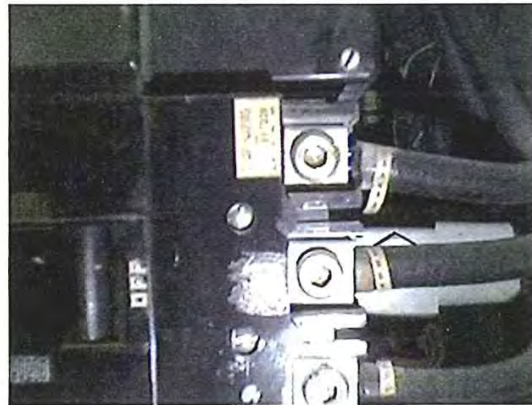
^[PROBLEM]^ - 62IIR\_2937.jpg

Unwanted bussiness loss and a fire hazard.

We did torque all the connection points of the breaker, we strongly believe that the B phase lug is cross threaded.

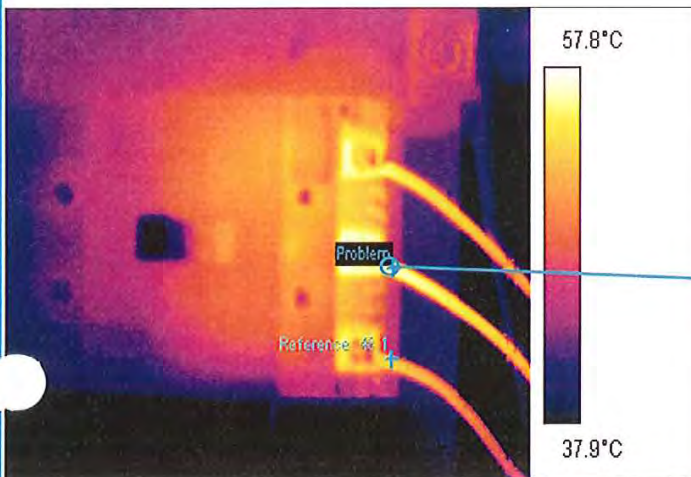
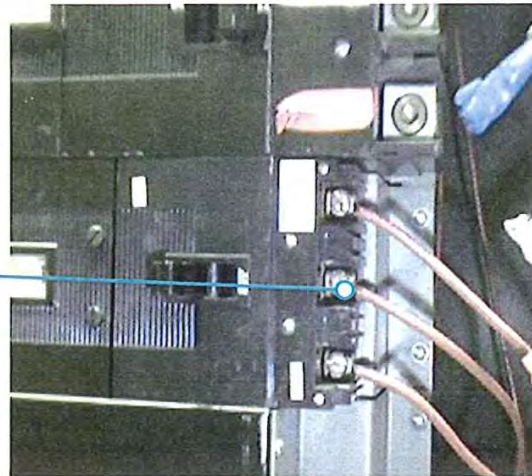
62\IR\_2943.jpg

Circuit #\_11\_B phase contact has a temperature rise greater than 10 degrees C over the ambient air surrounding it under normal operating conditions.

Exercise the breaker to prevent permanent pitting on the breakers contacts. Check the contacts internally for possible damage.

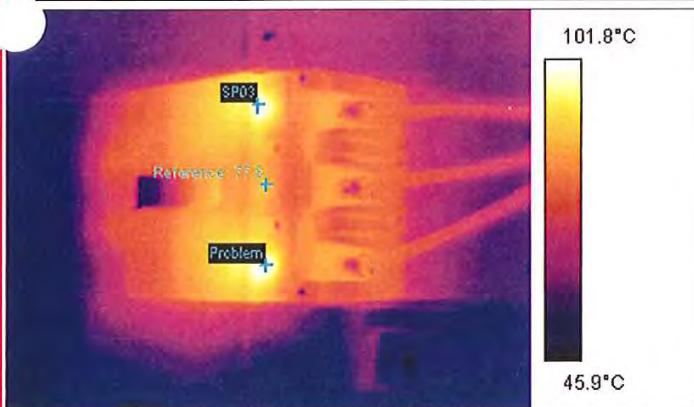
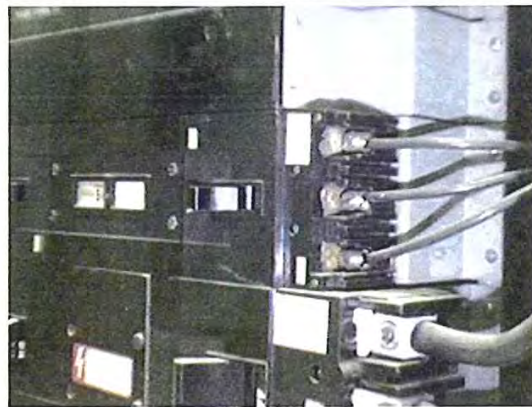
^ (PROBLEM)^ - 62\IR\_2892.jpg

Additional loading and continued exposure to this condition will more than likely accelerate a failure of this device.

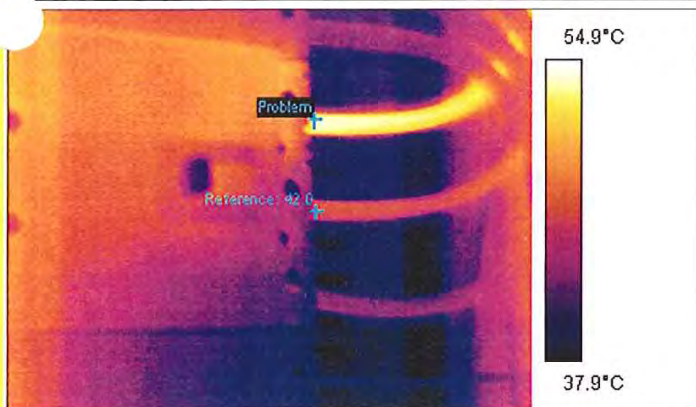
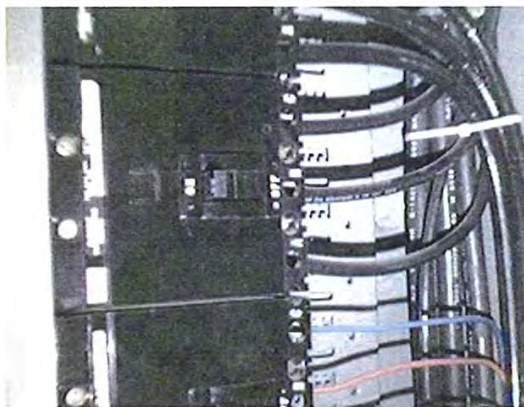
^[PROBLEM]^ - 62\IR\_2868.jpg

Additional loading and continued exposure to this condition will more than likely accelerate a failure of this device.

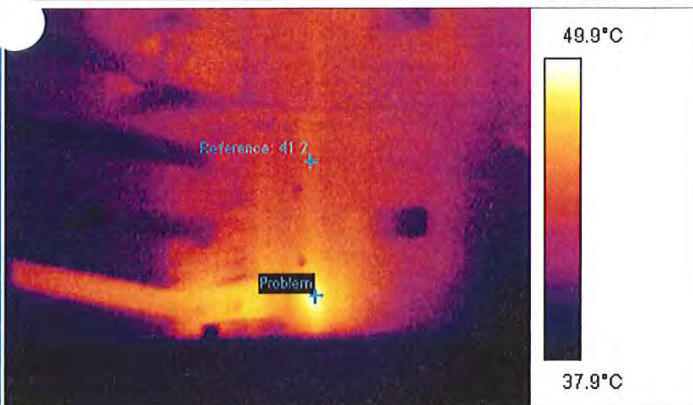
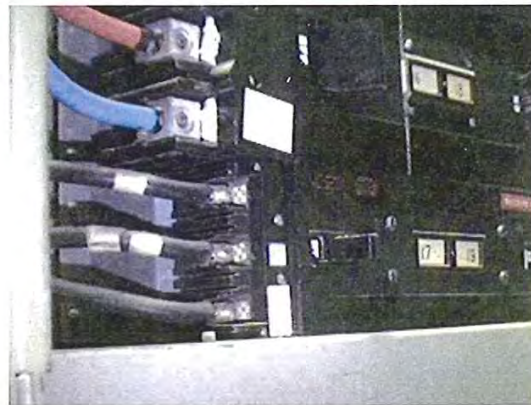
^[ PROBLEM ]^ - 62\IR\_2871.jpg

Additional loading and continued exposure to this condition will more than likely accelerate a failure of this device.

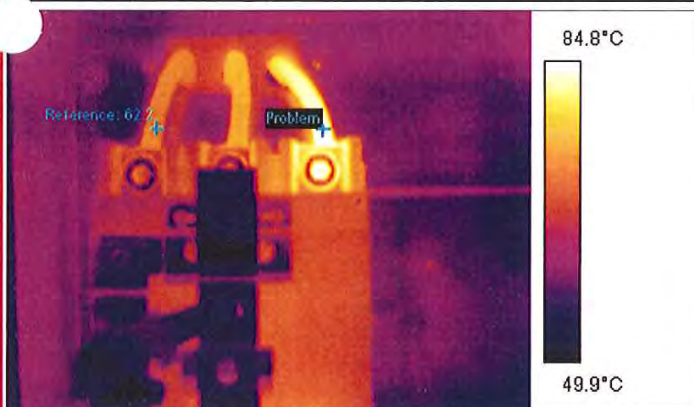
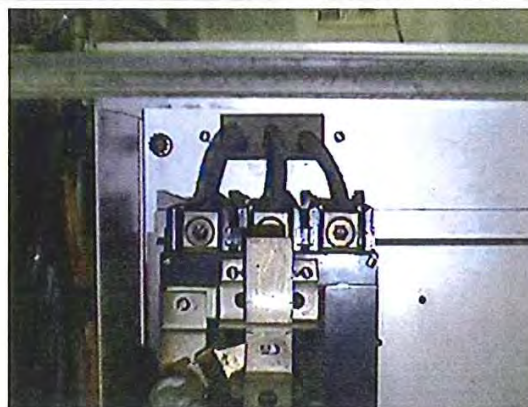
^[ PROBLEM ]^ - 62\IR\_2822.jpg

Additional loading and continued exposure to this condition will more than likely accelerate a failure of this device.

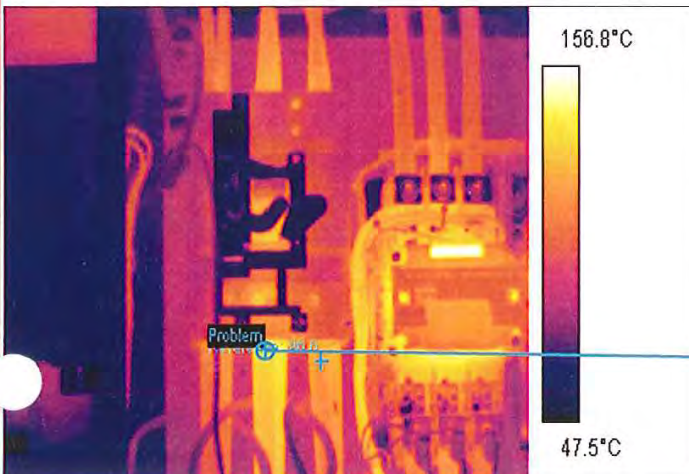
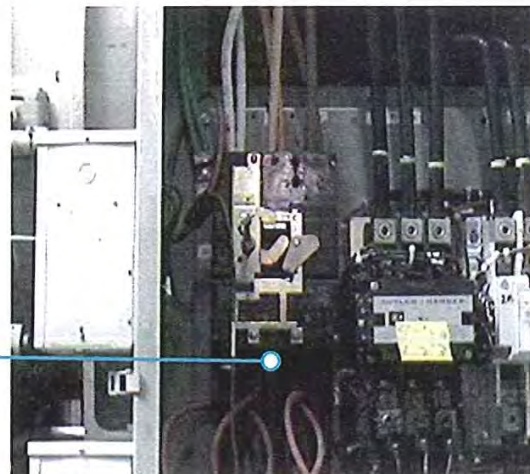
621DC\_3603.jpg

Additional loading and continued exposure to this condition will more than likely accelerate a failure of this device.

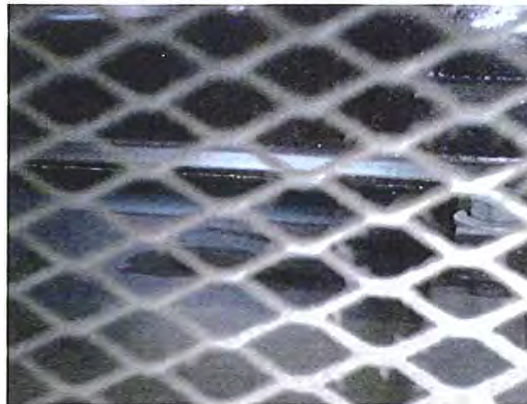
62IDC\_2984.jpg

There is possible resin residue beneath the phase coils.

Further coil testing must be done. Megger testing would be able to determine the state that the coils are in. It must be addressed immediately before further deterioration occurs to this transformer.

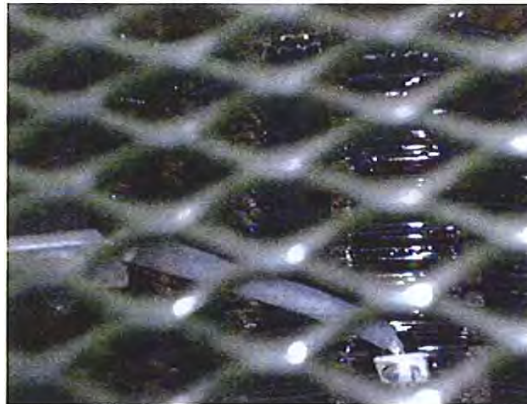
62IDC\_2985.jpg

Ultrasonic Anomaly, There is a significant higher decibal level and a strong sound of unwanted internal arcing on the 3rd phase coil in comparison to the 1st and second phase coils.

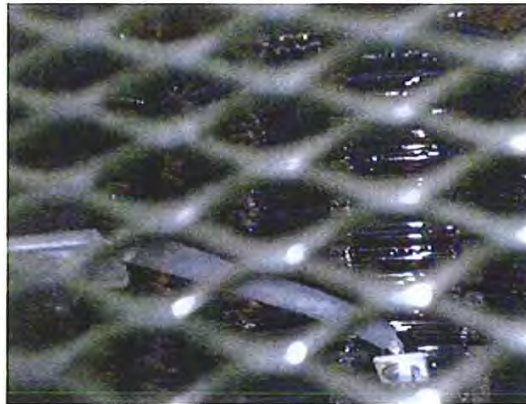
62IDC\_2985.jpg

Ultrasonic Anomaly, There is a significant higher decibal level and a strong sound of unwanted internal arcing on the 3rd phase coil in comparison to the 1st and 2nd phase coils.

Proper megger testing on all phase coils to determine deterioration.

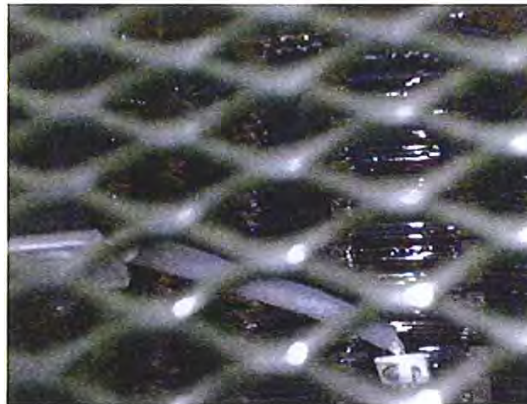
62DC\_2985.jpg

Ultrasonic Anomaly, There is a significant higher decibal level and a strong sound of unwanted internal arcing on the 3rd phase coil in comparison to the 1st and 2nd phase coils.

Proper megger testing on all phase coils to determine deterioration.

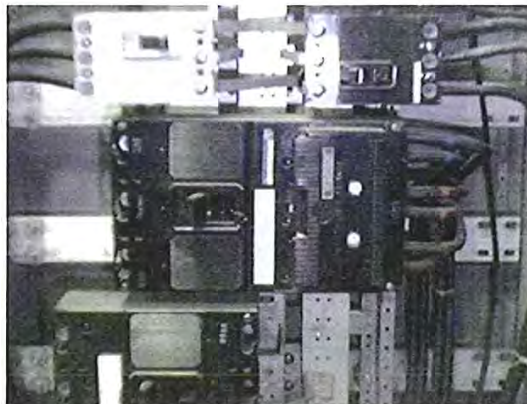
62\DC\_2990.jpg

Ultrasonic Anomaly, the contacts of breaker #11 are displaying very high decibal levels and need to be cleaned immediately.

Inspect and clean the contacts of this breaker, If the breaker appears to be in bad condition internally, "replace immediately".

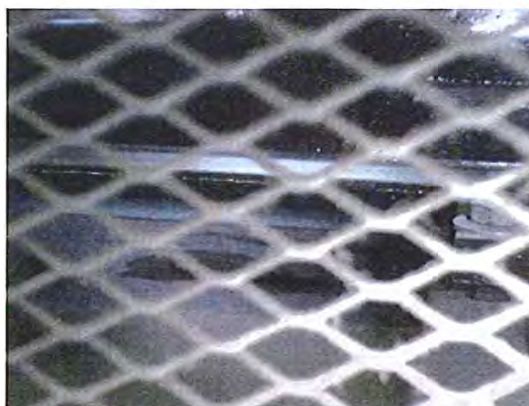
62IDC\_2984.jpg

There is possible resin residue beneath the phase coils.

Further coil testing must be done. Megger testing would be able to determine the state that the coils are in. It must be addressed immediately before further deterioration occurs to this transformer.

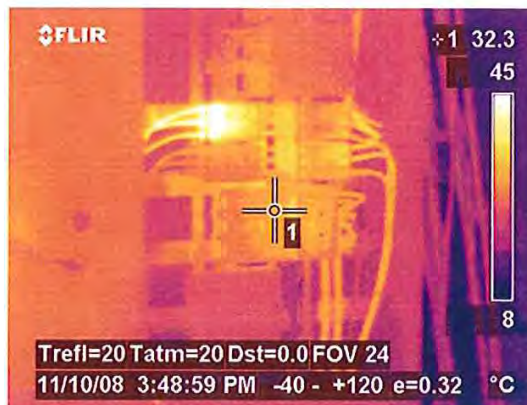
62lir\_2988.jpg

Millivolt drop is greater than 50% deviation of the lowest measured value on adjacent poles (2001 NETA Maintenance Testing Specification) or 100 millivolts at full load, which is defined as 80% of a device rating.

Deenergize device, clean, repair, or replace defective items as necessary and torque connection to manufacturer specifications.

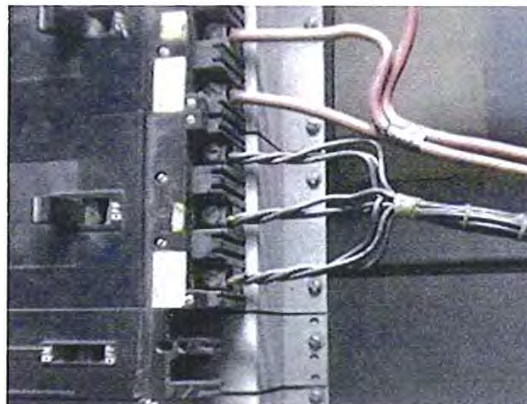
62IDC\_2995.jpg

Multiple conductors under one lug on a breaker or fused disconnect.

This may cause overloading of the protective device resulting in premature operation and unscheduled interruptions.

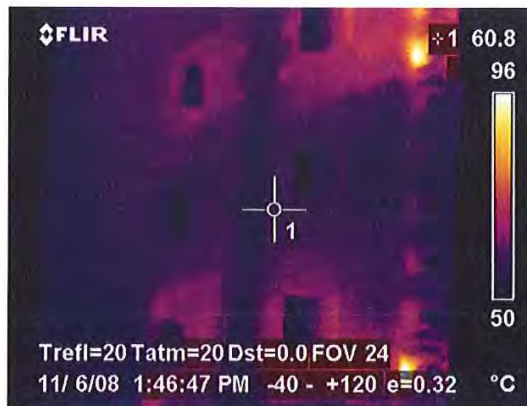
62lir\_2896.jpg

Current phase imbalance is greater than 20%.

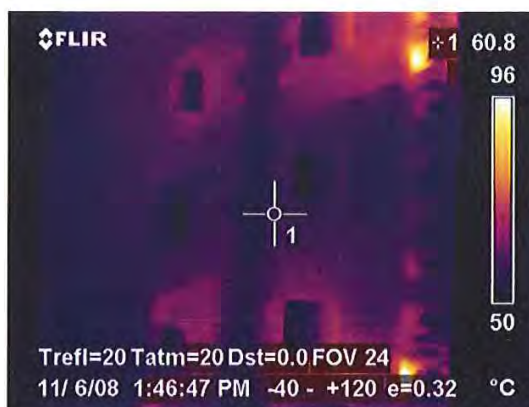
62lir\_2896.jpg

THDC%F (At the point of common coupling) is greater than 5% in an industrial building or greater than 20% in a commercial building. (IEEE 519-1992)

Not only will this cause increased heating at the main transformer, but it can cause excessive levels of voltage distortion that will escape the facility onto the utility distribution system and affect neighboring operations.

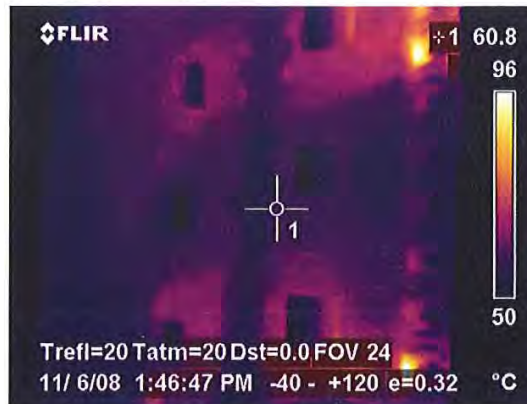
62\lr\_2896.jpg

THDC%F (At the point of common coupling) is greater than 5% in an industrial building or greater than 20% in a commercial building. (IEEE 519-1992)

Not only will this cause increased heating at the main transformer, but it can cause excessive levels of voltage distortion that will escape the facility onto the utility distribution system and affect neighboring operations.

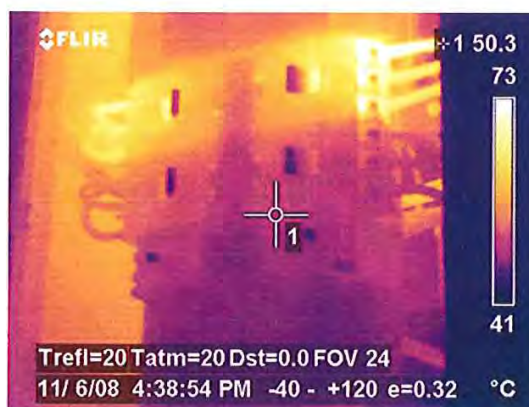
62lir\_2918.jpg

Current phase imbalance is greater than 20%.

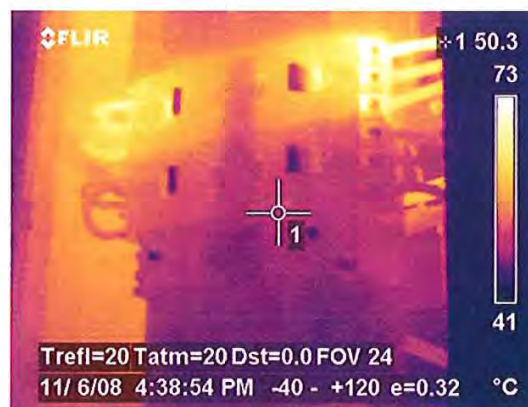
62lir\_2918.jpg

THDC%F (At the point of common coupling) is greater than 5% in an industrial building or greater than 20% in a commercial building. (IEEE 519-1992)

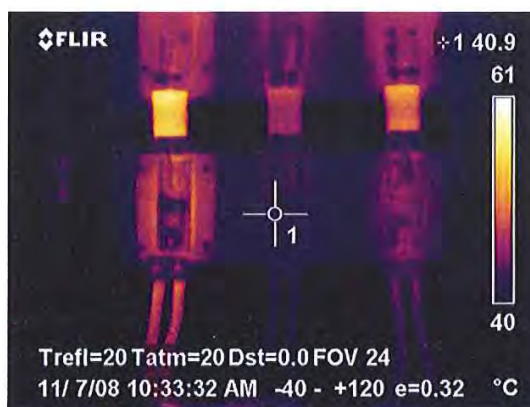
62\lr\_2926.jpg

Current phase imbalance is greater than 20%.

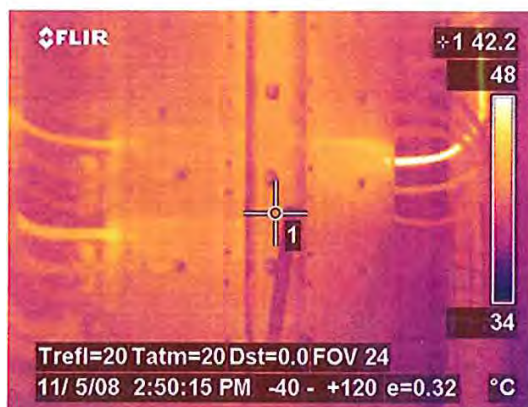
62lir\_2866.jpg

THDC%F (At the point of common coupling) is greater than 5% in an industrial building or greater than 20% in a commercial building. (IEEE 519-1992)

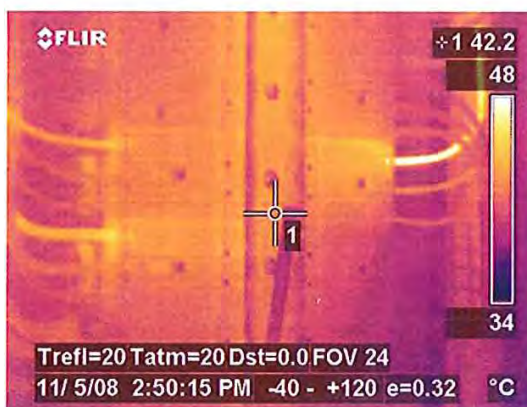
62lir\_2866.jpg

Current phase imbalance is greater than 20%.

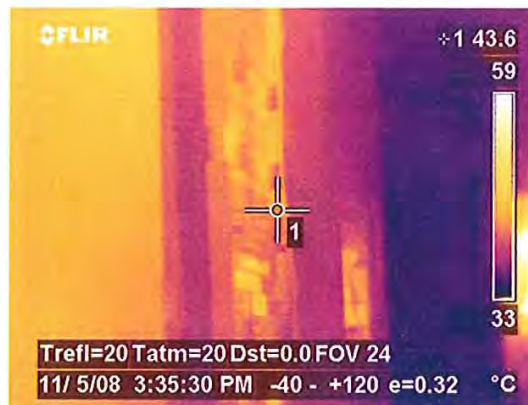
62lir\_2873.jpg

Current phase imbalance is greater than 20%.

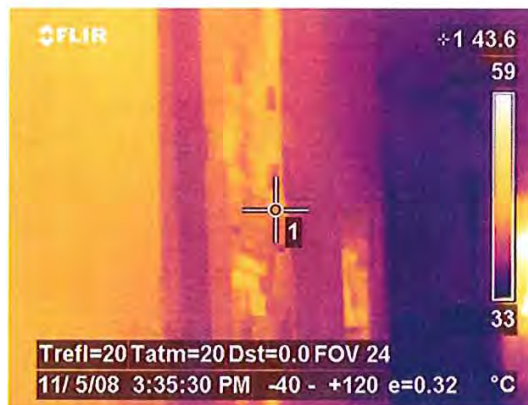
62\lr\_2873.jpg

THDC%F (At the point of common coupling) is greater than 5% in an industrial building or greater than 20% in a commercial building. (IEEE 519-1992)

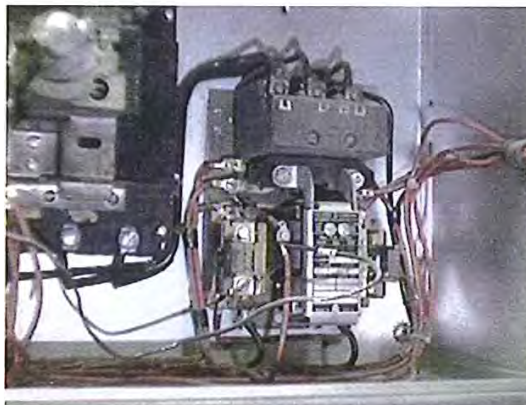
62lde\_2841.jpg

Ultrasonic Anomaly, The decibals are at high levels on this contactor in comparison to the other contactors surrounding it. Wave file-007

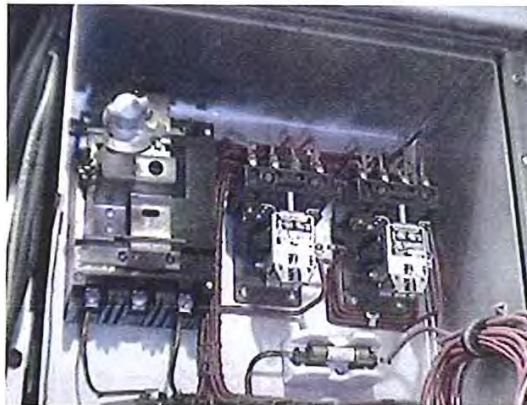
62ldc\_2839.jpg

Ultrasonic Anomaly, The decibal level of this contactor is far greater than the contactors surrounding it.  
Wave file-008
